Job Stamp 04-0120F4 SFOBB SAS
-------------------------------------

**Description of Operations @ W2 Cap Beam:**

EA	04-0120F4
Co-Rte-KP (PM)	SF-080-13.2/13.9 (8.2/8.7)
Structure Rep.	Rick Morrow

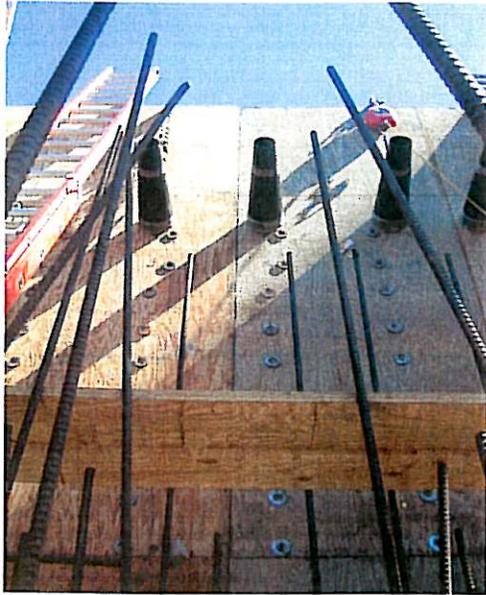
File Name:	Sept-22-2008 W2 Cap 005		
Date:	09-22-08	By Int:	M Bruce

Description: Washers from the #19 formsavers nailed to the plywood of the W2E east bulkhead forms.

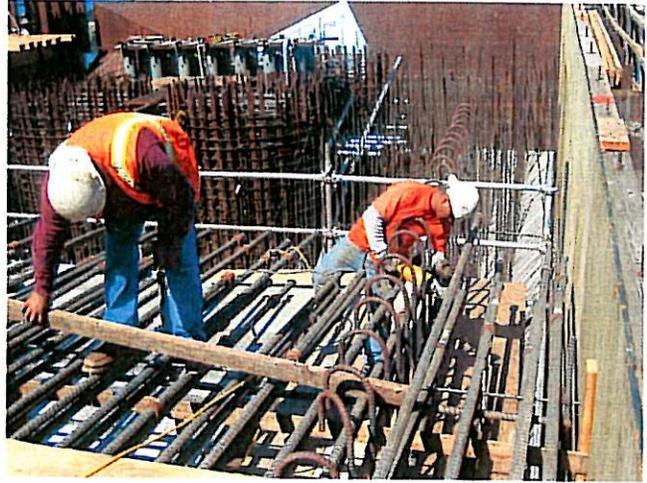
File Name:	Sept-22-2008 W2 Cap 011		
Date:	09-22-08	By Int:	M Bruce

Description: Ironworkers seen propping the #43 transverse bars to facilitate grinding operations.

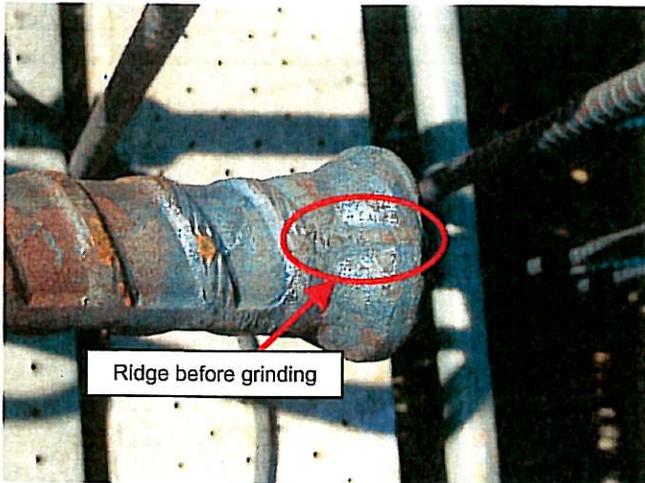
File Name:	Sept-22-2008 W2 Cap 008		
Date:	09-22-08	By Int:	M Bruce

Description: Photo of a #43 transverse bar before grinding operations. Per my conversation with RPS foreman Tim Greenlee he believes that the ridge seen in the photo above caused the excessive failure in slip in addition to the slag around the mushroomhead. I mentioned to RPS foreman Tim Greenlee that a few of the mushroomheads were not staggered at 600mm apart.

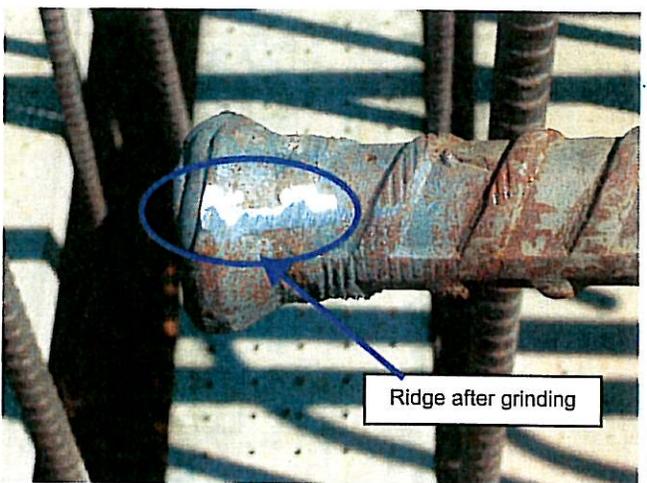
File Name:	Sept-22-2008 W2 Cap 007		
Date:	09-22-08	By Int:	M Bruce

Description: Photo of a #43 transverse bar after grinding operations. Many of the mushroomheads appeared to have drastic deformations even after grinding near the beveled edges and the bearing end of the bar. The vertical bars mushroomheaded in the column cages didn't have these characteristics. One theory regarding the difference in quality was the operator heating the bar.
