STATE OF CALIFORNIA	Job Stamp	7-day Const. Calendar	Day No. 611
DEPARTMENT OF TRANSPORTATION	SFOBB SAS	Project Work Day No.	Day No. 811
Form HC-10A (Rev. 6/80)	04-0120F4	Date	08/15/2008

ASSISTANT RESIDENT ENGINEER'S

Daily for Regional Steel

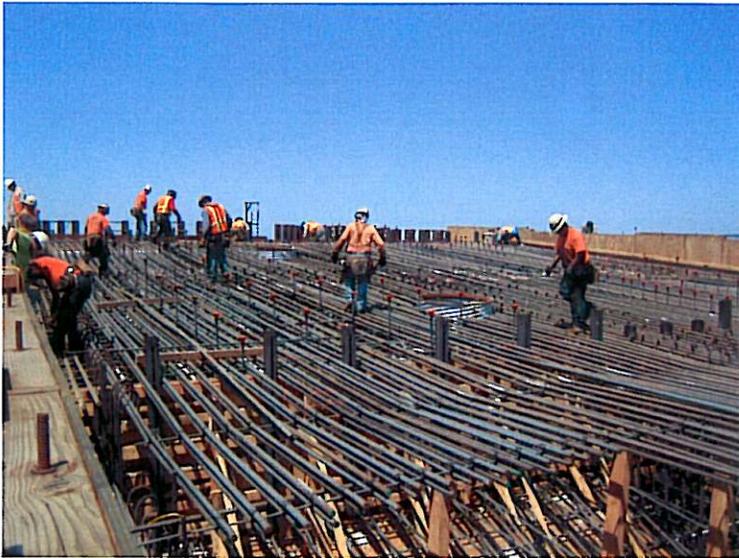
Installing rebar in the top mat.

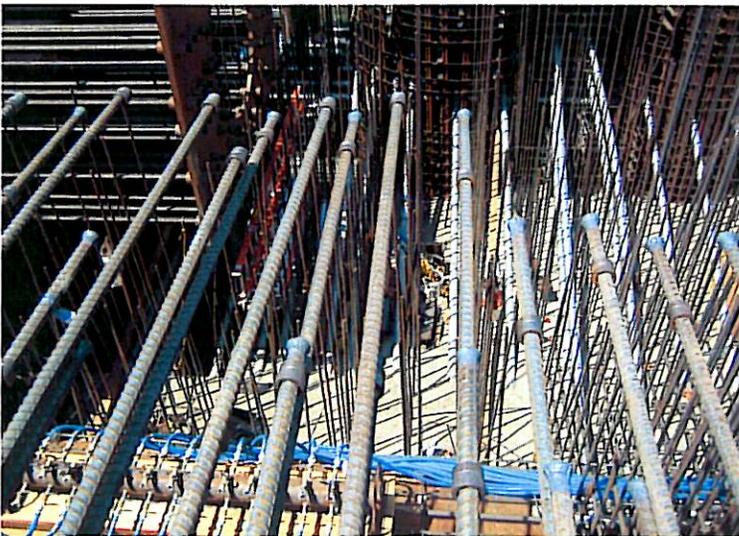
Field forged #43 reinforcement.

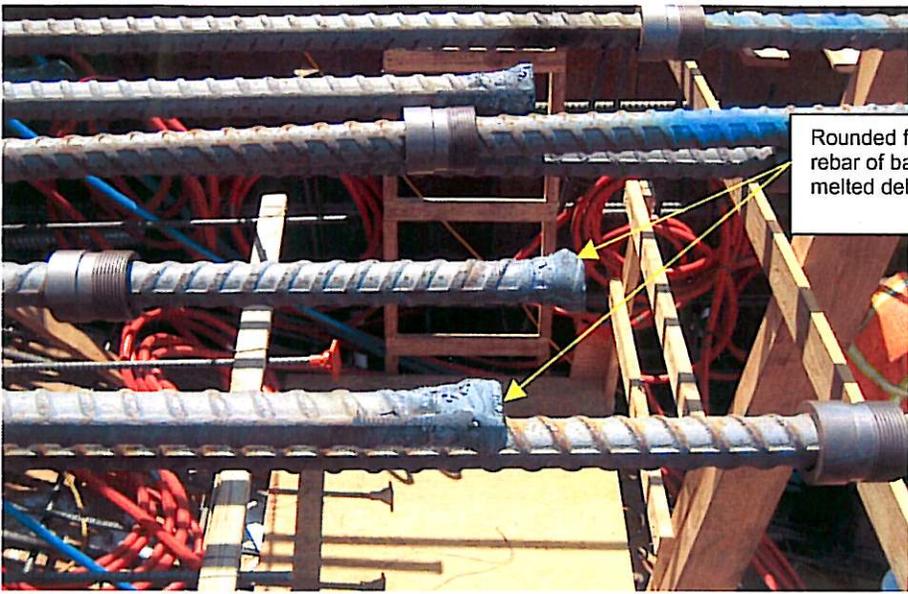
- Observed forged rebar with male couplers to be of bad quality, many of the forged mushrooms look rounded with melted debris on bar.

Rounded field forged rebar of bad quality, with melted debris on bar.
