Job Stamp:
04-SF-80-13.2/13.9 04-0120F4
SFOBB SAS
San Francisco Co. in San Francisco
Fm 0.6 km to 1.3 km East of Yerba Buena
Tunnel East Portal

ASSISTANT RESIDENT ENGINEER'S DAILY BRIDGE REPORT

Location: E2 Cross Beam
Remark: ironwork/mtg w/TYLIn/formwork
Weather: warm/hot
Hi 91F/Lo 59F

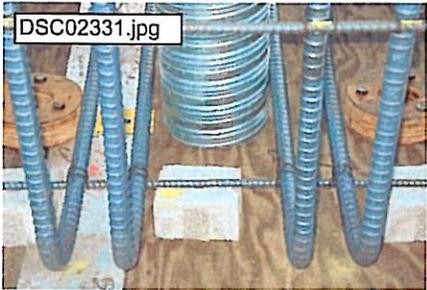
DSC02331.jpg

few bars may be not be placed at all due to the lack of space within column cage areas.
 I asked one of the designers from T.Y.Lin if the clearance of 110 on the bottom left corner of Detail A on sheet 512R1 was in reference to the bottom of the stirrup or the bottom of the main reinforcement #57. As the ironwork is placed now, the clearance is to the bottom of the #57 as planned. If this 110mm was to the bottom of the #25 stirrup, there would be 4 inches of unreinforced concrete. Alex (T.Y.Lin) stated that this clearance was to the bottom of the #57 bar.

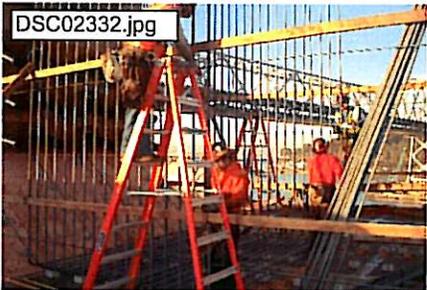
DSC02332.jpg

Question was brought up about the hoops around the column cages. According to plan, these hoops will need to be placed at a 2% slope to match the cross fall of the cross beam. These hoops would need to be oval shaped. This is not currently the case. T.Y.Lin is okay with them being oval. The T&L bars through this area are more important.
 The 160/180mm spacing I previously mentioned will not likely be achieved based on the configuration of the ducts. In DSC02331, the bars are placed at 250 but already close to snug tight against the ducts.
 Ironwork continues in the south end region of the cross beam by the bulkhead (DSC02332). Ironworkers also continue to align hoops on the barge while alternating the splices to ease installment over the column cages (DSC02333).
