Job Stamp:
04-SF-80-13.2/13.9 04-0120F4
SFOBB SAS
San Francisco Co. in San Francisco
Fm 0.6 km to 1.3 km East of Yerba Buena
Tunnel East Portal

ASSISTANT RESIDENT ENGINEER'S DAILY BRIDGE REPORT

Location: E2 Cross Beam	Weather: partly cloudy
Remark: Ironwork/PT ducts	Hi 64F/Lo 55F

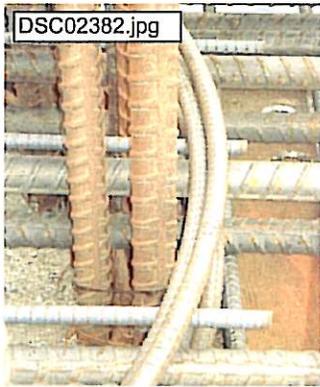
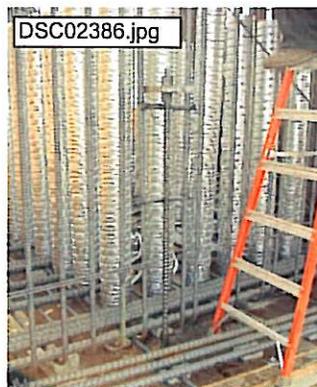
ABF did not work overtime today
In the morning around 0830, Masoud informed the general foreman (Bob) that the hoops around the column cages were wrong. They were oversized and were not properly bearing against the vertical reinforcement of the Pier (DSC02382/DSC02387). I noticed this as well after seeing that the hoops were not bundled vertically according to plan. They were carelessly bundled with the transverse #57 lying on top. 0930, Masoud reiterates that the hoops are wrong, not to proceed until the issue is addressed, and that they will be proceeding at their own risk; Bob stated that he talked to ABF about the issue and that ABF states that there wasn't a problem and to proceed. Workers are seen continuing to tie the #57s on top of the hoops.
Mark MacDonald (ABF engineer) arrives on the site and gives instruction to Bob on how to tie the grillage ironwork in the shear key/bearing areas using ISD model from RFI 967.

I discussed the hoops with Mark after Masoud left and showed him how there was a large gap between the hoops and the vertical ironwork. Pushing the hoops back and forth, he acknowledged the situation and asked if they could center the ring. I said I would have to talk to the designer

Pushing the hoops back and forth, he acknowledged the situation and asked if they could center the ring. I said I would have to talk to the designer. The designers were unable to be reached so Ron Matin (CT) came to the site to discuss the hoops. Measuring between the vertical steel and the hoop after pushing the hoop to one side against the vertical steel on the other side, the hoops were oversized by about 22mm.
