Job Stamp:
04-SF-80-13.2/13.9 04-0120F4
SFOBB SAS
San Francisco Co. in San Francisco
Fm 0.6 km to 1.3 km East of Yerba Buena
Tunnel East Portal

Report No. 7-day const. cal.: 653
Project work day: 863
Date the Shift Began: 9/26/08
 NIGHTWORK FRIDAY
Shift Hrs Start 6:30 Stop 15:00
Engineer's Hrs Start 6:45 Stop 15:15

ASSISTANT RESIDENT ENGINEER'S DAILY

Location: E2 Cross Beam	Weather: warm w/slight breeze
Remark: ironwork	Hi 67F/Lo 55F

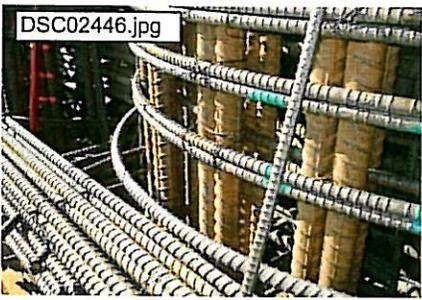
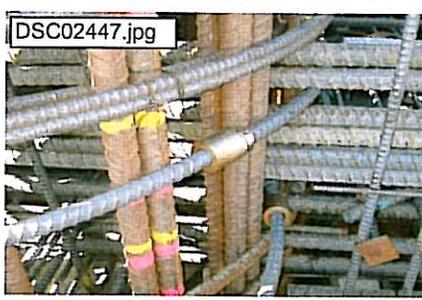
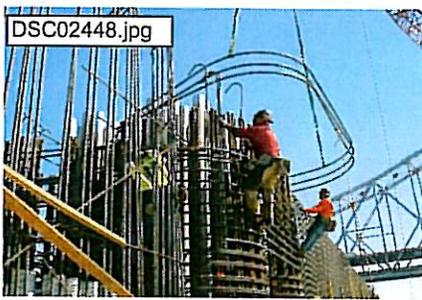
The #36 hoops that were allowed to replace the #25 hoops at the bottom of the column cages from RFI 962, have been started. However, the hoops were fabricated too large. They came as two piece sets. In DSC02446, the bottom hoop next to the #43s on the left side of the picture, are too wide and do not rest against the vertical steel from the Pier. The measured space between the vertical steel and the hoop is about 3.5 inches. T.Y.Lin has been notified. A coupler on the two piece hoop can be seen in DSC02447. See Diary on Sept 11.
The #36 hoops confining all four column cages together at the top - 2.8m from the soffit - have also been started (DSC02448).
Ironworkers were seen cutting several hoops away from the E2E column cages. I did not ask why they were doing this.
Minor safety incident: In the afternoon I smelled smoke what smelled as if there was burning wood. One of the ironworkers agreed with me but we

Location: E2 Cross Beam
Weather: warm w/slight breeze
 Minor safety incident: In the afternoon I smelled smoke what smelled as if there was burning wood. One of the ironworkers agreed with me but we could not find the source; nor could we see any smoke. Moments later I noticed one of the pant legs of the apprentice pile butt (Jamal) had sparks. I immediately grabbed a water bottle that was close to me and poured it on his leg. The apprentice was doing a lot of cutting of metal plates in order to remedy the support system of the vertical rods within the column cages.
 Ironworkers continue to place steel for the PT blockouts at the north end of the cross beam.
