Job Stamp 04-0120F4 SFOBB SAS

ASSISTANT RESIDENT ENGINEER'S **CONTRACTOR – ABFJV, Subs CMC-RS**

Description of Operations @ W2 Cap Beam:

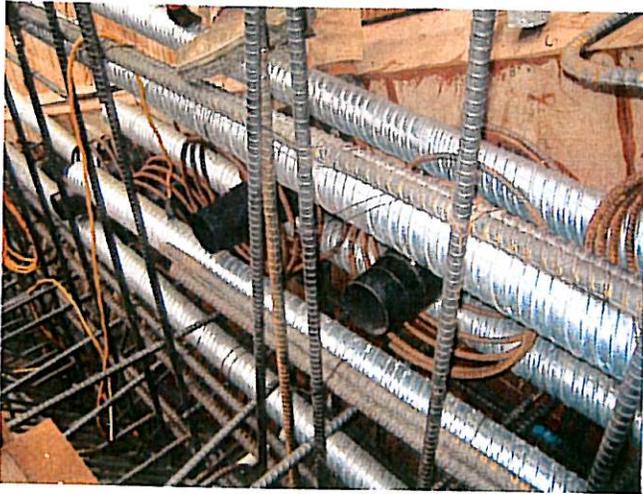
File Name:	Oct-07-2008 W2 Cap 001
Date:	10-07-08
By Int:	M Bruce

Description: There are multiple conflicts between transverse tendons and continuity tendons. As anticipated the spiral pitch has been dramatically altered from the SDI shop drawings as seen in the photo.

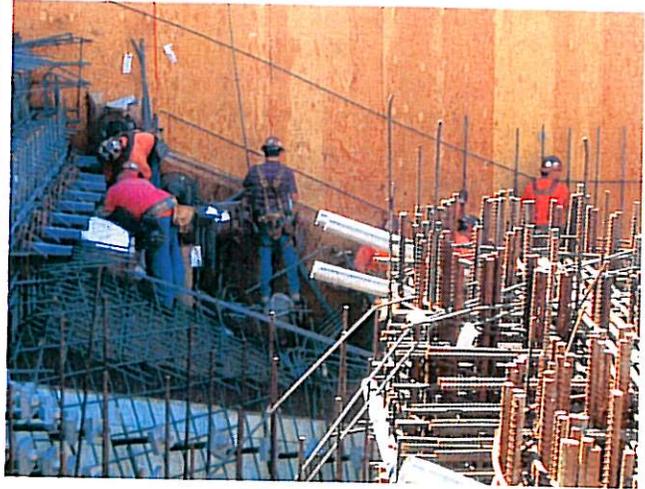
File Name:	Oct-07-2008 W2 Cap 005
Date:	10-07-08
By Int:	M Bruce

Description: Ironworkers seen placing berry bars on the southwest wall near the deviation saddle. Also marking points for placing #25 vertical bars and #36 horizontal bars.

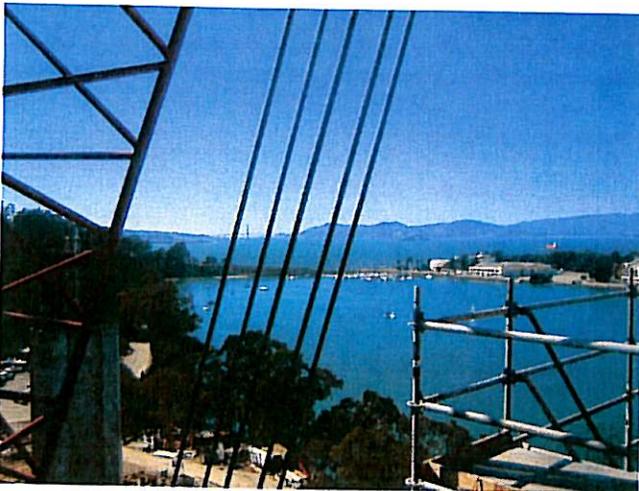
File Name:	Oct-07-2008 W2 Cap 008
Date:	10-07-08
By Int:	M Bruce

Description: Cables of the lifting block from the Manitowoc 4100W which were a few feet away from the stairs on the soffit. The cables could have been grabbed from the stairs.

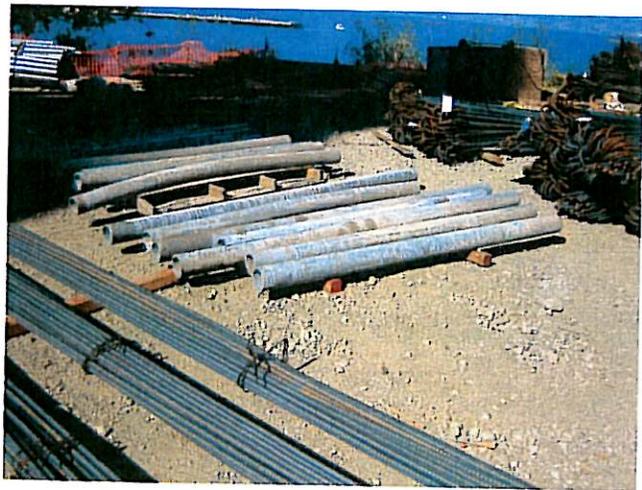
File Name:	Oct-07-2008 W2 Cap 010
Date:	10-07-08
By Int:	M Bruce

Description: X-strong ducts on the ground which need to be cleaned from dirt, grease, etc. ABF has been notified several times to clean materials before incorporating it into the permanent structure.
