Job Stamp 04-0120F4 SFOBB SAS
-------------------------------------

ASSISTANT RESIDENT ENGINEER'S **CONTRACTOR – ABFJV, Subs CMC-RS**

**Description of Operations @ W2 Cap Beam:**

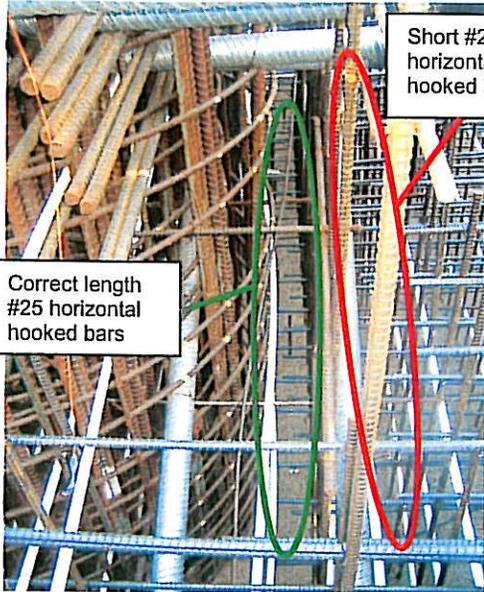
File Name:	Oct-18-2008 W2 Cap 005		
Date:	10-18-08	By Int:	M Bruce
Description:	Some rows of the #25 horizontal ties are approximately a few feet short from the east side of the column cages. Per sheet 497S19 section F-F the bars need to be closer to the east side of the cages.

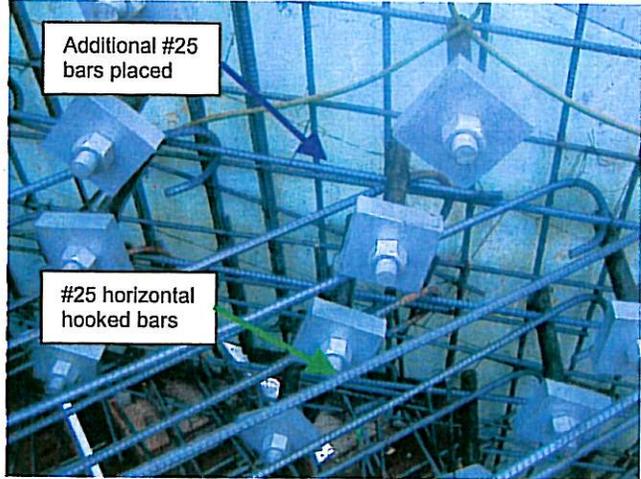
File Name:	Oct-18-2008 W2 Cap 006		
Date:	10-18-08	By Int:	M Bruce
Description:	Late Friday ironworkers placed additional #25 bars through the vertical bars at the deviation saddle and tried to engage the hooks of the #25 horizontal bars.

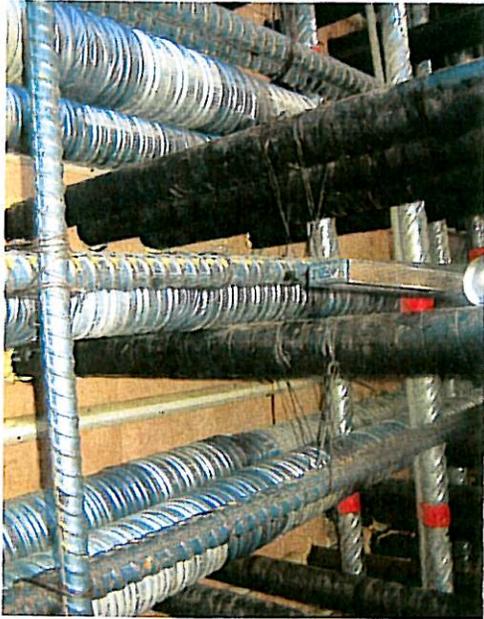
File Name:	Oct-18-2008 W2 Cap 008		
Date:	10-18-08	By Int:	M Bruce
Description:	CBT-3, 4, 7 and 8 touching the Macalloy rods at the South Hinge K assembly. This issue is on the punchlist for ABF and CMC-RS to correct before concrete placement.

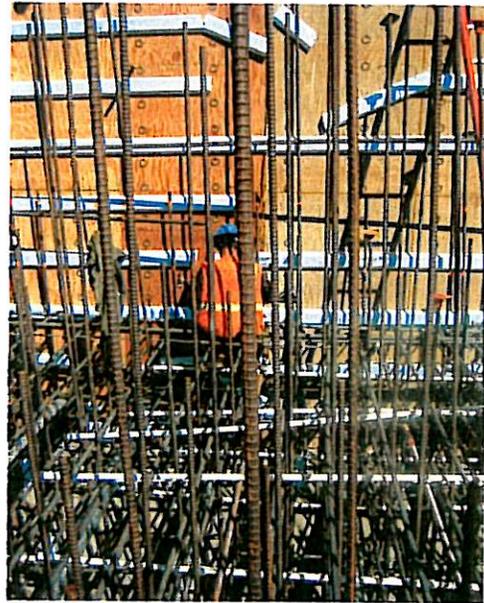
File Name:	Oct-18-2008 W2 Cap 010		
Date:	10-18-08	By Int:	M Bruce
Description:	Piledriver seen fixing the displaced/damaged polystyrene shear keys at the W2E east bulkhead. This was an item on the punchlist given to ABF and CMC-RS.
