Job Stamp:
04-SF-80-13.2/13.9 04-0120F4
SFOBB SAS
San Francisco Co. in San Francisco
Fm 0.6 km to 1.3 km East of Yerba Buena
Tunnel East Portal

ASSISTANT RESIDENT ENGINEER'S DAILY

Location: E2 Cross Beam		Weather: partly cloudy
Remark: ironwork/formwork		Hi 71F/Lo 62F

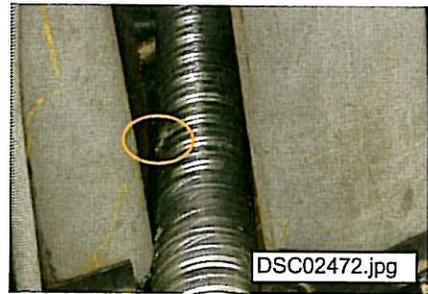
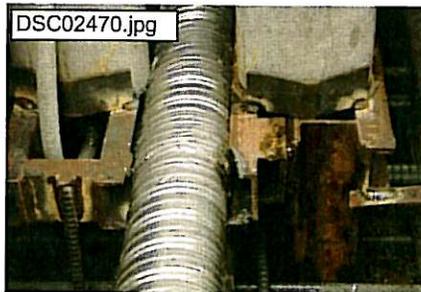
In the morning one of the pile butts was using a flame close to one of the ducts at the E2W column cages within the vicinity of the vertical rods. The duct tape caught fire and was quickly put out. It was at this time that I noticed a hole in the duct: left side of duct in DSC02472. The pile butt that was using the flame knew of this hole and was working on repairing it.
I also noticed how congested ABFs support system is. The channel beams supporting the large pipes have less than an inch of clearance. I am skeptical as to whether or not the aggregate will be able to flow through. Although they will be using SCC, if the opening of this hole is blocked, there will essentially be a rockpocket through the entire channel beam (DSC02470 & DSC02471).

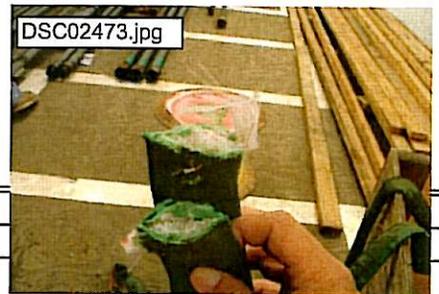
To follow up from yesterday's concern about the rigging straps ("chokes"), I found the one that I saw damaged and brought it to the attention of the foreman (RPS-Jon) and asked if it belonged to either RPS or ABF. He said it belonged to RPS and acknowledged that it needed to be put out of commission. He immediately cut the strap (DSC02473).
