Job Stamp 04-0120F4 SFOBB SAS

ASSISTANT RESIDENT ENGINEER'S **CONTRACTOR – ABFJV, Subs CMC-RS**

Description of Operations @ W2 Cap Beam:

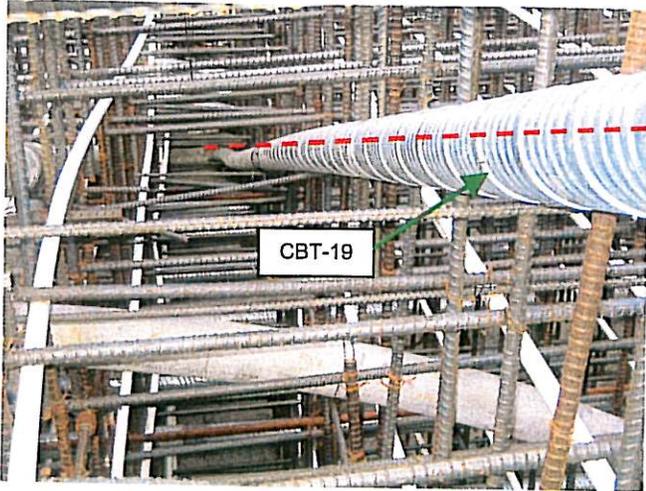
File Name:	Nov-05-2008 W2 Cap 006
Date:	11-05-08
By Int:	M Bruce

Description: CBT-19 still needs to be profiled prior to concrete placement as the ironworkers were supposed to correct this yesterday. However there still is time to correct this duct.

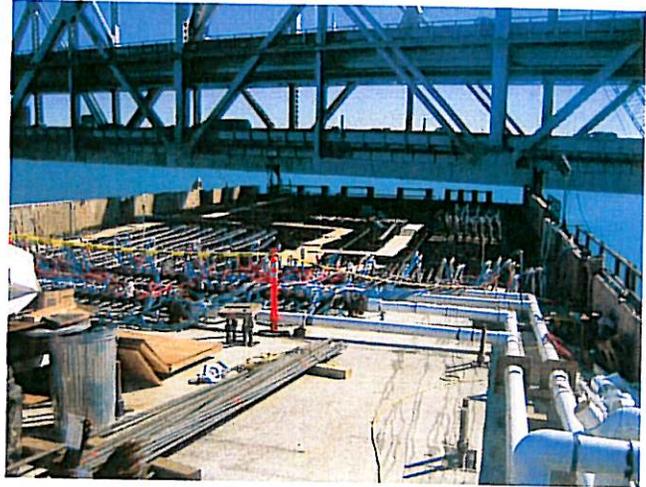
File Name:	Nov-06-2008 W2 Cap 001
Date:	11-06-08
By Int:	M Bruce

Description: Pour 4 progress to date looking south.

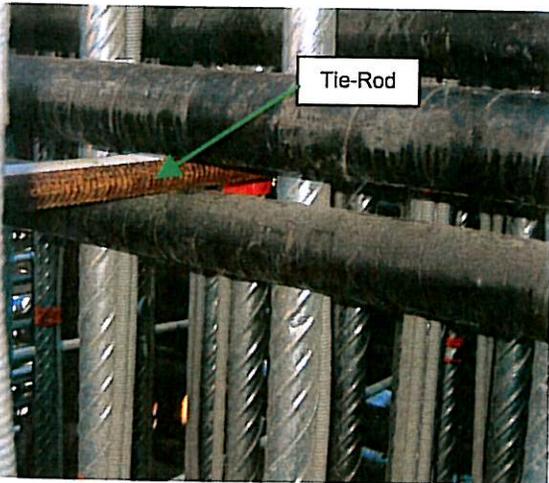
File Name:	Nov-06-2008 W2 Cap 006
Date:	11-06-08
By Int:	M Bruce

Description: Tie rod bearing on a Macalloy rod in the south Hinge K assembly. This picture was shown to Nigel and he agreed to resolve this issue.

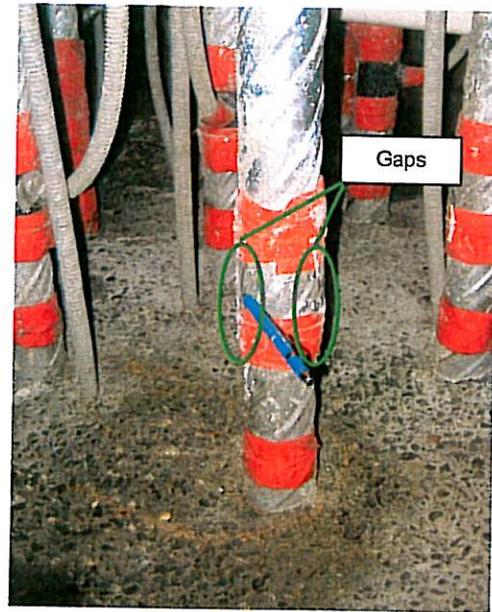
File Name:	Nov-06-2008 W2 Cap 007
Date:	11-06-08
By Int:	M Bruce

Description: Typical gaps found in the grout tube saddles at the bottom of the long vertical rods. This picture was shown to Nigel and he agreed to resolve this issue.
