Job Stamp 04-0120F4 SFOBB SAS

ASSISTANT RESIDENT ENGINEER'S **CONTRACTOR – ABFJV**

**Description of Operations @ W2 Cap Beam:**

EA	04-0120F4
Co-Rte-KP (PM)	SF-080-13.2/13.9 (8.2/8.7)
Structure Rep.	Rick Morrow

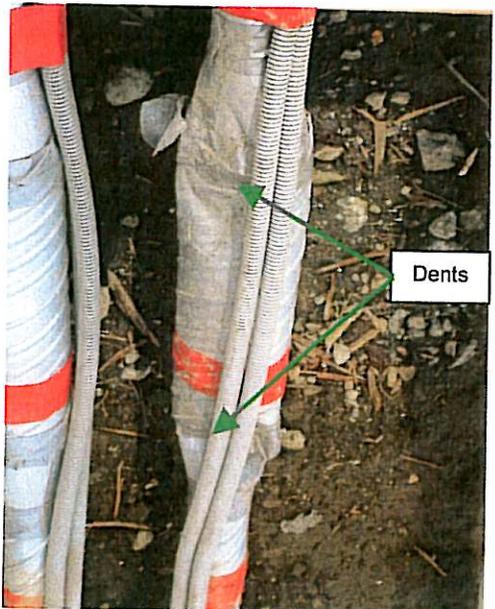
File Name: Nov-11-2008 W2 Cap 001  
 Date: 11-11-08 By Int: M Bruce  
 Description: Short vertical PT bars mobilized on the ground, which had dents near the coupler. ABF pildrivers were seen repairing the dents to one vertical bar prior to placing in between the W2W Hinge K assemblies.

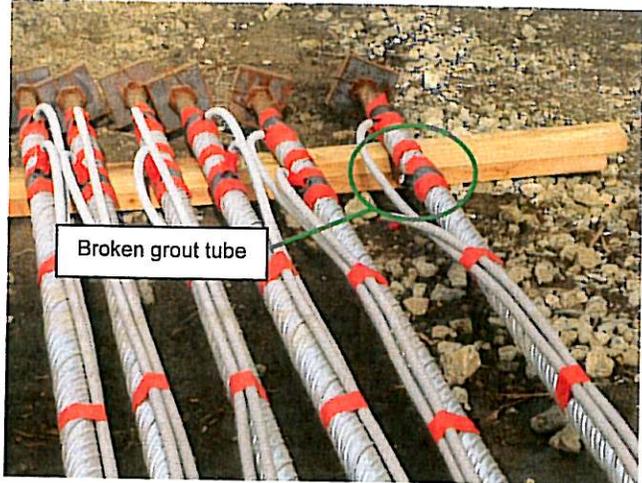
File Name: Nov-11-2008 W2 Cap 002  
 Date: 11-11-08 By Int: M Bruce  
 Description: Broken grout tubes were found on the short vertical PT bar assembly.

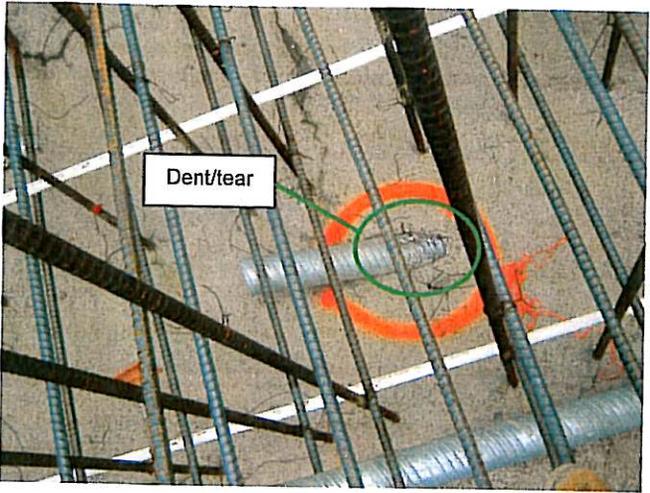
File Name: Nov-11-2008 W2 Cap 004  
 Date: 11-11-08 By Int: M Bruce  
 Description: Photo of CBT-20, which has a major dent and tear near the face of concrete. ABF and or RS have presumably identified this duct to be fixed denoted by the orange spray paint.

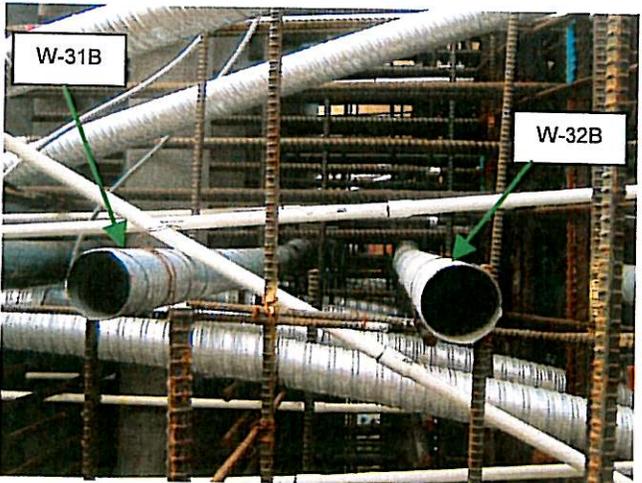
File Name: Nov-11-2008 W2 Cap 007  
 Date: 11-11-08 By Int: M Bruce  
 Description: Continuity tendons W-30B through W-37B need to be straightened out in the column cages. RS has been notified of this issue several times. The X-strong pipes are the culprit of the problem coupled by the column cage rebar. This item was on the pour 4 punchlist for E-30B to E-37B that is similar.

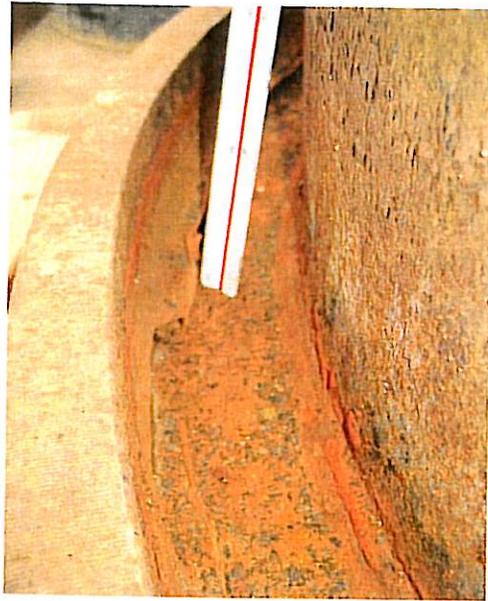
File Name:	Nov-11-2008 W2 Cap 008
Date:	11-11-08
By Int:	M Bruce

Description: It appeared that the falsework settled after pour 4 looking at a sandjack located near the woodshop. A settlement of 1/4" has been recorded thus far.

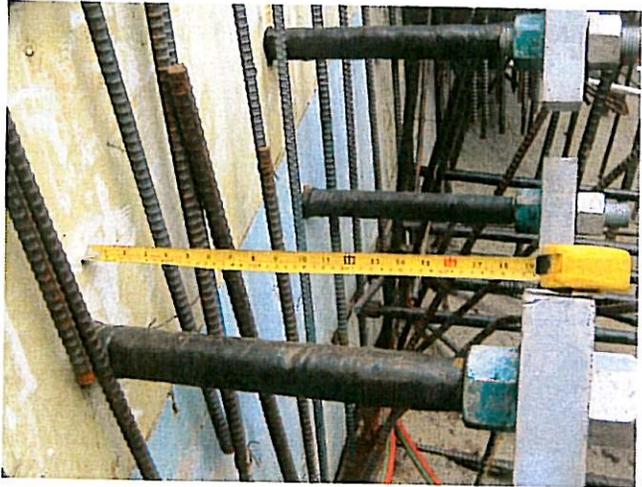
File Name:	Nov-11-2008 W2 Cap 012
Date:	11-11-08
By Int:	M Bruce

Description: Random deviation saddle anchor rods were measured at 485mm from the grout pad and the bottom of the anchor plate as seen in the photo above. A measurement of 390mm was measured from the steel forms to the end of the rod on the front side.

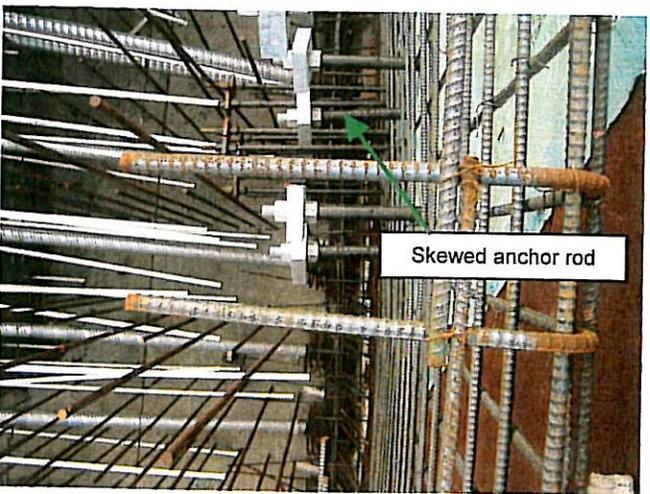
File Name:	Nov-11-2008 W2 Cap 016
Date:	11-11-08
By Int:	M Bruce

Description: Skewed anchor rods were found mostly at Panel CC. As a result the distance from the grout pad was shortened by roughly 30mm to the bottom of the anchor plate.

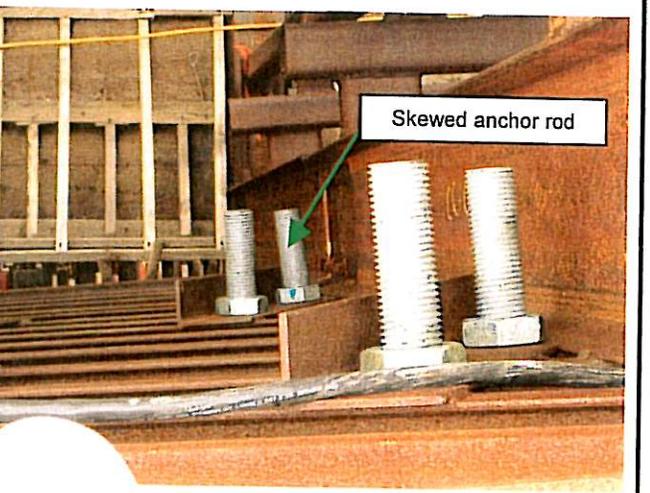
File Name:	Nov-11-2008 W2 Cap 018
Date:	11-11-08
By Int:	M Bruce

Description: The front side of the anchor rod seen in the previous photo. It appears that some of the templates on the steel deviation saddle forms don't "lock" in the anchor rods sufficiently therefore some movement may occur.
