Job Stamp 04-0120F4 SFOBB SAS

Const. Calendar:	722			
Project Work Day No.:	932			
Date	12/04/2008			
Inspectors	Start	08:40	Stop	09:20
Hours		12:10		16:30
Shift Hours		07:00		16:30

ASSISTANT RESIDENT ENGINEER'S **CONTRACTOR – ABFJV, Subs CMC-RS**

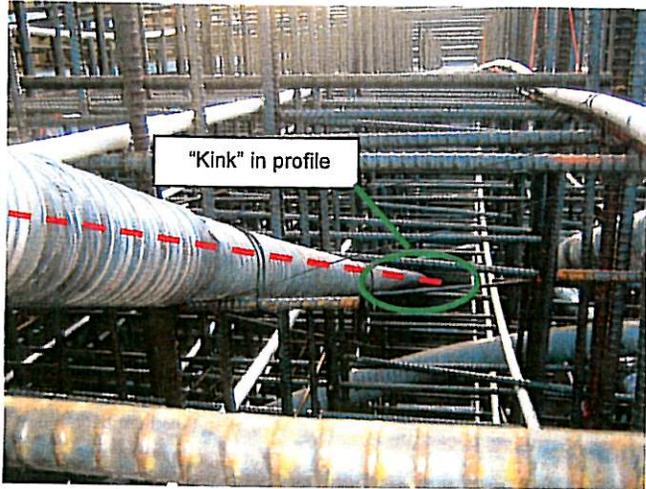
File Name: Dec-04-2008 W2 Cap 001

Description: Transverse tendon CBT-19 needs to be straightened in profile.

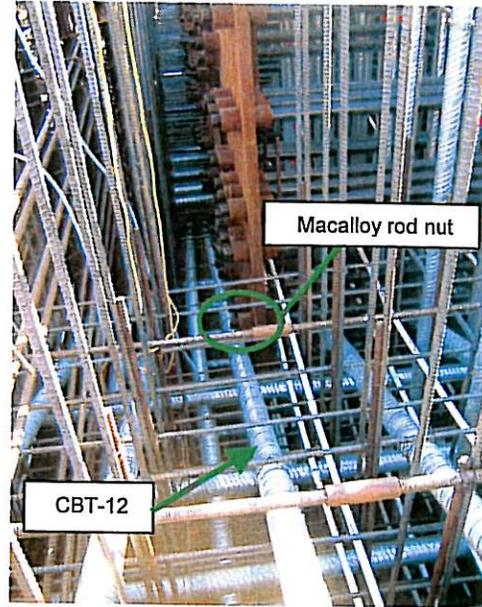
File Name: Dec-04-2008 W2 Cap 005

Description: Similar to the south end a nut attached to a Macalloy rod on the north Hinge K assembly was touching the top of the duct for transverse tendon CBT-12.

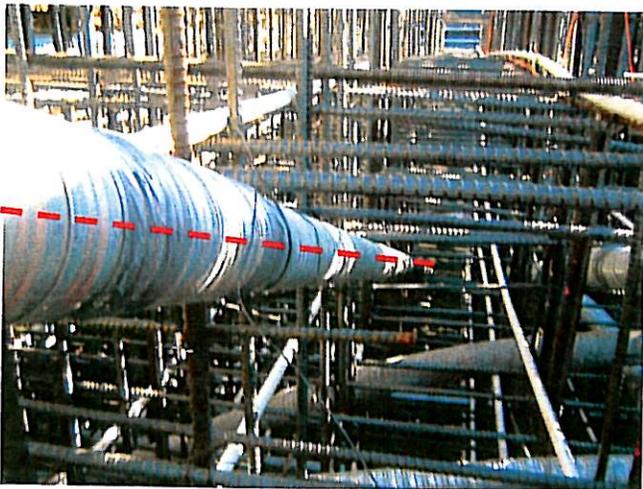
File Name: Dec-04-2008 W2 Cap 007

Description: Transverse tendon CBT-19 straightened in profile after the ironworkers corrected the duct.

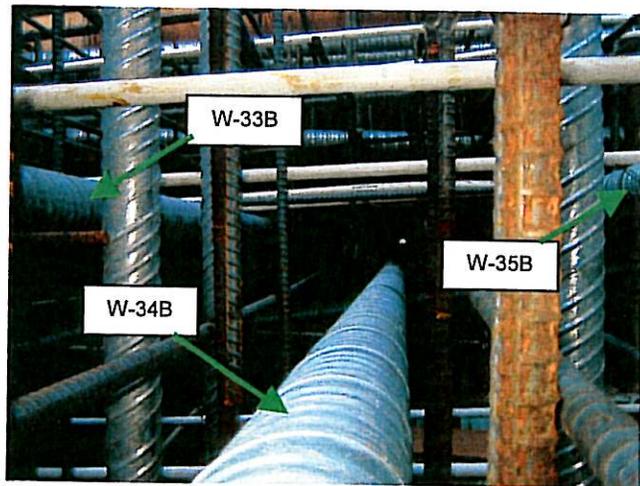
File Name: Dec-04-2008 W2 Cap 009

Description: Photo of continuity tendon W-34B taken from the north W2W column cage after being adjusted in elevation. It was difficult to get a measurement of the bearing plate. However the duct was straight from a mark on the rebar where the picture was taken, therefore the bearing plate is in the correct location. Also the relative location of the duct was compatible with plan sheet 470R3.

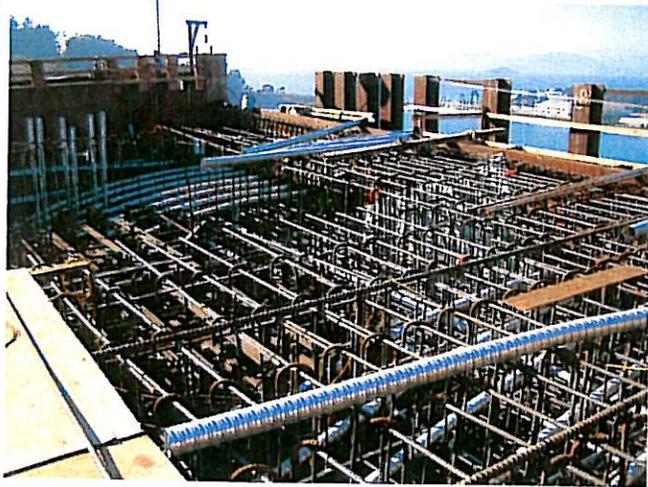
File Name:	Dec-04-2008 W2 Cap 010		
------------	------------------------	--	--

Description: Photo of the flexi-duct for transverse tendons CBT-9 to CBT-15 placed today.

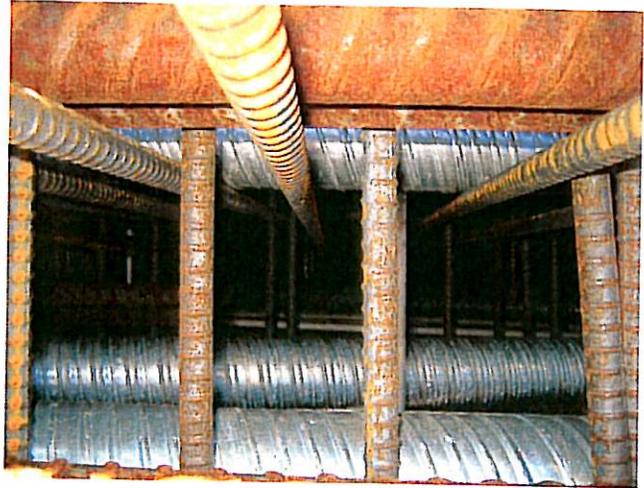
File Name:	Dec-04-2008 W2 Cap 012		
------------	------------------------	--	--

Description: Photo taken on the south end of the E2 cap beam with the assistance of a spotlight. I spoke with Jim Davidson about cutting holes in the top forms near the shear keys, bearings, and wide areas of the rebar to which he agreed. No forms were placed while I was in the field as I left at 4:30pm.
