Job Stamp 04-0120F4 SFOBB SAS

Const. Calendar:	723 and 724			
Project Work Day No.:	933 and 934			
Date	12/05/2008 and 12/06/2008			
Inspectors	Start	08:40	Stop	11:10
Hours		20:30		24:00
		00:00		04:15
		05:30		08:30
Shift Hours		07:00		15:30
		20:30		24:00
		00:00		08:30

ASSISTANT RESIDENT ENGINEER'S CONTRACTOR – ABFJV, Subs CMC-RS and Conco

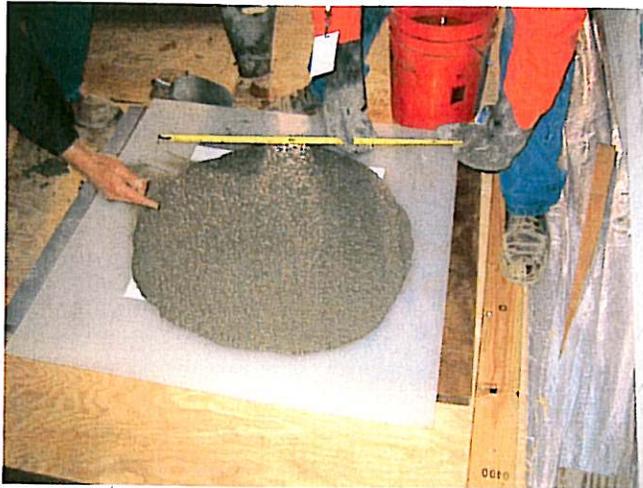
File Name:	Dec-05 and 06-2008 W2 Cap 005
Date:	12-05-08
By Int:	M Bruce

Description: One of the successful flow tests done from the first three trucks where the flow was 27 1/2". This was within the tolerance of ± 2" from the target value of 28".

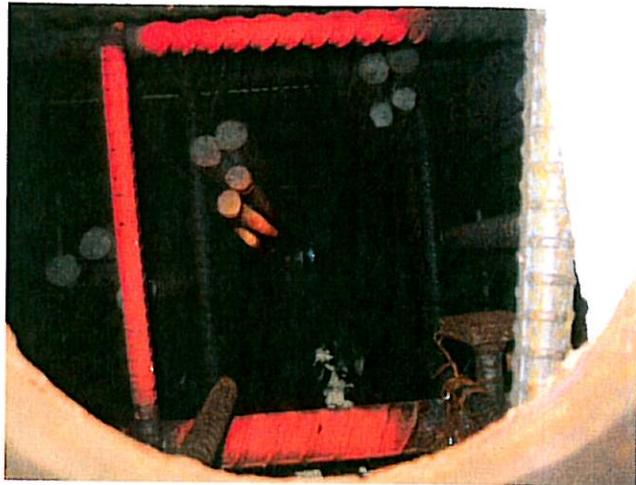
File Name:	Dec-05 and 06-2008 W2 Cap 009
Date:	12-05-08
By Int:	M Bruce

Description: Photo taken from one of the southern access holes around 10:00pm. The photo taken from the camera didn't reflect the actual sight down the access holes, however it still was difficult to see down inside the forms.

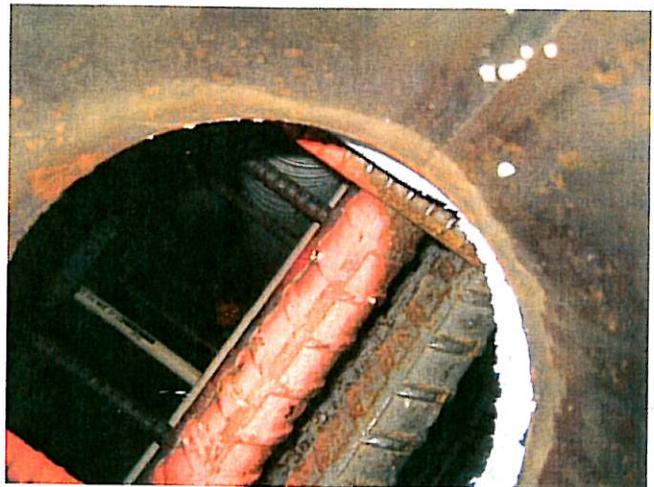
File Name:	Dec-05 and 06-2008 W2 Cap 011
Date:	12-05-08
By Int:	M Bruce

Description: Access hole on the south end where rebar and PVC pipes prevented the hose from the pump to be placed down the hole.

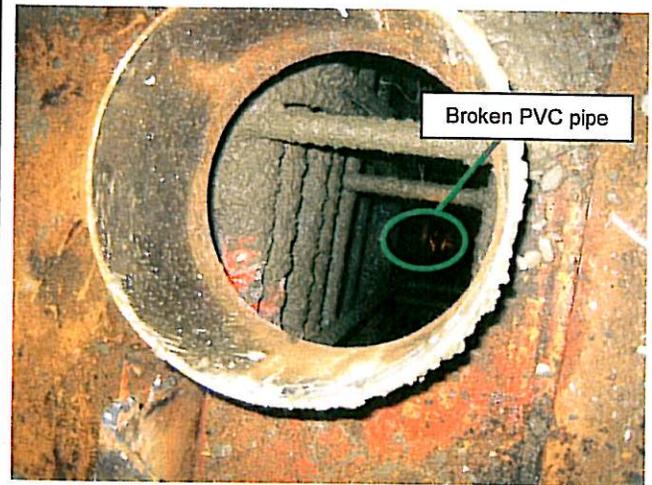
File Name:	Dec-05 and 06-2008 W2 Cap 012
Date:	12-05-08
By Int:	M Bruce

23:40	The broken PVC pipe was indentified as 3D which was approximately 4'-6' from the soffit near the north end of the southern column cages and near a mark labeled "5E" on the top east horizontal strongback. ABF project manager Jim Davidson informed me that the water cooling pipe will be shut-off for the duration of the pour. From the southern end of the cap to the southern end of the north column cages water puddles were seen on the top of the concrete surface. The exact cause of the PVC pipe is not known however when the hose was removed from this access hole the broken pipe was discovered.

Description: Photo taken from the access hole where the broken PVC pipe was discovered. The water being sprayed from the PVC pipe could be heard from the top in addition to the water being seen on the concrete surface. The photo was taken at 11:30pm even though the image doesn't clearly display the broken PVC pipe.

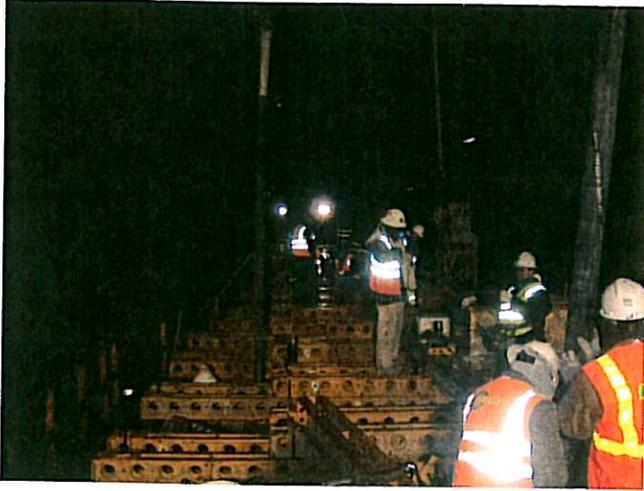
File Name:	Dec-05 and 06-2008 W2 Cap 013		
Date:	12-05-08	By Int:	M Bruce

Description: Photo taken at 11:35pm as ABF tried to determine the row(s) in which the PVC pipe broke. It took a total of 30 minutes to identify the broken pipe and shut it off.

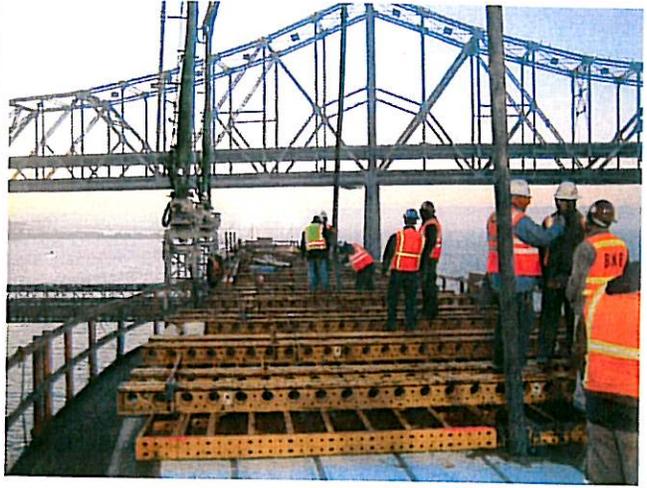
File Name:	Dec-05 and 06-2008 W2 Cap 021		
Date:	12-06-08	By Int:	M Bruce

Description: Concrete placement at the center and north end of the E2 cap beam at 7:15am.
