Job Stamp 04-0120F4 SFOBB SAS

Const. Calendar:	741			
Project Work Day No.:	951			
Date	12/23/2008			
Inspectors	Start	09:40	Stop	10:40
Hours		13:10		14:30
Shift Hours		07:00		15:30

ASSISTANT RESIDENT ENGINEER'S **CONTRACTOR – ABFJV, Subs CMC-RS**

Description of Operations @ W2 Cap Beam:

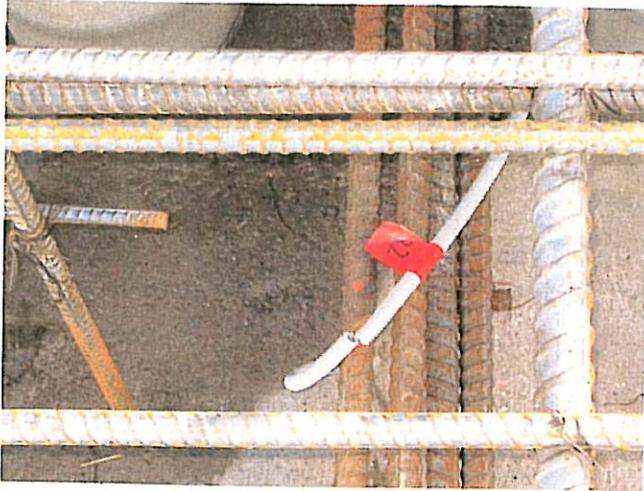
File Name:	Dec-23-2008 W2 Cap 001
Date:	12-23-08
By Int:	M Bruce

Description: Broken grout tube for CBT-32 near the cable tie-down pipes that needs to be repaired.

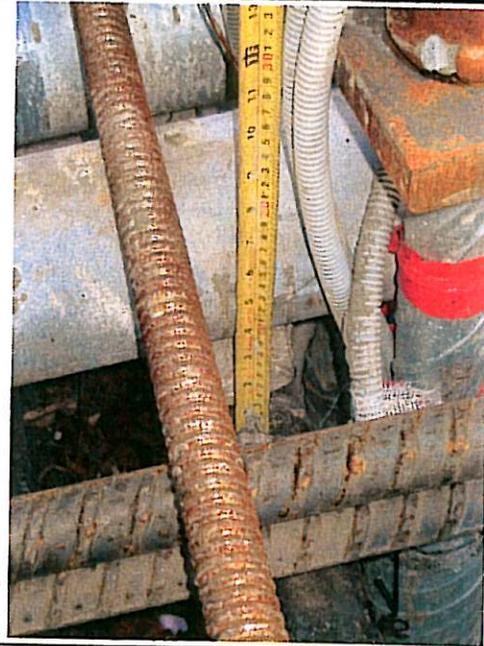
File Name:	Dec-23-2008 W2 Cap 003
Date:	12-23-08
By Int:	M Bruce

Description: The extra strong steel pipes for CBT-1 and 5 have been lifted off the Macalloy rods by approximately 75mm.

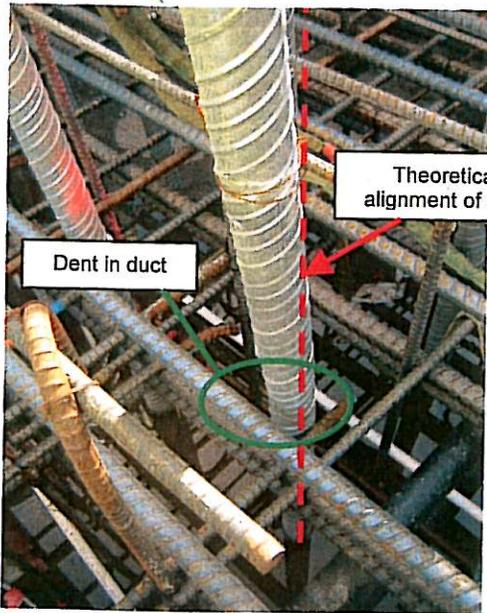
File Name:	Dec-23-2008 W2 Cap 010
Date:	12-23-08
By Int:	M Bruce

Description: Damage to the duct of VT2 as there is a dent in the duct approximately 1m from concrete and the duct is out of plumb.

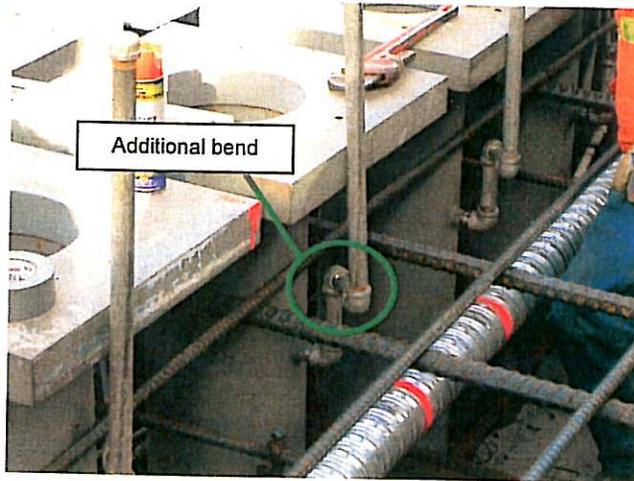
File Name:	Dec-23-2008 W2 Cap 011
Date:	12-23-08
By Int:	M Bruce

Description: Future grout pipes for the cable tie down pipes that were modified to place the ducts for continuity tendons E-29A and E-31A.
