Job Stamp 04-0120F4 SFOBB SAS

Const. Calendar:	749			
Project Work Day No.:	959			
Date	12/31/2008			
Inspectors	Start	09:00	Stop	11:20
Hours				
Shift Hours		07:00		15:30

**Description of Operations @ W2 Cap Beam:**

EA	04-0120F4
Co-Rte-KP (PM)	SF-080-13.2/13.9 (8.2/8.7)
Structure Rep.	Rick Morrow

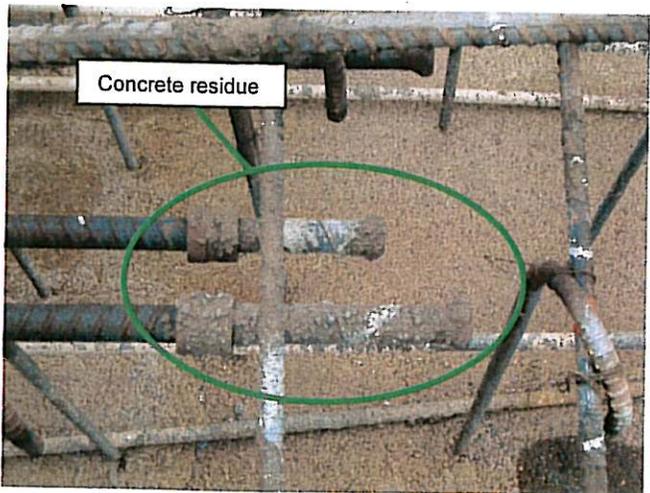
File Name: Dec-31-2008 W2 Cap 001  
 Date: 12-31-08 By Int: M Bruce  
 Description: Concrete residue found on the mushroomheads and female couplers of the #43 transverse bars located at the north end of pour 3 construction joint.

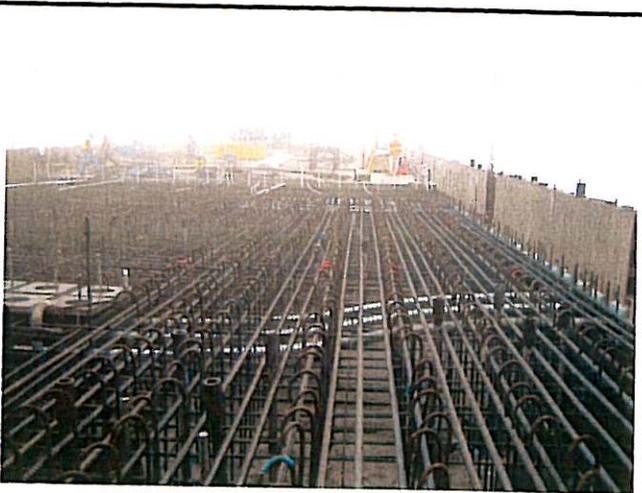
File Name: Dec-31-2008 W2 Cap 003  
 Date: 12-31-08 By Int: M Bruce  
 Description: Pour 6 south construction progress to date.

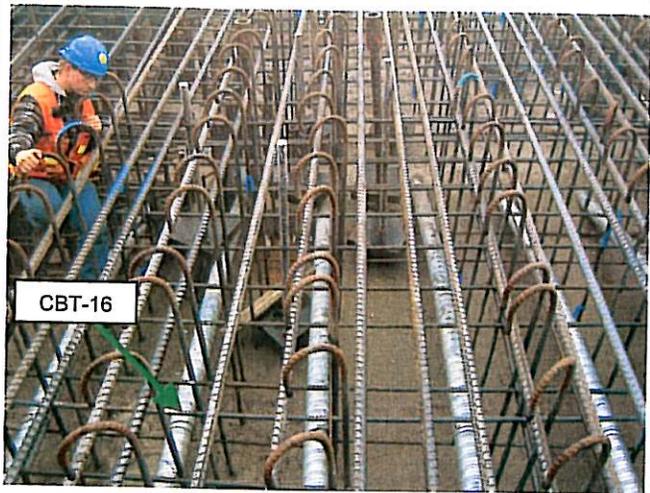
File Name: Dec-31-2008 W2 Cap 005  
 Date: 12-31-08 By Int: M Bruce  
 Description: Deviation saddle erection rod/plate placement at the south end of the cap beam near transverse tendons CBT-16 to CBT-18. There may be some potential conflicts as the shear cone from the plates is close to the PT ducts.

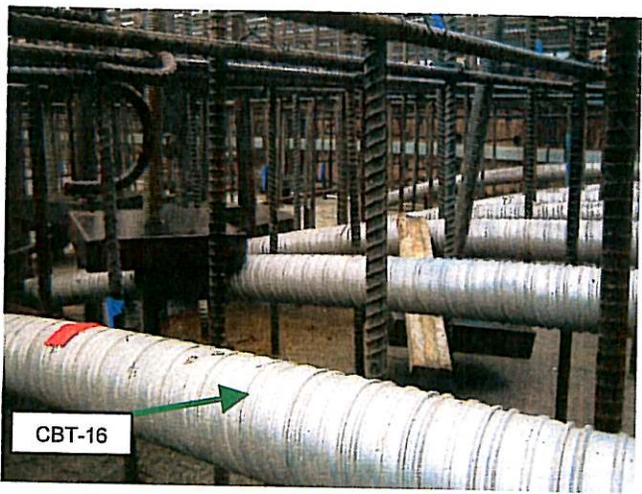
File Name: Dec-31-2008 W2 Cap 006  
 Date: 12-31-08 By Int: M Bruce  
 Description: Deviation saddle erection rod/plate placement at the south end of the cap beam near transverse tendons CBT-16 to CBT-18. This is the same rod/plate placement location as seen in the last photo looking in northeast direction.

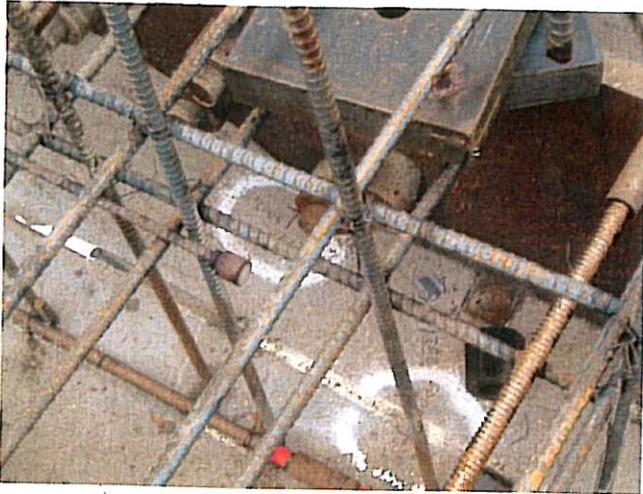
File Name:	Dec-31-2008 W2 Cap 007
Date:	12-31-08
By Int:	M Bruce

Description: Layout for deviation saddle erection rod/plate near the south W2E Hinge K anchor plate. There is a conflict with the DS erection plate and the Hinge K anchor plate and a couple of the nuts for the Macalloy rods.

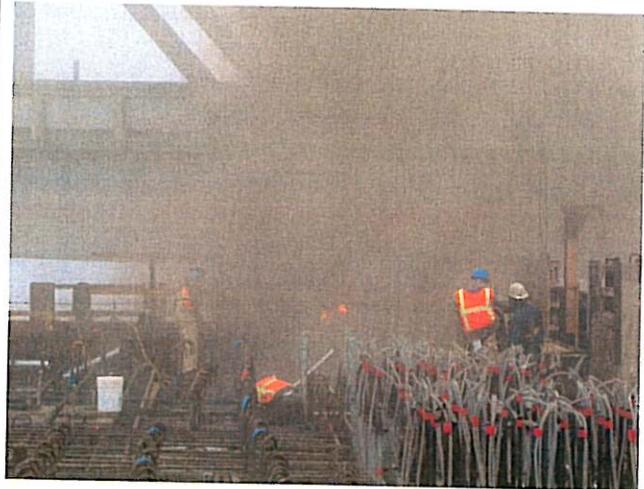
File Name:	Dec-31-2008 W2 Cap 009
Date:	12-31-08
By Int:	M Bruce

Description: Fire on the southwest end of the cap beam at 10:20am. The fire was started from the piledrivers using the torch to cut holes in the steel forms. The foam sprayed on the outside of the forms caught fire. Once the fire was extinguished the piledrivers removed the rest of the foam on the forms and carefully monitored cutting the remaining holes for the bikepath bolts.
