STATE OF CALIFORNIA	Job Stamp	7-day Const. Calendar	Day No. 706
DEPARTMENT OF TRANSPORTATION	SFOBB SAS	Project Work Day No.	Day No. 916
Form HC-10A (Rev. 6/80)	04-0120F4	Date	11/18/2008

ASSISTANT STRUCTURE REP.  
JASON WILCOX

**CONTRACTOR – TRAYLOR DUTRA JV**

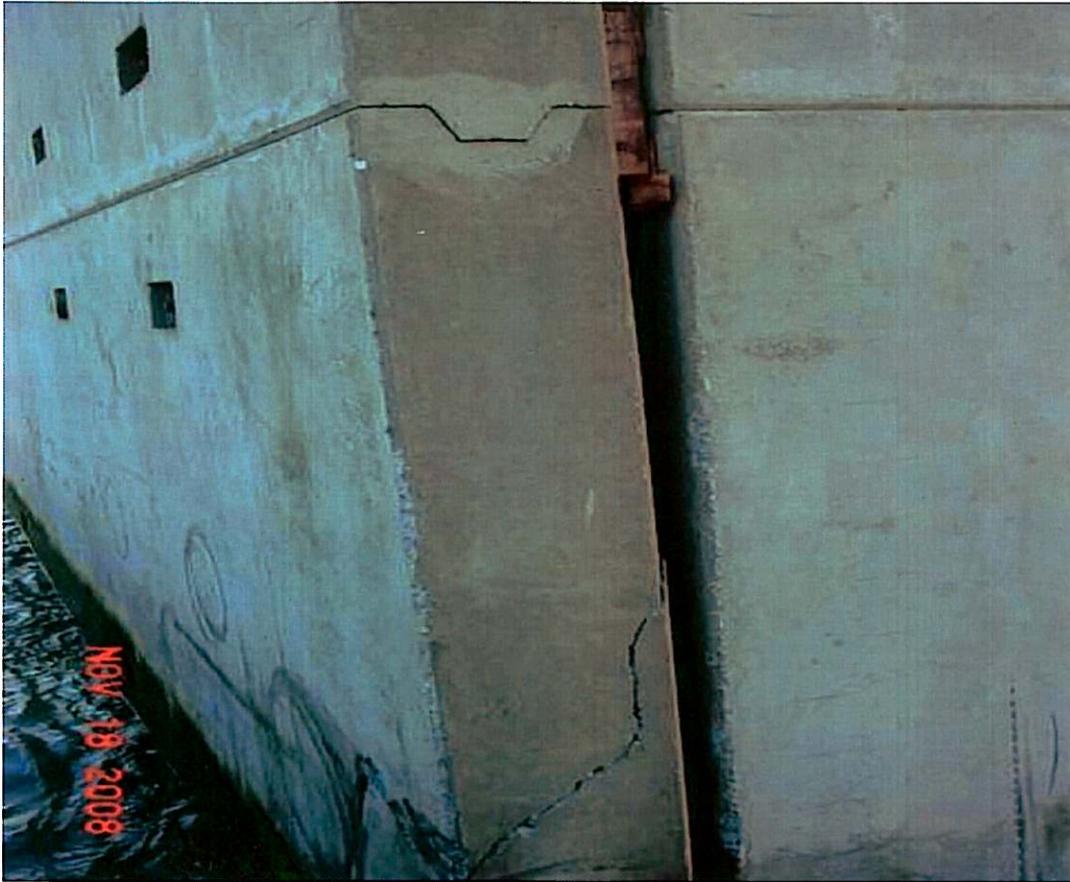
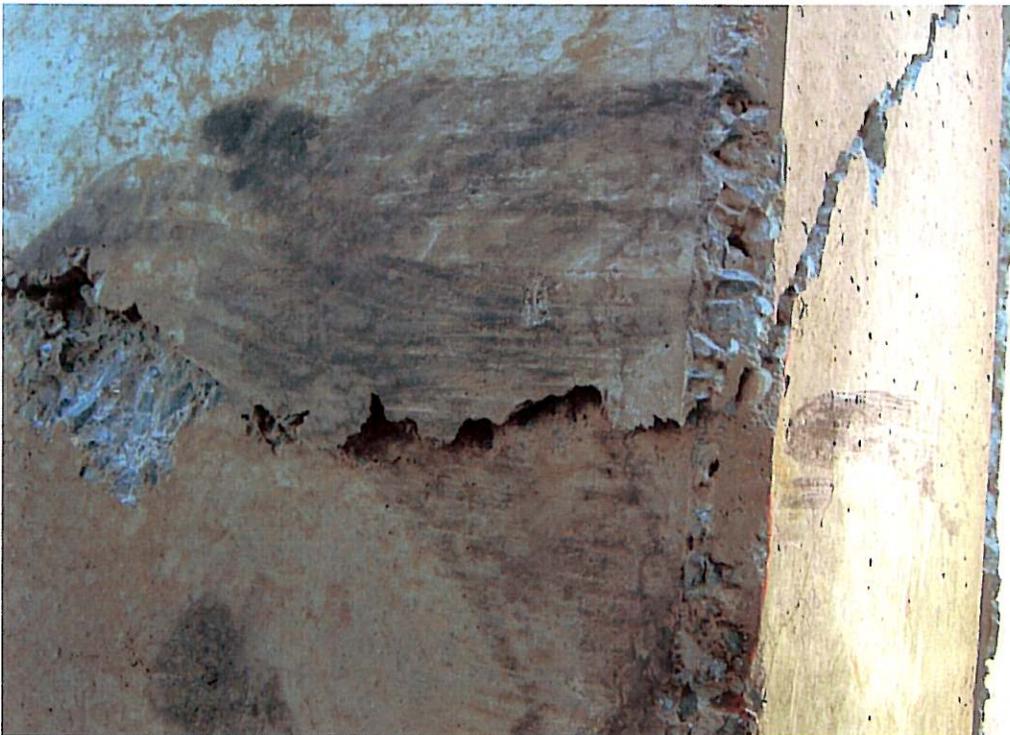
I received a call late yesterday from Mark Vilcheck about a barge hitting one of the fender panels of Tower D. He asked if any of our workers were on site to go take a look, but there was not. He said he would go take a look at it. When I came in today, Gil Klebanov, Mark, and I went to take a look after Thanh Le went and took pictures of the damage. The bottom panel of the North face, on the North side of Tower D, is where the damage was concentrated. The West most bottom corner has a crack all the way through to the back face. Since there was no bracing between the North panels and the West panels, there was approximately 4 inches for the corner to deflect. During this deflection the panel cracked in the unsupported area of the panel, out to the supported area of the closest B6 beam. There is cracking in the shear key area of the top panel on the North face, possibly due to the impact. These appear minimal. Upon looking from the back side of the panel, from on top of the driving frame, it is easy to see that the bottom corner of the panel was pushed in about 1 inch and was unable to elastically rebound. See the photos on the next page for views of the damaged area. This is the Northwest corner of the North driving frame for Tower D.

Attended the 1:30 PM Construction Meeting with ABF. Bill O'Sullivan was there as the only representative for ABF. The collision with the North panel of the D driving frame was discussed and Bill agreed that they will investigate the structure to make sure it is not structurally damaged and that they will survey it to make sure it is in position.
