Job Stamp:
04-SF-80-13.2/13.9 04-0120F4
SFOBB SAS
San Francisco Co. in San Francisco
Fm 0.6 km to 1.3 km East of Yerba Buena
Tunnel East Portal

ASSISTANT RESIDENT ENGINEER'S DAILY

BRIDGE

Location: W2 Cap Beam	Weather: partly cloudy/windy
Remark: cooling pipes	Hi 61F/Lo 53F

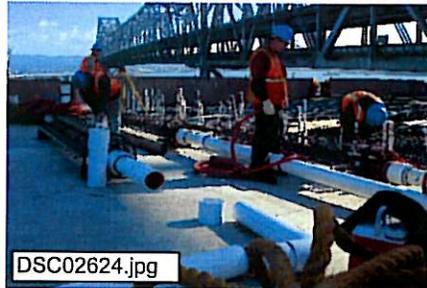
DSC02624

ABF is continuing to place cooling pipes in the pour 4 void. They are starting to connect the PVC tubes to the manifold with hoses (DSC02624). One of the manifolds has a pressure gauge on it. Before, we were relying on the normal pump rate as 100% of pressure and increasing the flow rate to test the system. Now we have a direct reading (DSC02625).

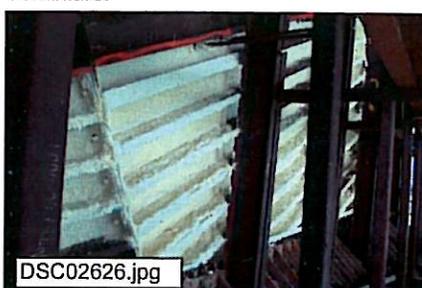
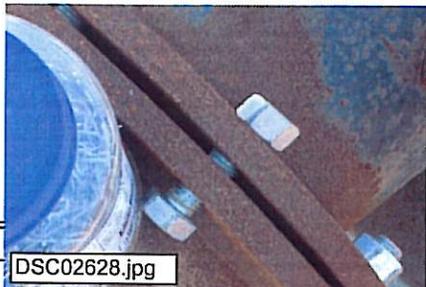
DSC02627.jpg

ABF has started to spray styrofoam on the exterior forms on the south end of the cap beam (DSC02626 & DSC02627). In effect, they are reducing the chance of a thermal bridge of the steel forms. They are not done spraying.
