Job Stamp:  
04-SF-80-13.2/13.9 04-0120F4  
SFOBB SAS  
San Francisco Co. in San Francisco  
Fm 0.6 km to 1.3 km East of Yerba Buena  
Tunnel East Portal

**ASSISTANT RESIDENT ENGINEER'S DAILY BRIDGE REPORT**

Location: Pier E2	7-day const. cal.: 693	Weather: Sunny & Cold
Remark:	Project work day: 903

Description of Operation: Placement of Reinforcing Steel, Cooling Pipes, Panel Forms...

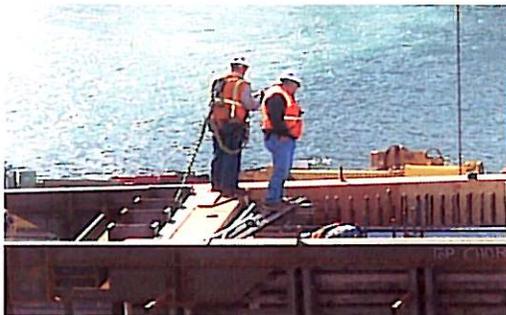
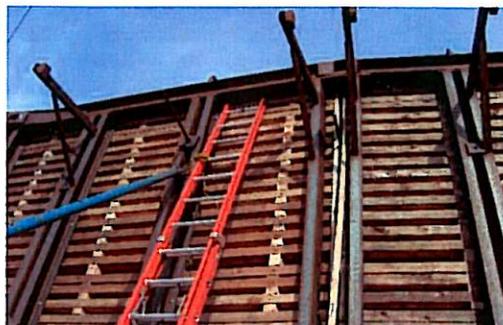
One of the items discussed in this meeting was the SAFET concerns at E2. In particular, I discussed the violation of the CalOSHA safety regulations when I cited the ladders do not extend beyond the landing. James Davidson countered that one is required to wear a harness while climbing the ladder. CT reminded him that the the extending the ladder 3' above landing is to the exclusion of a need to wear a harness. He did say that he will look into this matter but insisted that a harness needs to be worn because of this deficiency. I reiterated our position and stated while it is re-assuring that he is going to explore this matter, but he should not qualify his comments by stating that one needs to wear a harness. I did not tell him that he was standing at the edge of the panel forms that did not have any handrail while not wearing a harness.
