| DEPARTMENT OF TRANSPORTATION | SFOBB SAS | Project Work Day No. | Day No. 930 |
| Form HC-10A (Rev. 6/80) | 04-0120F4 | Date | 12/2/2008 |

Erect Temporary Towers: North Node Tower F Driving Frame Assembly & TTF South Retap

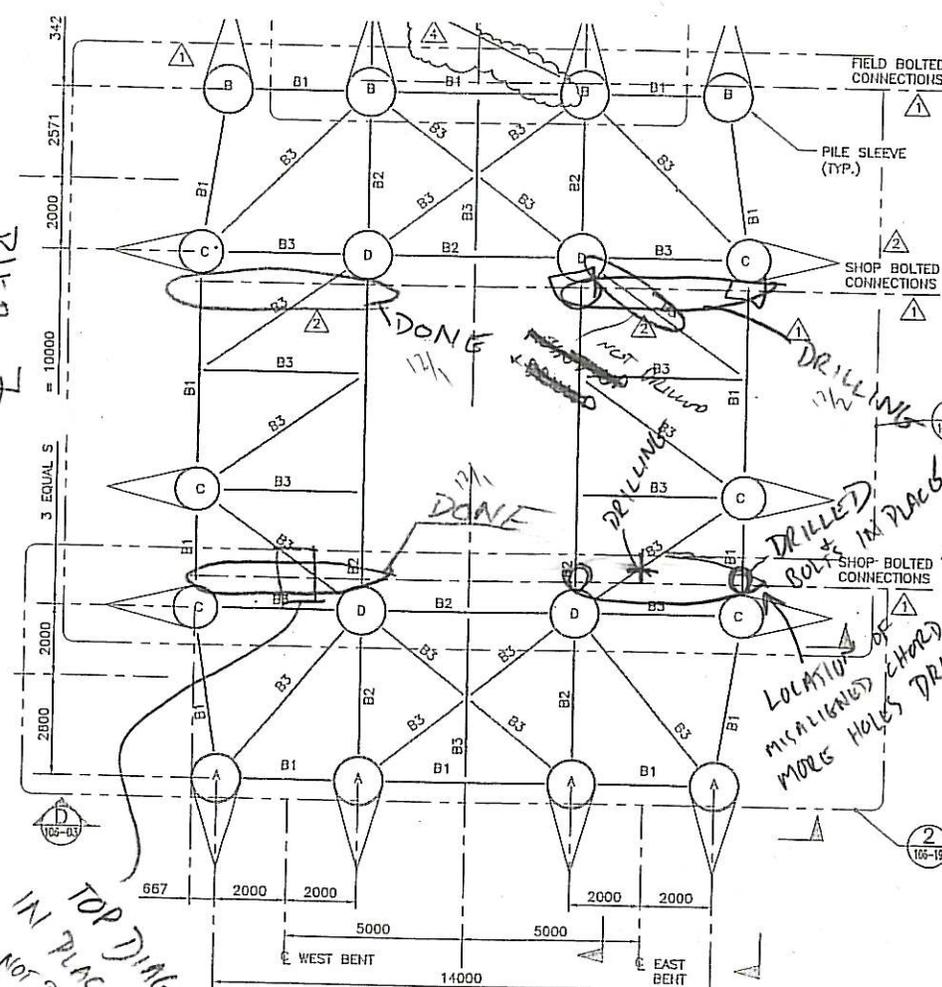
PLAN @ EL. 1.500
SCALE 1:100

The crew of the Big Digger is continuing to assemble the North node of the Tower F driving frame at pier 7. See the attached drawing for locations of the frame that were worked on today. A brief description of the progress thus far is as follows. For the bottom elevation of 1.5 meter, the northeast corner has been drilled and torqued as of yesterday. The southeast corner was drilled and about 80% of it was torqued yesterday, so this morning the rest of the bolts were torqued. These same workers moved over to the southwest corner to continue the drilling of these connection. It is at this corner that the diagonal is a little short, between 50 and 100 mm short. At the northwest corner there is a worker continuing to drill holes. This is the location where there is a misaligned chord on the West side of the connection. The same thing was on the South node and the designer gave the "OK" to drill another row of bolt holes and bolt them up.

TOP DING
IN PLACE;
NOT DRILLED
S. SHOWN

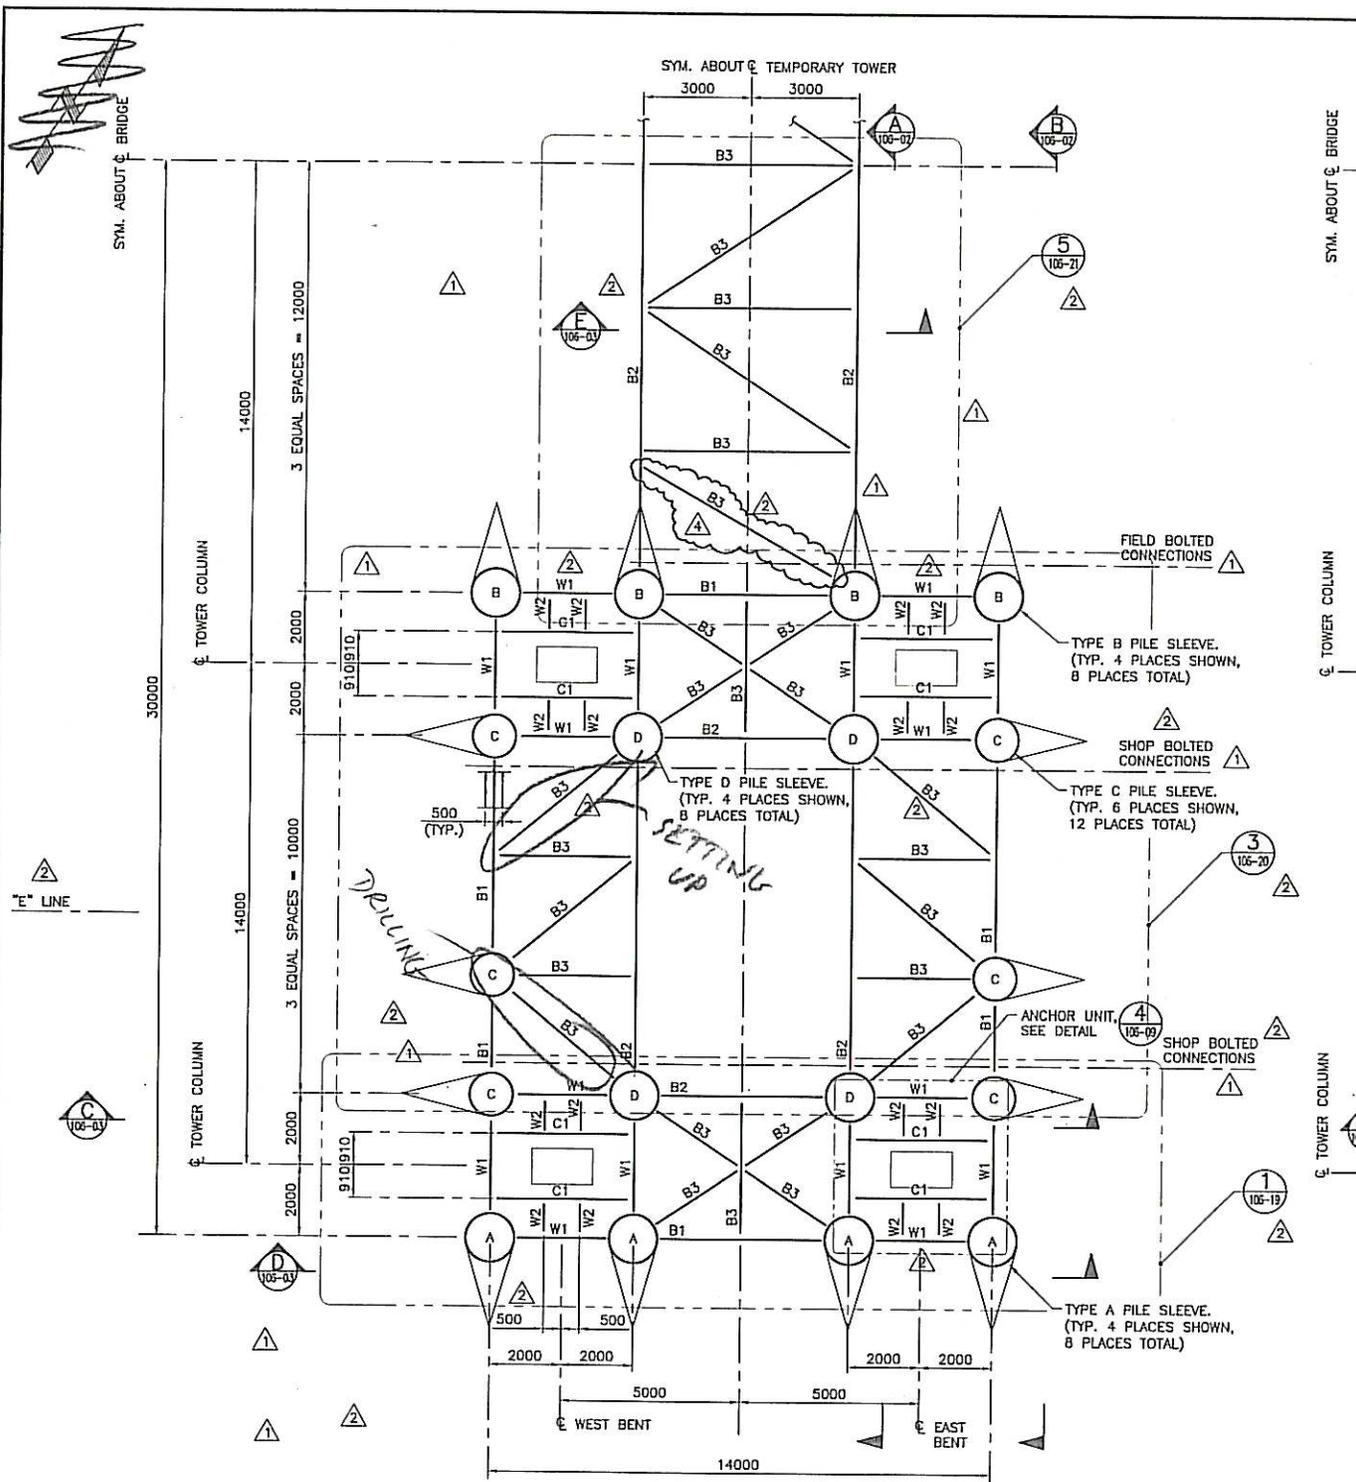
PLAN @ EL. 5.500
SCALE 1:100

On the top of the frame, elevation 5.5 meter, the diagonal is in on the northwest side, and toward the end of the day a couple workers were drilling holes all around that location, in the diagonal and in the chords.

In the 1:30 pm meeting with ABF, Bill O'Sullivan was there to talk about the diagonal being too short on the southwest corner. He said there was going to be an RFI generated and sent to Kohn Crippen Berger regarding this situation. After the meeting John Denis and I went to take a look at the diagonal and John saw that some of the field drilled holes looked to be too close to the edge of the box section on the North side of the frame. It appeared that on the northeast corner of the field drilled connections between the 8-sleeve piece and the 1-sleeve piece are approaching 35 – 40 mm, when the plans call for 50 mm minimum. This same situation happened on the South frame and is noted in Thanh Les diary on October 13, 2008. Bill O'Sullivan and Sean Heydan came out after John and I left the site, and I met with them to show them the areas of concern. They measured these locations and agreed that some are less than 50 mm, and that they will be included in the RFI that will be sent to KCB.
