Job Stamp 04-0120F4 SFOBB SAS

Const. Calendar:	763			
Project Work Day No.:	973			
Date	01/14/2009			
Inspectors	Start	08:50	Stop	10:30
Hours		13:30		14:30
Shift Hours		07:00		15:30

ASSISTANT RESIDENT ENGINEER'S **CONTRACTOR – ABFJV, Subs CMC-RS**

Description of Operations @ W2 Cap Beam:

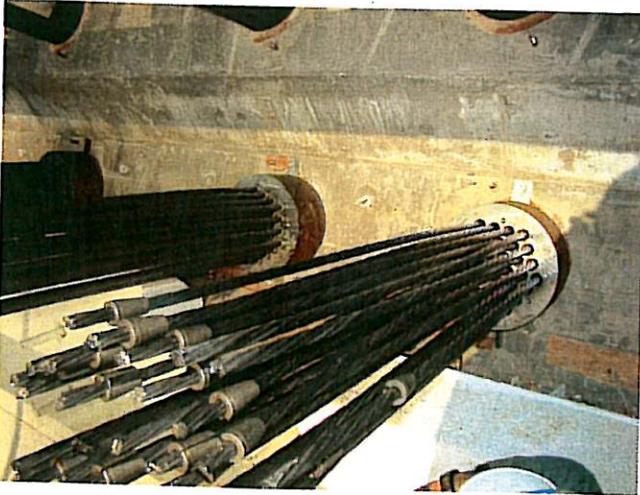
File Name:	Jan-14-2009 W2 Cap 001
Date:	01-14-09
By Int:	M Bruce

Description: Anchor heads at the south end of the E2 cap beam on the bottom row. The hole patterns of the anchor heads need to be oriented relative to the position of the suspended jack from the A-frame. The hole patterns for some of the anchor heads on the north and south side weren't symmetrical as the anchor head was rotated.

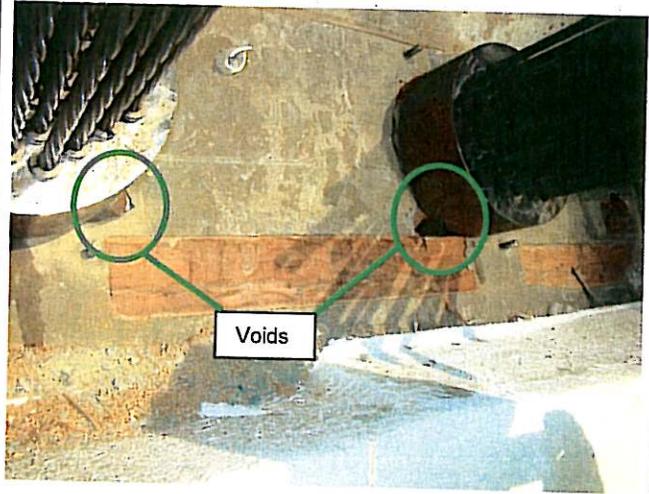
File Name:	Jan-14-2009 W2 Cap 002
Date:	01-14-09
By Int:	M Bruce

Description: Close up view of the two anchor heads seen in the previous photo. There is a void between the face of concrete and the backside of the bearing plate.

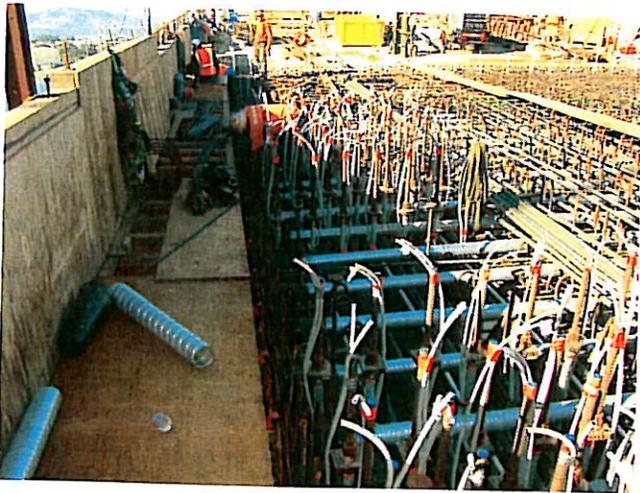
File Name:	Jan-14-2009 W2 Cap 003
Date:	01-14-09
By Int:	M Bruce

Description: Ironworkers placing spirals on the seismic joint blockout on the west end of the cap beam.
