Job Stamp 04-0120F4 SFOBB SAS

Description of Operations @ W2 Cap Beam:

EA	04-0120F4
Co-Rte-KP (PM)	SF-080-13.2/13.9 (8.2/8.7)
Structure Rep.	Rick Morrow

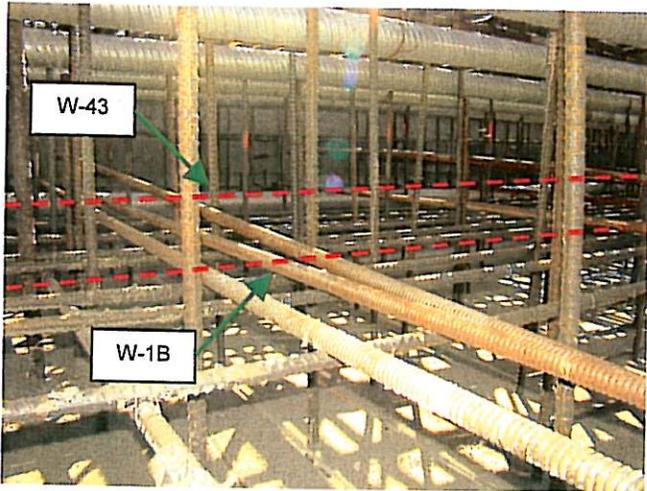
File Name:	Jan-20-2009 W2 Cap 001		
Date:	01-20-09	By Int:	M Bruce

Description: There appears to be appreciable sags (over 25mm) for the ducts of continuity tendons W-43 and W-1B. This photo was taken towards the southwest end of the tendons. W-1B has been cast into concrete but W-43 can be fixed. RS foreman Tim Greenlee was informed of this situation. It was difficult to actually see or measure the duct due to all the vertical rebar.

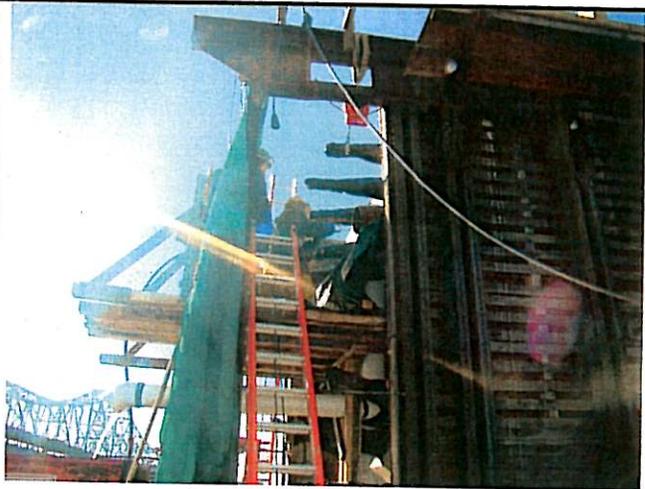
File Name:	Jan-20-2009 W2 Cap 008		
Date:	01-20-09	By Int:	M Bruce

Description: AWJ in the process of cleaning out the concrete in the duct. The operation appeared to be under control as the water was for the most part contained.

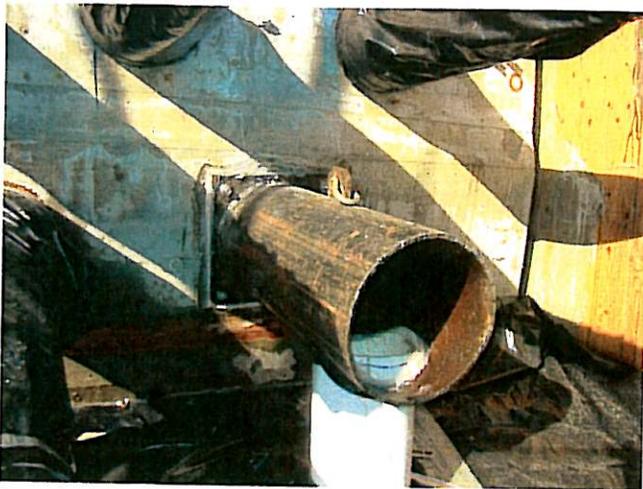
File Name:	Jan-20-2009 W2 Cap 009		
Date:	01-20-09	By Int:	M Bruce

Description: End connection constructed by ABF to direct contaminated water into a Baker tank set up behind the south end of the E2 cap beam. This connection appeared to be water-tight during the operation.

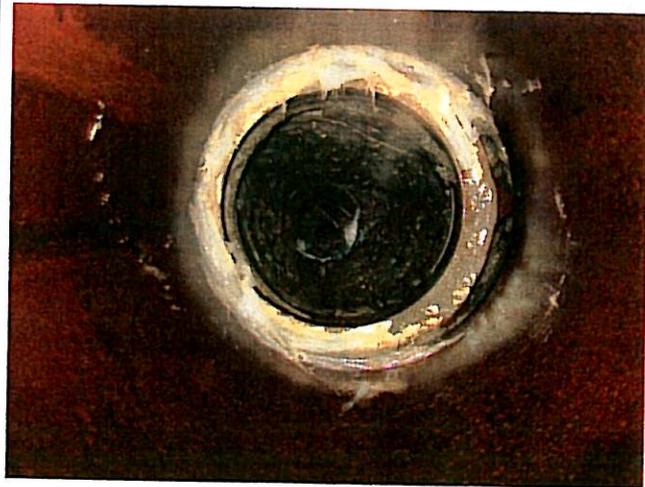
File Name:	Jan-20-2009 W2 Cap 010		
Date:	01-20-09	By Int:	M Bruce

Description: Photo looking inside the blocked duct after water jetting for approximately a half an hour. At this point AWJ has removed approximately 1 foot at 1:30pm. Representatives for AWJ informed me that this concrete wasn't as hard as they expected and were going to finish the operation within the next couple of days.
