| Job Stamp 04-0120F4 SFOBB SAS |

ASSISTANT RESIDENT ENGINEER'S **CONTRACTOR – ABFJV, Subs CMC-RS**

Description of Operations @ W2 Cap Beam:

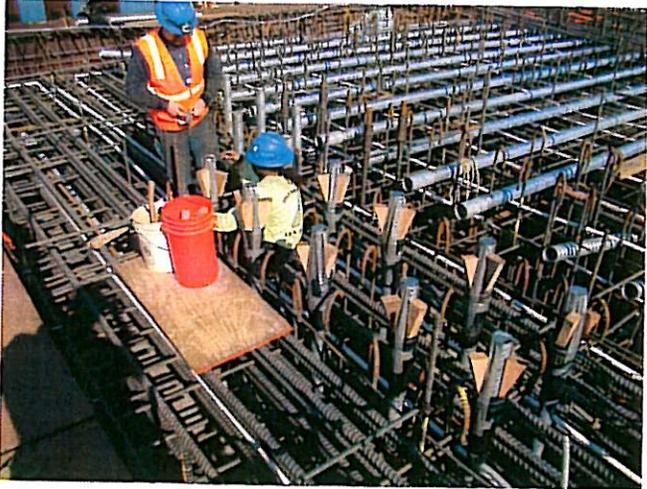
| File Name: | Feb-02-2009 W2 Cap 001 | | |

Description: ABF piledrivers installing trumpets for VT1 to VT16 near the W2W deviation saddle. Timber wedges are being used to center the duct with the trumpet prior to bearing plate installation.

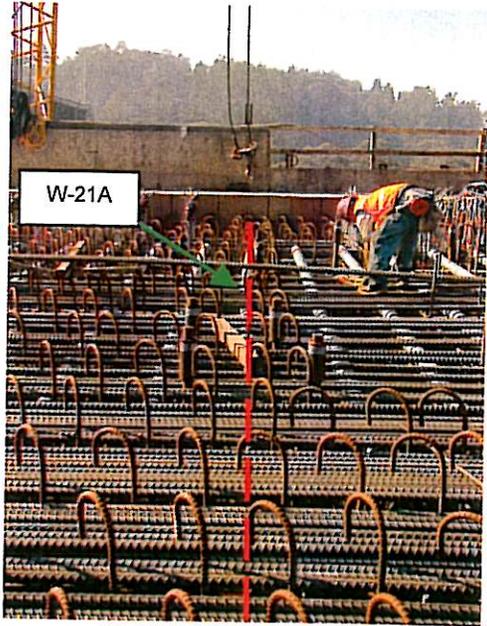
| File Name: | Feb-02-2009 W2 Cap 002 | | |

Description: Ironworker placing a #43 transverse bar with a female coupler near the center of the cap south of the W2W cable tie down pipes. Also the duct for continuity tendon W-21A needs to be straightened out. There are a couple of deviation saddle erection rods obstructing the path of the duct.
