Matt Bruce Matt Bruce Transportation Engineer (D)

EA	04-0120F4
Co-Rte-KP (PM)	SF-080-13.2/13.9 (8.2/8.7)
Structure Rep.	Rick Morrow

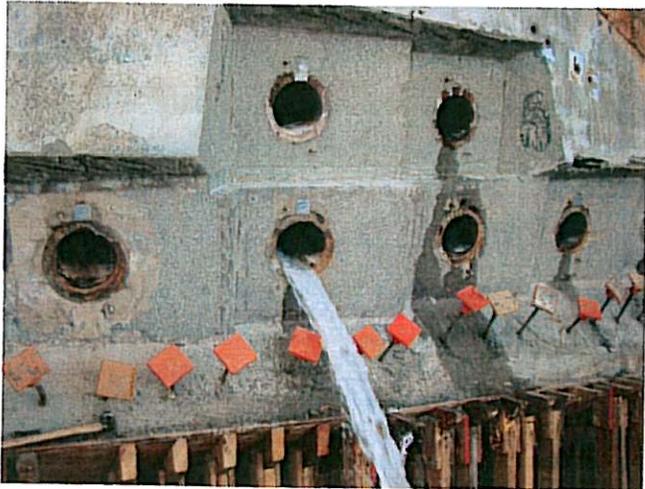
File Name:	Apr-13-2009 W2 Cap 001		
Date:	04-13-09	By Int:	M Bruce
Description:	Residual water pushed out by the blowdart and pressurized air at the north end of CBT-31.

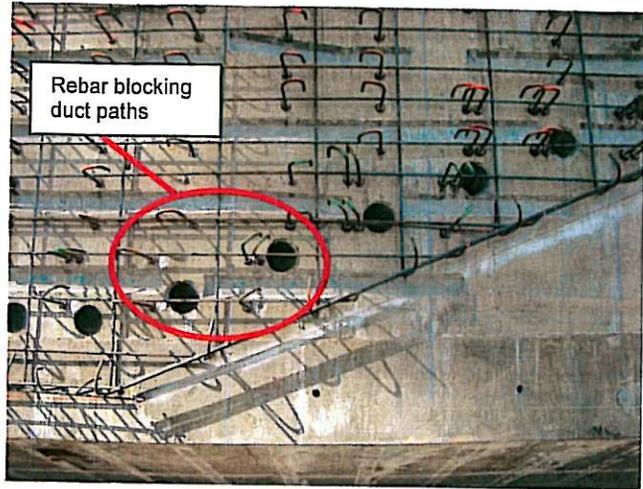
File Name:	Apr-13-2009 W2 Cap 002		
Date:	04-13-09	By Int:	M Bruce
Description:	Rebar placed for the closure pour at W2E blocking the continuity tendons at the east end.

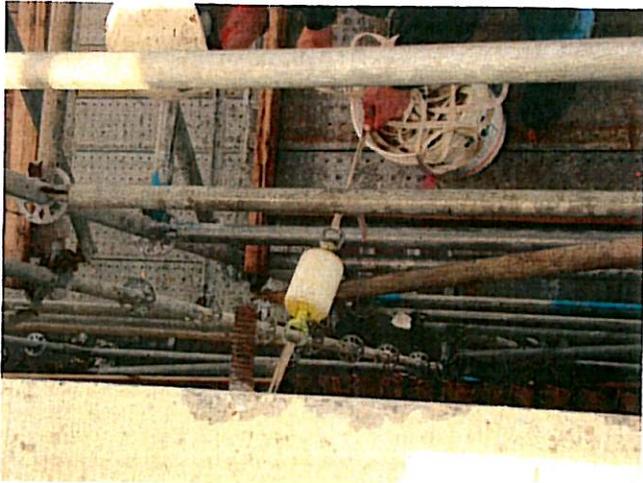
File Name:	Apr-13-2009 W2 Cap 011		
Date:	04-13-09	By Int:	M Bruce
Description:	Rabbit passing through a transverse tendon on the north end of the cap beam.

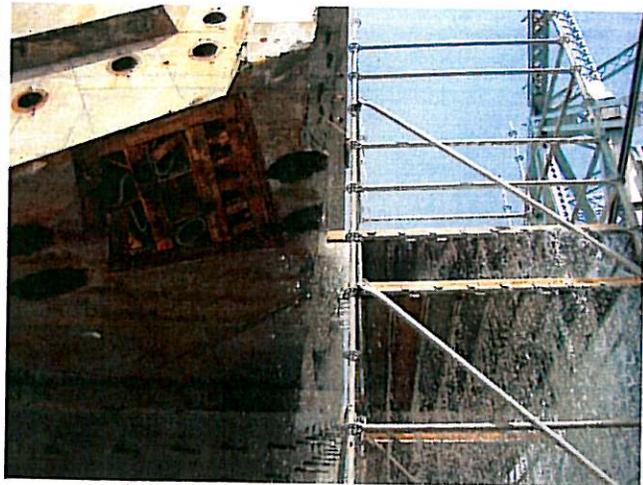
CBT	Comments	CBT	Comments
28	SDI did prior to me being in the field	35	Ran the rabbit through from the north to the south end, with some water, and a 5"x4"x1.5" chunk of concrete
29	SDI did prior to me being in the field	36	Ran the rabbit through, some water
25	Ran the rabbit through, no water	22	Ran the rabbit through, no water
26	Rabbit didn't go through, no water	21	Ran the rabbit through, some water
27	Ran the rabbit through, some water	20	Ran the rabbit through, some water
30	Ran the rabbit through, no water	19	Ran the rabbit through, some water
23	Ran the rabbit through, no water	18	Ran the rabbit through, some water
31	Ran the rabbit through, some water	17	Ran the rabbit through, no water
24	Ran the rabbit through, no water	16	Ran the rabbit through, some water
32	Ran the rabbit through, some water	9	Ran the rabbit through, no water
33	Ran the rabbit through, some water	10	Too much water in duct for rabbit to go through

File Name:	Apr-13-2009 W2 Cap 019		
Date:	04-13-09	By Int:	M Bruce
Description:	Water blown out of CBT-10 on the south end of the cap beam.
