04-0120F4  
SFOBB SAS

Date: 04/16/2009

ASSISTANT RESIDENT ENGINEER'S

**Description of Operations @ W2 Cap Beam:**

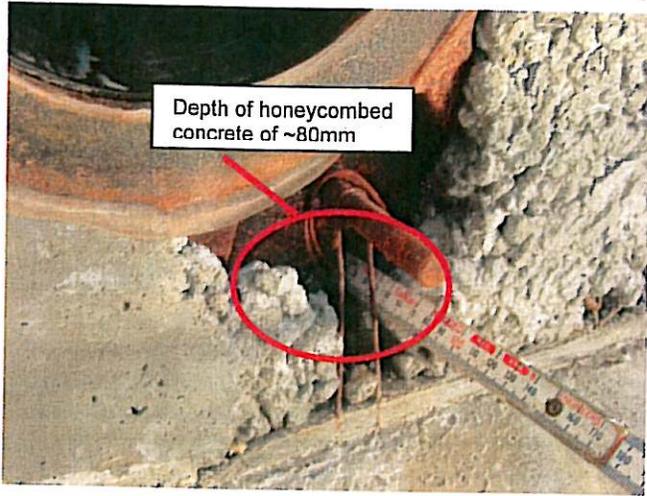
File Name: Apr-16-2009 W2 Cap 003

Description: Unsound concrete found near the bearing plates of transverse tendons CBT-9 to 22. This photo was taken on the southwest end of the cap beam where the most of the bearing plates looked similar.

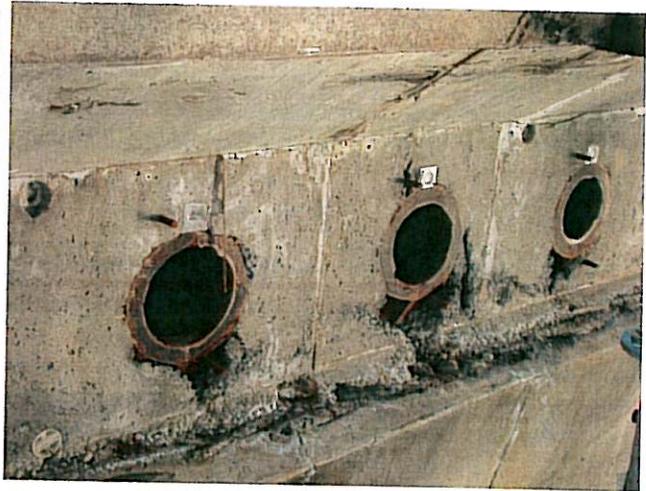
File Name: Apr-16-2009 W2 Cap 004

Description: Overall view of the concrete around the bearing plates of CBT-9 to 15. Representatives of SDI informed ABF that they wouldn't stress until the unsound concrete was removed and patched.

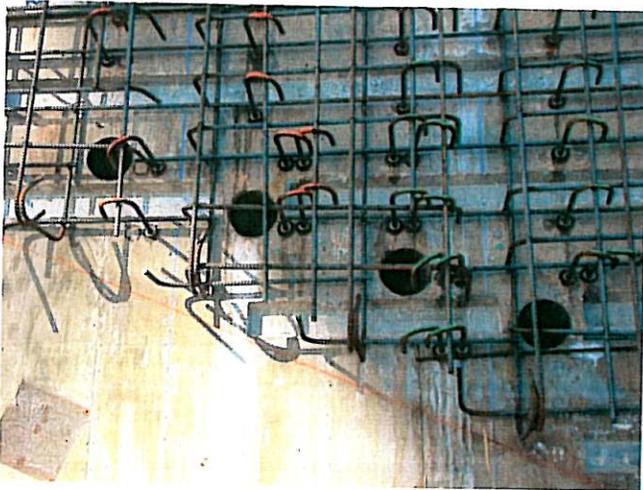
File Name: Apr-16-2009 W2 Cap 005

Description: Rebar at the W2E construction joint with the OBG. Currently there are some horizontal bars that are conflicting with continuity tendon paths.

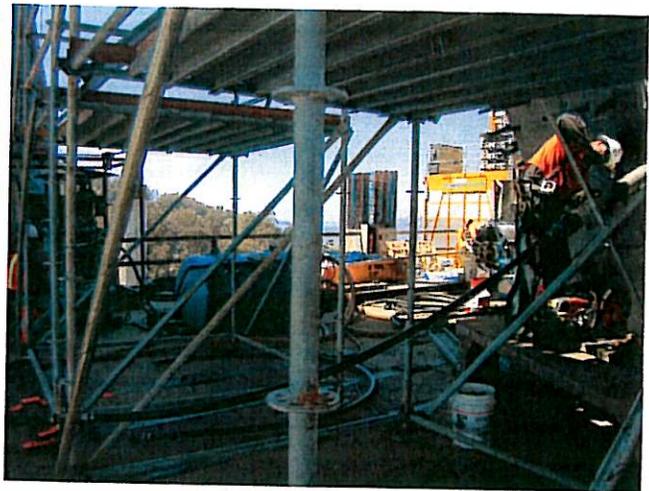
File Name: Apr-16-2009 W2 Cap 007

Description: SDI ironworkers pushing strand from the south end of the cap beam.
