Job Stamp
04-0120F4
SFOBB SAS

ASSISTANT RESIDENT ENGINEER'S

Description of Operations @ W2 Cap Beam:

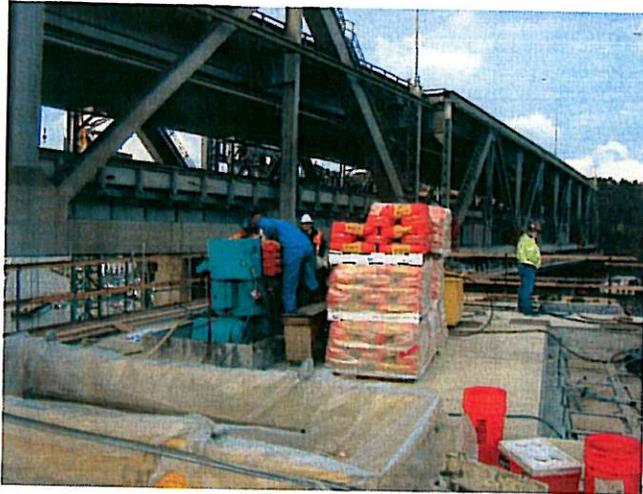
File Name:	Apr-30-2009 W2 Cap 002		
Date:	04-30-09	By Int:	M Bruce

Description: SDI ironworker mixing grout and water before placing into CBT-11 to 22.

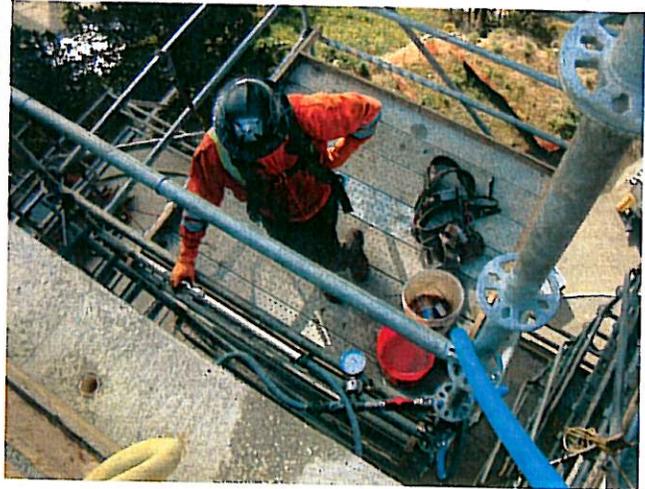
File Name:	Apr-30-2009 W2 Cap 004		
Date:	04-30-09	By Int:	M Bruce

Description: Placing grout into CBT-22 under pressure from the south end of the cap beam.

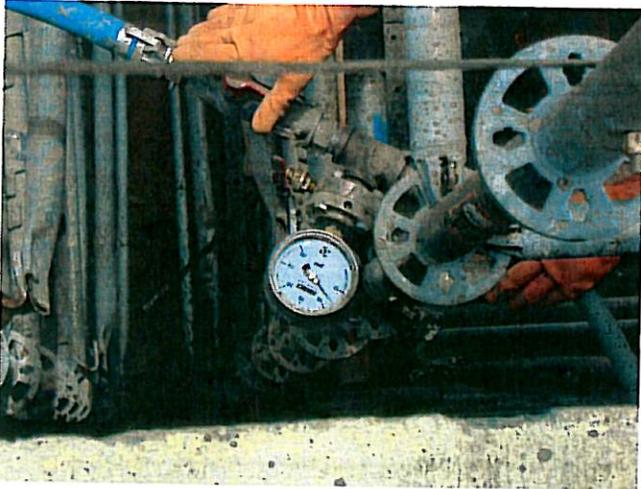
File Name:	Apr-30-2009 W2 Cap 007		
Date:	04-30-09	By Int:	M Bruce

- 4) Saman and myself witnessed the entire operation as we watched inlet and outlet valves at both ends of the cap beam. The outlet valve wasn't closed until there was good grout. In a few cases water came out before the grout for roughly 10 seconds before "good" grout was seen. The inlet was then pressurized to 70 to 100 psi before closing the inlet valve.

Description: A recharge pressure of 70psi to 100psi was seen /achieved at the inlet valve. The recharge is done after "good" grout comes out of the outlet valve and closed on the north end.

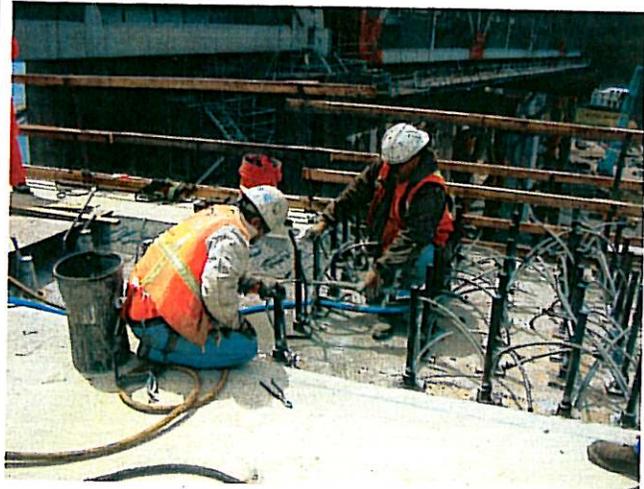
File Name:	Apr-30-2009 W2 Cap 008		
Date:	04-30-09	By Int:	M Bruce

Description: SDI ironworkers grouting vertical bar VB-9 at W2E. It took 43 seconds on average to grout these ducts. After the pressure from the pump was released and the grout valve was closed the grout head dropped roughly 50 to 80mm from the hexnut grout vents.
