| 04-0120F4 |
| SFOBB SAS |

ASSISTANT RESIDENT ENGINEER'S

Description of Operations @ W2 Cap Beam:

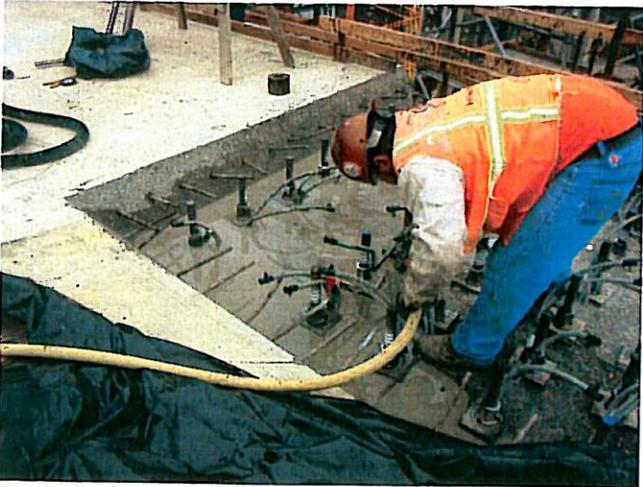
| File Name: | May-04-2009 W2 Cap 001 | | |

| Description: SDI ironworkers grouting vertical bar: VB-107 at W2W. It took 43 seconds on average to grout these ducts. After the pressure from the pump was released and the grout valve was closed the grout head dropped roughly 50 to 80mm from the hexnut grout vents. | | | |

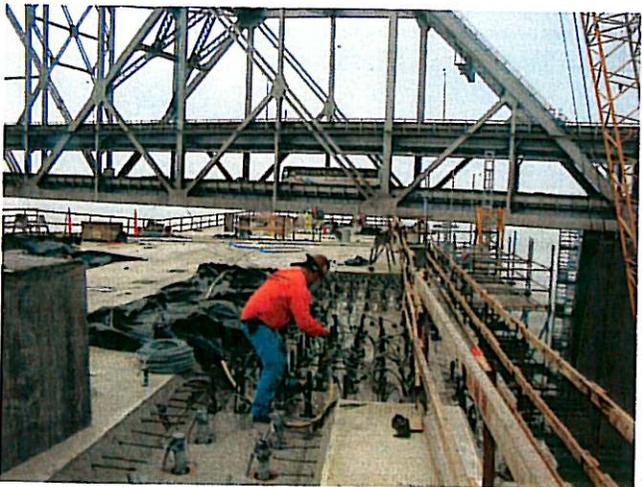
| File Name: | May-04-2009 W2 Cap 004 | | |

| Description: Grouting operation setup for the W2W long vertical PT bars. The grout mixing equipment was still located at the south end of the cap beam. | | | |

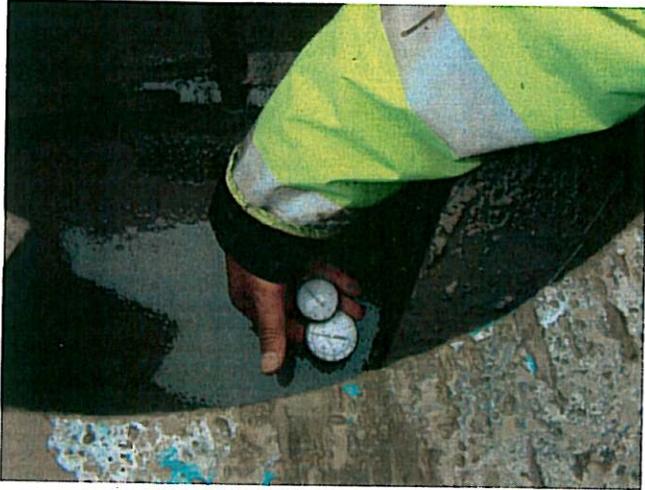
| File Name: | May-04-2009 W2 Cap 005 |

Description: Grout temperature at the grout mixer of 89°F at 9:00am. SDI ironworkers were warned several times to keep the temperature down otherwise measures would need to be taken to cool the grout temperature down. There were a few instances where the temperature exceeded 90°F.

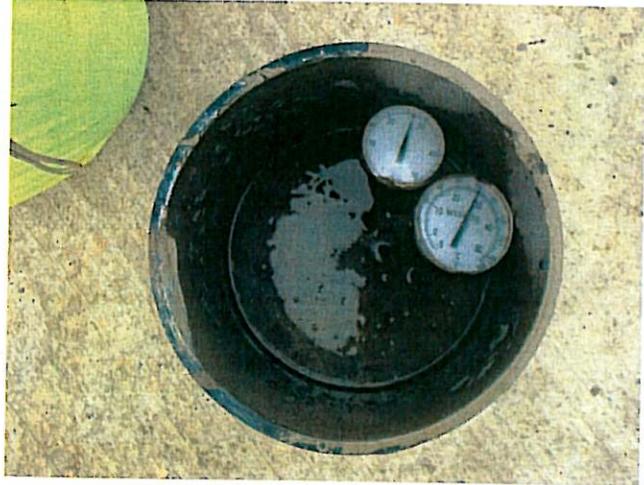
| File Name: | May-04-2009 W2 Cap 006 |

Description: Grout temperature at the end of the hose was found to be 81°F at 9:05am. It was then determined that the grout was being mixed too fast or in high quantities at the grout mixing equipment.

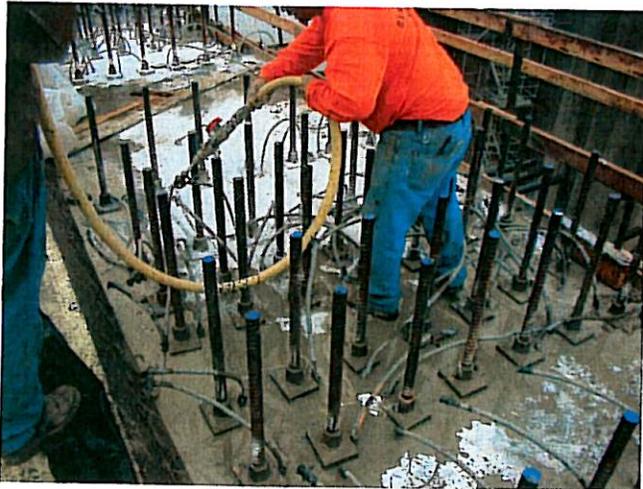
| File Name: | May-04-2009 W2 Cap 008 |

Description: SDI ironworkers "topping-off" the long vertical bars at W2E. As stated above the drop in the grout head after the release of pressure from the grout pump left part of the bar un-grouted.

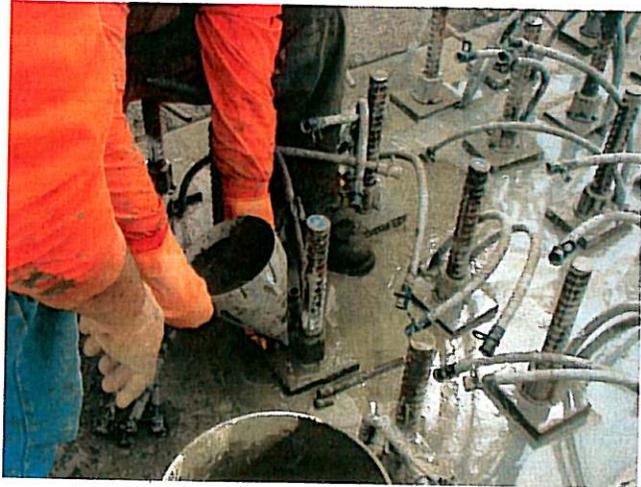
| File Name: | May-04-2009 W2 Cap 010 |

Description: SDI ironworkers missed grouting VB-16W, when the grout mixing equipment was being cleaned. The ironworkers then mixed one bag of grout in a bucket per the manufacturers recommendation. The grout was then placed through the tubes and hexnut vents.
