04-0120F4
SFOBB SAS

Date: 08/12/2009

ASSISTANT RESIDENT ENGINEER'S

**Description of Operations @ W2 Cap Beam:**

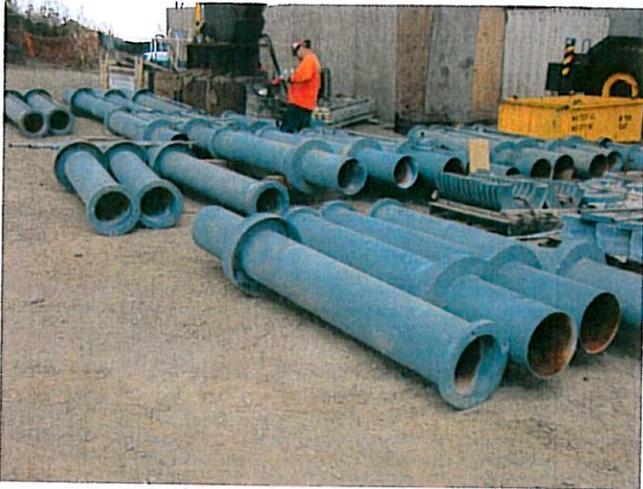
File Name:	Aug-12-2009 W2 Cap 001
Date:	08-12-09
By Int:	M Bruce

Description: SDI ironworker drilling oversized holes into the top flange of the bottom bearing pipe assembly. This was done in lieu of a fabrication error, dimensions of the grouting pipes were offset. Myself and Gil told them to place the bottom bearing assemblies on dunnage. Lalit identified rust on the inner face of the pipe needs to be addressed.

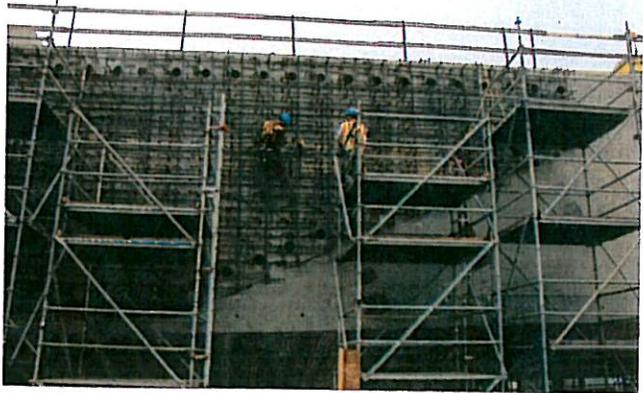
File Name:	Aug-12-2009 W2 Cap 006
Date:	08-12-09
By Int:	M Bruce

Description: ABF laborers drilling holes for the dowels to be epoxied at the W2E east face construction joint.

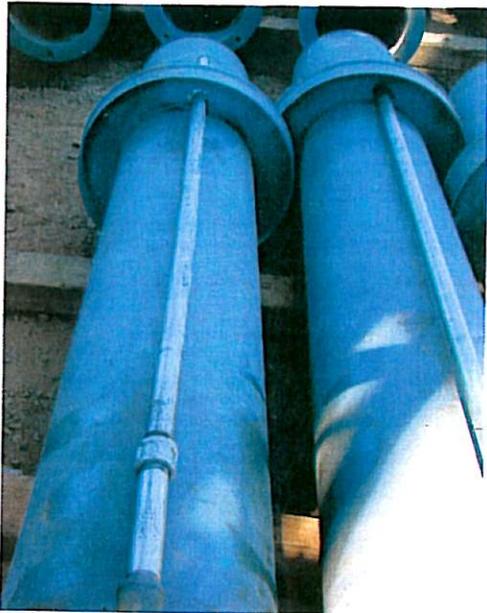
File Name:	Aug-12-2009 W2 Cap 017
Date:	08-12-09
By Int:	M Bruce

Description: Bottom bearing assembly pipe with future grouting pipes connected ready for installation in the foundation grillage. I witnessed one flange cut with the torch. I informed SDI superintendent Raplh Craig that this was unacceptable and it was agreed that no more steel would be cut. A flexi coupler was used to divert the pipe through the hole in the flange as seen on the left pipe.

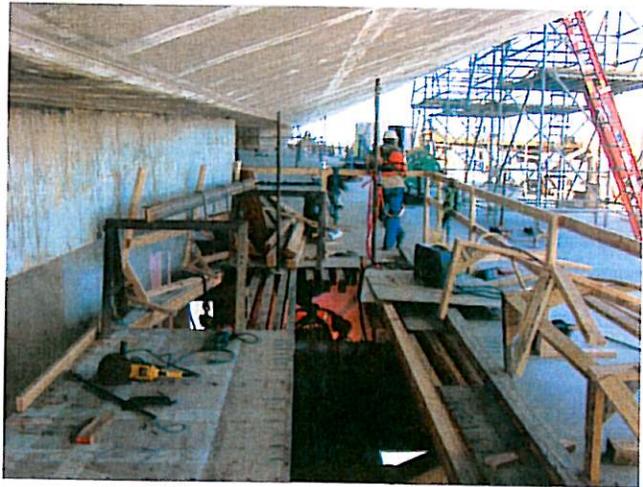
File Name:	Aug-12-2009 W2 Cap 020
Date:	08-12-09
By Int:	M Bruce

Description: ABF piledriver welding a horizontal brace to a soffit cap beam near the northeast end of W2E. S/E inspector was onsite to check these welds.
