04-SF-80-13.2/13.9  
04-0120F4  
SFOBB - SAS

Report No 800 (7 Workday Calendar)

Date Feb 20, 2009

**ASSISTANT RESIDENT ENGINEER'S DAILY** T1 (1/4) Anchorage Mock Up on Pier 7 Yard **REPORT**

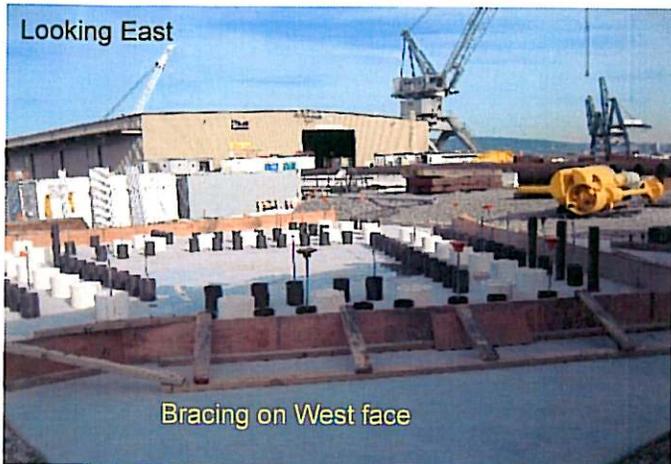
Photo 1  
20-Feb-09  
T1 (1/4) Anchorage Mock Up  
on Pier 7 Yard

Location & Description of Operation Contractors placed 2" x 4" brace form work around the South & West faces of T1 (1/4) Anchorage area (see Photo 1-2). Four 16" long extended steel pipes were nailed into the concrete pad (see Photo 3). The missing threaded rod was not installed. I marked up the location on the concrete pad and informed both field & office engineers.

Looking East

Bracing on West face

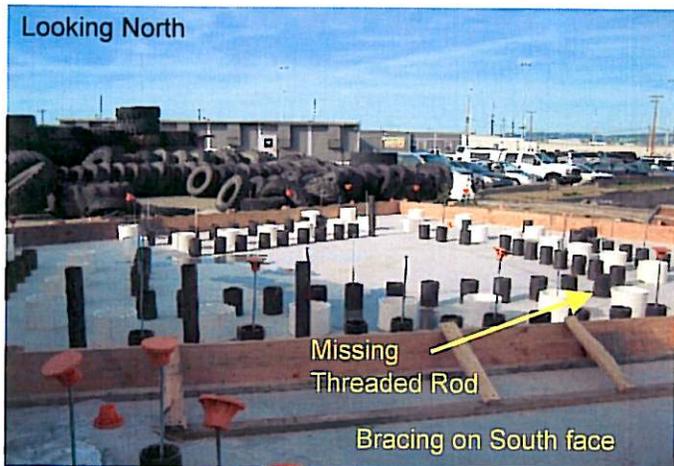
Photo 2  
20-Feb-09  
T1 (1/4) Anchorage Mock Up  
on Pier 7 Yard

Looking North

Missing  
Threaded Rod

Bracing on South face

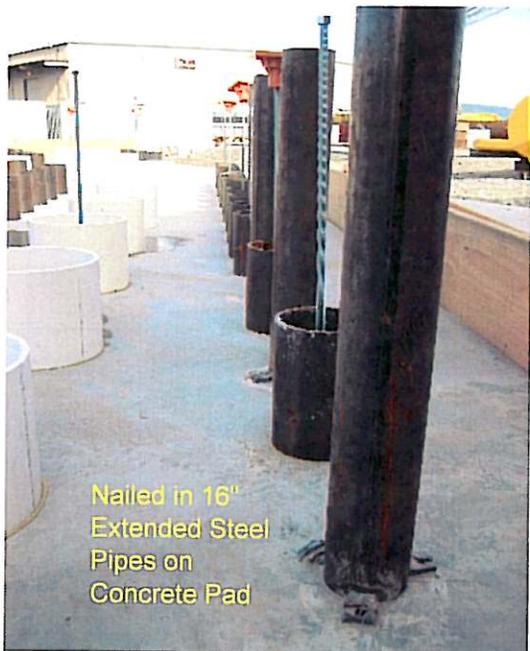
Photo 3  
20-Feb-09  
T1 (1/4) Anchorage Mock Up  
on Pier 7 Yard

Nailed in 16"  
Extended Steel  
Pipes on  
Concrete Pad
