04-0120F4

SFOBB SAS

Date 08/31/2009

ASSISTANT RESIDENT ENGINEER'S

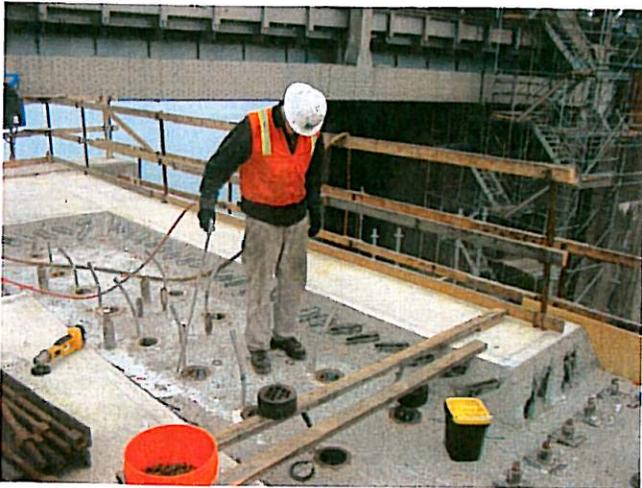
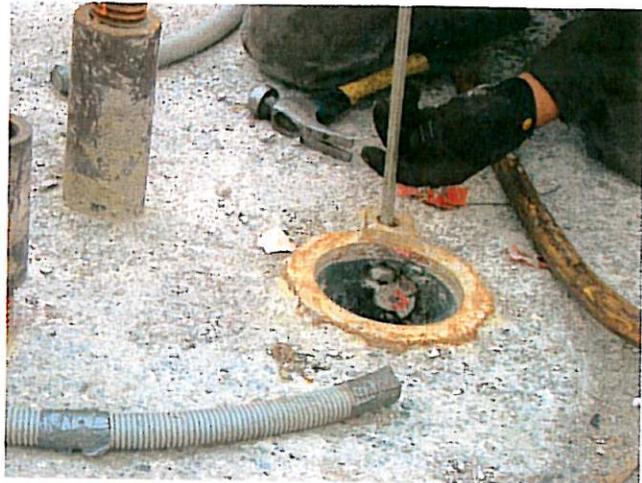
File Name:	Aug-31-2009 W2 Cap 003		
Date:	08-31-09	By Int:	M Bruce
Description: SDI ironworkers attempted to clean the annular void between the duct and the trumpet for the W2E vertical PT tendons. However some minor debris was found in this void after cleaning. Not much of an attempt was made by foreman Erin Jones to clean the voids at all.			
File Name:	Aug-31-2009 W2 Cap 004		
Date:	08-31-09	By Int:	M Bruce
Description: SDI ironworker chipping concrete out of the grouting vent in the vertical PT bearing plate.

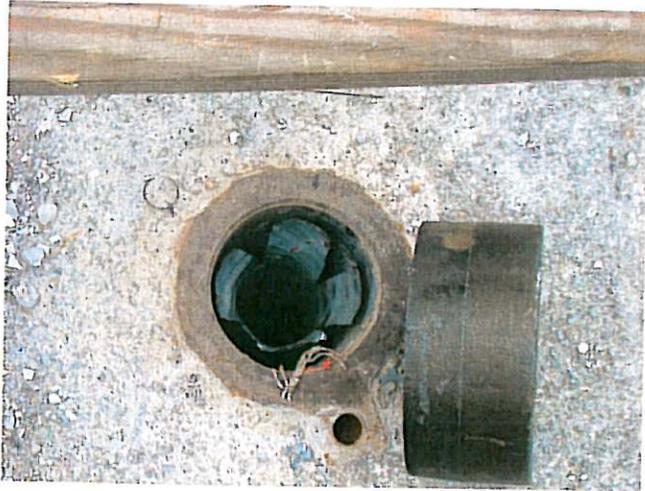
File Name: Aug-31-2009 W2 Cap 006
 Date: 08-31-09 By Int: M Bruce
 Description: The rust was grinded/cleaned off of the top of the W2E vertical PT bearing plates. Also the duct was cut and splayed towards the trumpet after cleaning. Only the upper anchor heads were placed today at the W2E vertical PT tendons.

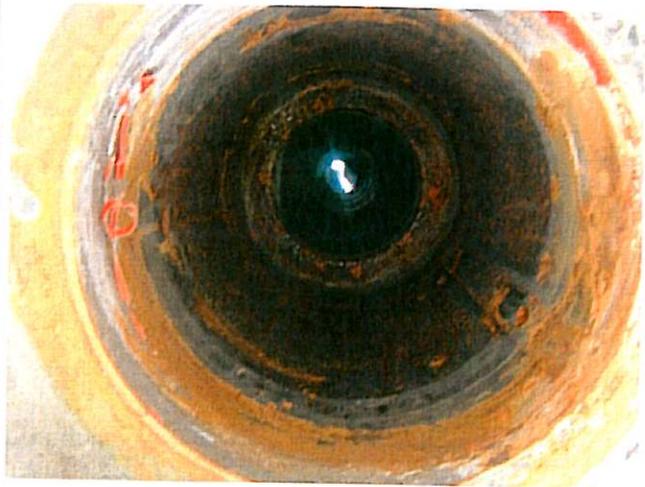
File Name: Aug-31-2009 W2 Cap 007
 Date: 08-31-09 By Int: M Bruce
 Description: Bottom bearing plate and pipe sleeve blockout where there appears to be some rust. Also a 1/4" silicone bead was still on the outer diameter of the bearing plate. It was difficult to distinguish whether or not there was pitting on the bearing plate. I notified SDI foreman Erin Jones to clean these plates before placing strand.

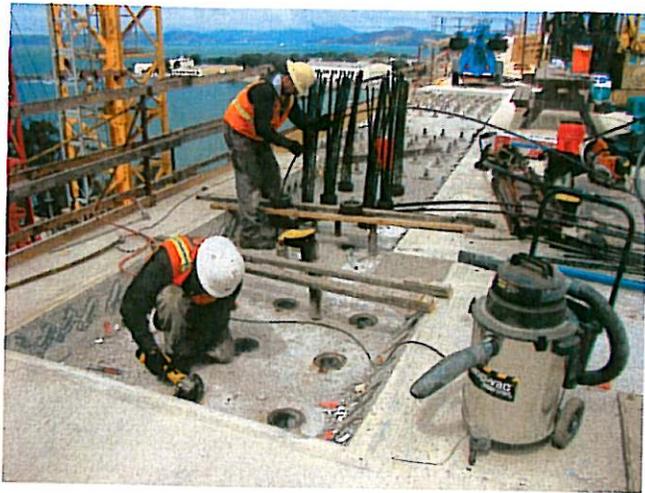
File Name: Aug-31-2009 W2 Cap 011
 Date: 08-31-09 By Int: M Bruce
 Description: SDI ironworkers placing strand for the vertical PT tendons and grinding/cleaning the bearing plates from rust and other debris. There was some rust found on the strand, which could be easily rubbed off by my fingers, no pitting was seen on the strands.

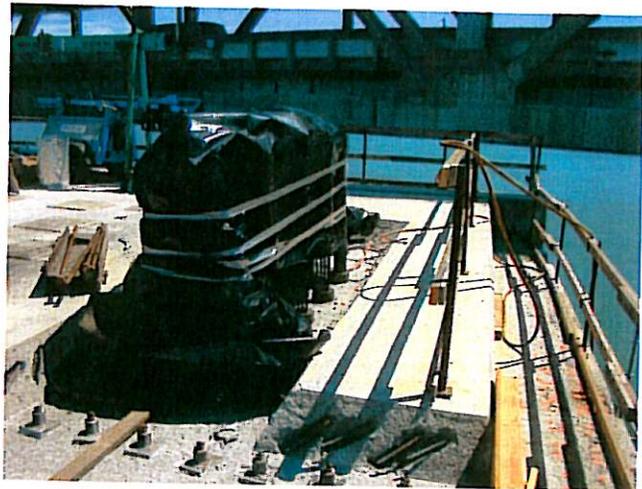
File Name: Aug-31-2009 W2 Cap 015
 Date: 08-31-09 By Int: M Bruce
 Description: The top of the strand tails for the W2E vertical PT tendons was covered with plastic. I expressed my concern to cover the full length of the placed strands. SDI foreman Erin Jones didn't acknowledge my request and left the jobsite. I spoke with SDI superintendent Ralph Craig and told him about Erin's behavior and reluctance to perform certain tasks related to quality.
