Job Stamp  
04-0120F4  
SFOBB SAŚ

ASSISTANT RESIDENT ENGINEER'S

Description of Operations @ W2 Cap Beam:

EA		04-0120F4	
Co-Rte-KP (PM)		SF-080-13.2/13.9 (8.2/8.7)	
Structure Rep.		Rick Morrow

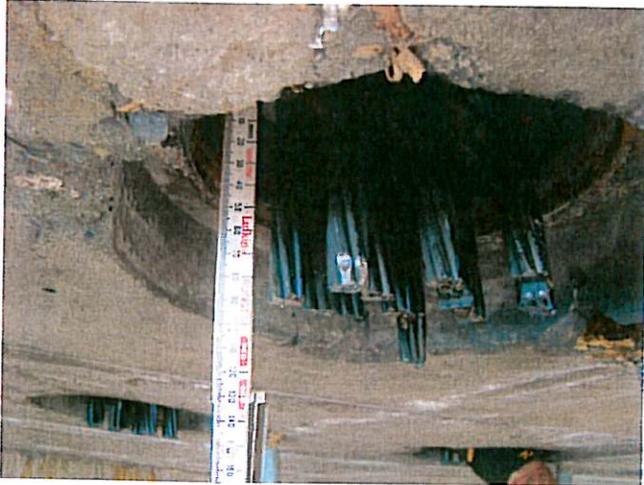
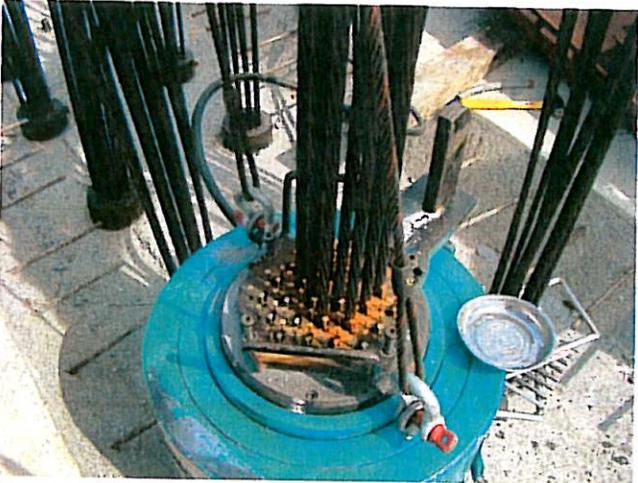
File Name:	Sept-02-2009 W2 Cap 002		
Date:	09-02-09	By Int:	M Bruce
Description: Strand tails cut approximately 4" below the anchorhead at the W2W vertical PT tendons. There was one recycle stroke of the jack to suck in or pull up the bottom anchorhead to the bearing plate. I didn't want to look in the recess during or after stressing for safety reasons. However I took a video of the anchorhead being pulled up during stressing. It appears that the anchorhead engaged the bearing plate. Also it was difficult to check for strand slip.			
File Name:	Sept-02-2009 W2 Cap 011		
Date:	09-02-09	By Int:	M Bruce
Description: Strands eccentrically positioned in the ram hole pattern. This was done because of the conflicts with placing the ram near the rebar dowels, embedded lifting rods, etc.

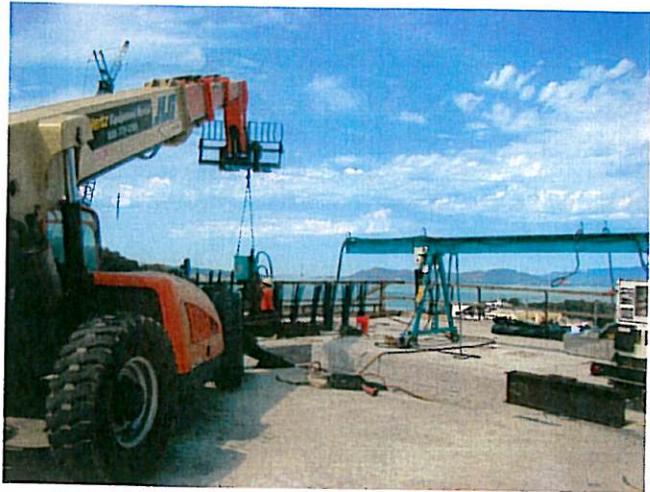
File Name:	Sept-02-2009 W2 Cap 013		
Date:	09-02-09	By Int:	M Bruce
Description:	Placing the ram over strands for a W2W vertical PT tendon using the forklift.

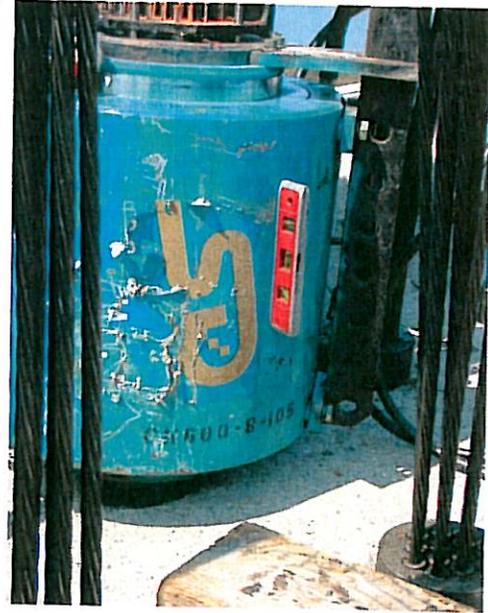
File Name:	Sept-02-2009 W2 Cap 014		
Date:	09-02-09	By Int:	M Bruce
Description:	The ram wasn't always perfectly plumb as a result of the eccentric strand placement through the ram, and some of the anchoreheads resting on the bearing plates. ABF installed the bearing plates prior to concrete placement and were made aware of them not being perfectly plumb. It appears that there were no problems as a result of this occurrence.

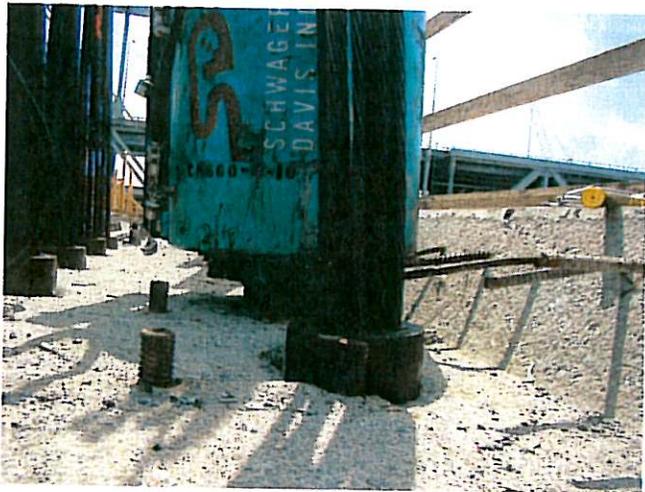
File Name:	Sept-02-2009 W2 Cap 015		
Date:	09-02-09	By Int:	M Bruce
Description:	Ram placement to stress a W2W vertical PT tendon.

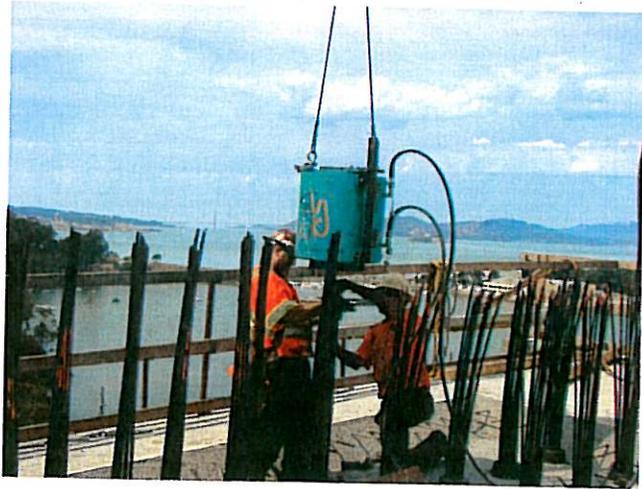
File Name:	Sept-02-2009 W2 Cap 016		
Date:	09-02-09	By Int:	M Bruce
Description:	SDI ironworkers placing the ram over the strand.
