04-0120F4
SFOBB SAS

ASSISTANT RESIDENT ENGINEER'S

Description of Operations @ W2 Cap Beam:

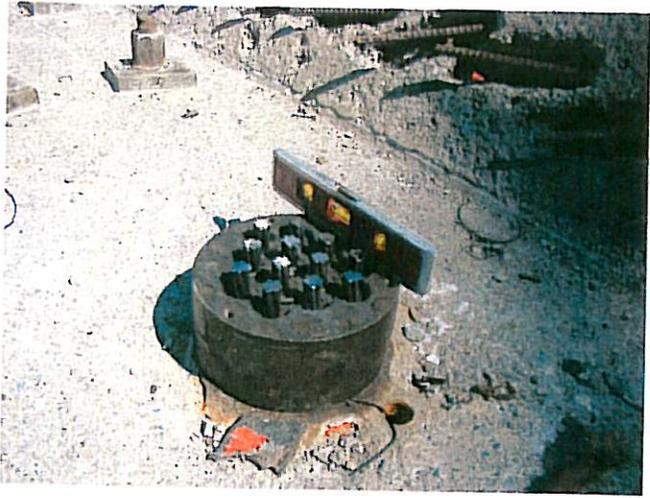
File Name:	Sept-03-2009 W2 Cap 010		
Date:	09-03-09	By Int:	M Bruce

Description: Anchorhead wasn't level in the north/south direction. ABF installed the bearing plates prior to concrete placement and were made aware of them not being perfectly plumb. It appears that there were no problems as a result of this occurrence.

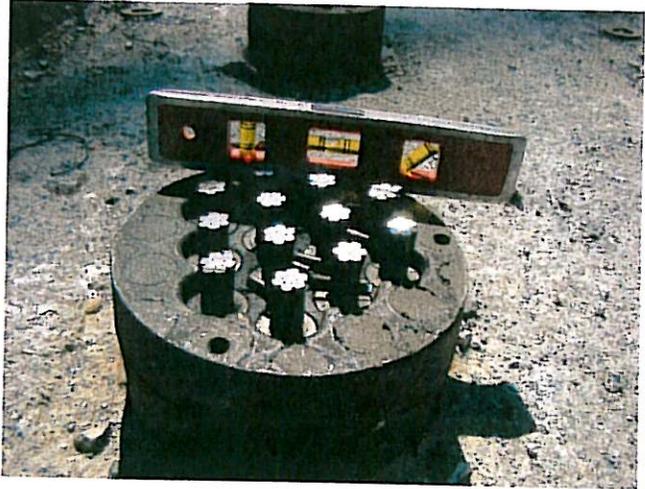
File Name:	Sept-03-2009 W2 Cap 011		
Date:	09-03-09	By Int:	M Bruce

Description: Anchorhead was closer to being perfectly leveled in the east/west direction. Once again the ram wasn't always perfectly plumb as a result of the eccentric strand placement through the ram, and some of the anchor heads resting on the bearing plates.
