04-0120F4
SFOBB SAS

Date 09/09/2009

ASSISTANT RESIDENT ENGINEER'S

Description of Operations @ W2 Cap Beam:

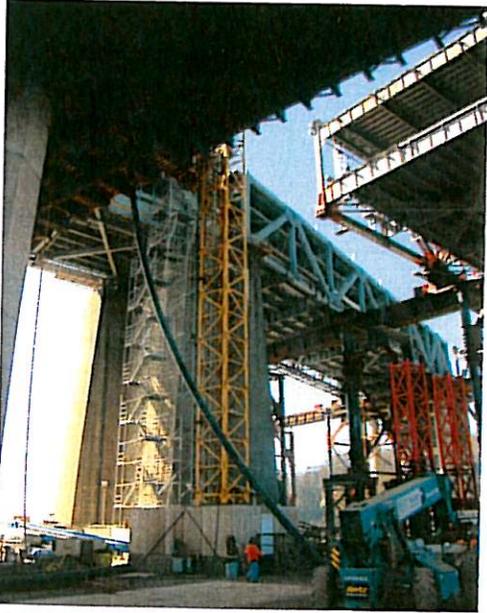
File Name:	Sept-09-2009 W2 Cap 002		
Date:	09-09-09	By Int:	M Bruce
Description: Erecting the second HDPE pipe cable tie down sheathing at W2E. ABF assisted SDI by guiding the pipe on the ground with their forklift.			
File Name:	Sept-09-2009 W2 Cap 007		
Date:	09-09-09	By Int:	M Bruce
Description: The SDI hoisting system on top of the W2 cap beam. One winch was attached to the end of the forklift rented by SDI performing the initial lift of the pipe from the ground. Once the pipe was raised through the soffit 20ft, the winch over the tendon hole was used to position horizontally and vertically the pipe into it's final position.

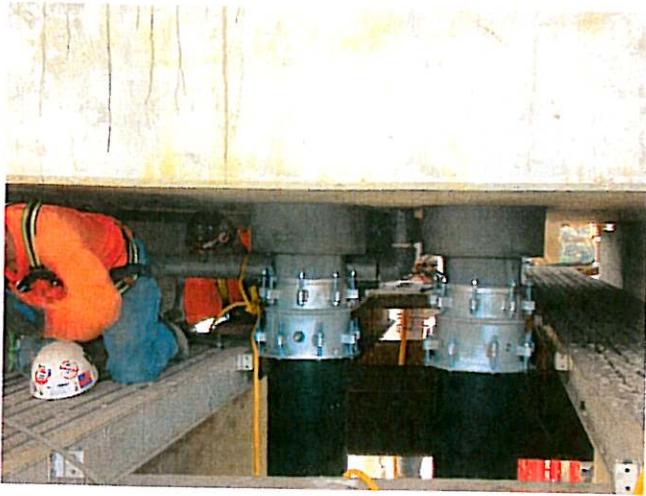
File Name: Sept-09-2009 W2 Cap 008
 Date: 09-09-09 By Int: M Bruce
 Description: Upper dresser coupler connections at the bottom of the top pier slab. The gasket and groove in the dresser coupler connection relies upon friction against the steel pipe. It was observed that some of the couplers looked skewed in relation to the steel pipe. I informed all SDI representatives of this issue and expressed my concern to maintain a straight path throughout the length of the cable tie-down tendon.

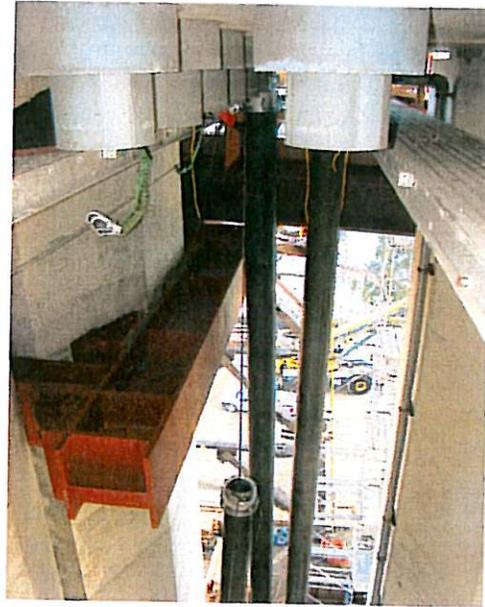
File Name: Sept-09-2009 W2 Cap 013
 Date: 09-09-09 By Int: M Bruce
 Description: Two pipes in place for the far east end tendon sheathing with the third in the process of being erected. The HDPE pipes at the bottom looked curved like a banana. SDI expects the dead load of the pipe to naturally straighten out the pipe. I expressed my concern to ABF and SDI about room to install lower bearing plate pipe assemblies, anchorheads, bottom couplers, etc if too many HDPE pipes are placed.

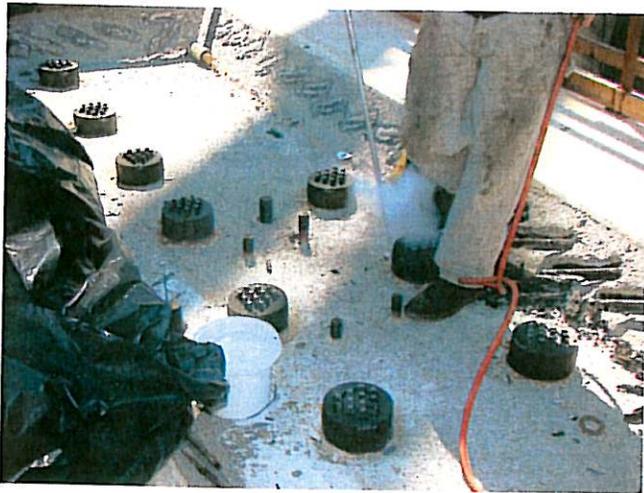
File Name: Sept-09-2009 W2 Cap 015
 Date: 09-09-09 By Int: M Bruce
 Description: Blowing VPI powder in the W2E vertical PT tendons through the top bearing plate-grouting vent. The strands were installed 10 days ago August 31st.

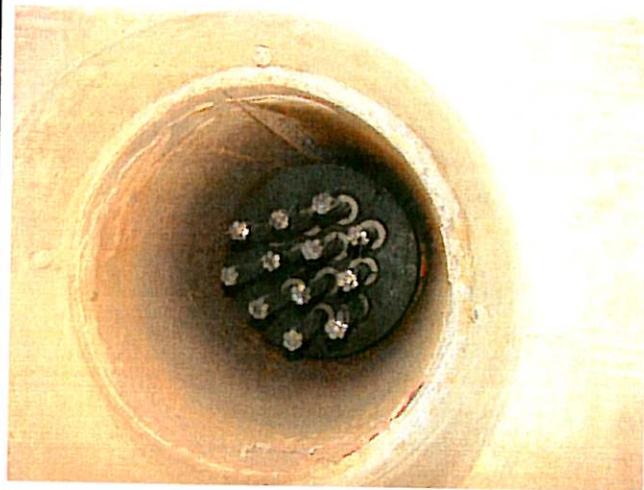
File Name: Sept-09-2009 W2 Cap 016
 Date: 09-09-09 By Int: M Bruce
 Description: The bottom end of a W2E vertical PT tendon where it was noticed that the anchorhead was not concentric with the bearing plate. The eccentricity was not greater than 1".
