04-0120F4

SFOBB SAS

Date 09/16/2009

ASSISTANT RESIDENT ENGINEER'S

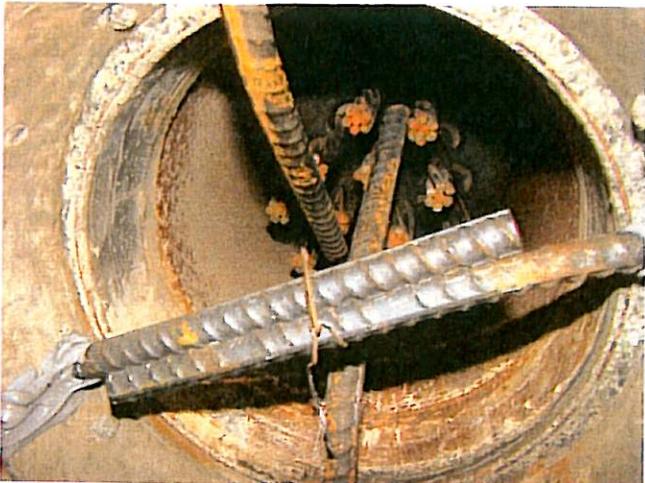
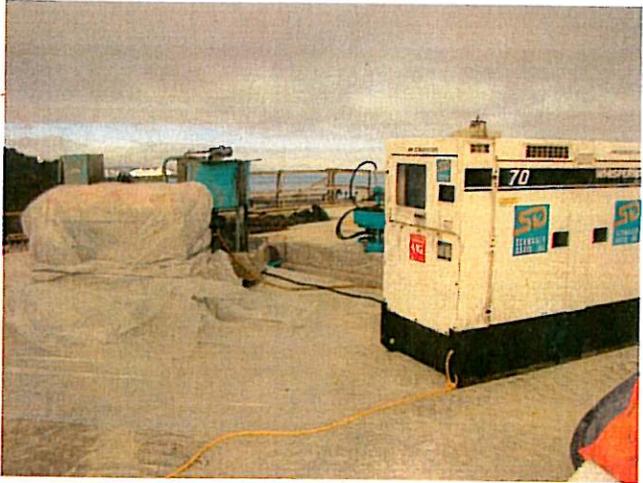
File Name:	Sept-16-2009 W2 Cap 001		
Date:	09-16-09	By Int:	M Bruce
Description: New rust was discovered on the ends of the strand tails of the vertical PT tendons where water was seen dripping. It is difficult to determine if there is more rust on the strand, wedges, or the anchorhead. I tried to rub off the rust with my fingers and couldn't remove the rust. Also seen is the dead end pipe sleeve dowel rebar.			
File Name:	Sept-16-2009 W2 Cap 005		
Date:	09-16-09	By Int:	M Bruce
Description: SDI's grouting equipment mobilized near the W2W vertical PT tendons. The pallet of grout bags was covered with plastic.

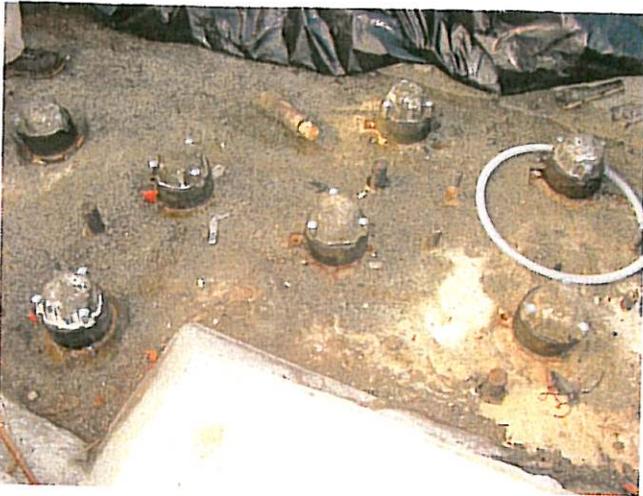
File Name: Sept-16-2009 W2 Cap 006

Description: Standing water on the concrete surface of the W2E vertical PT tendons. As mentioned before this water seeped into the grouting vent in the bearing plates, into the duct, and out the dead end pipe sleeve. It is unclear how much water got into these tendons from the rain last weekend.

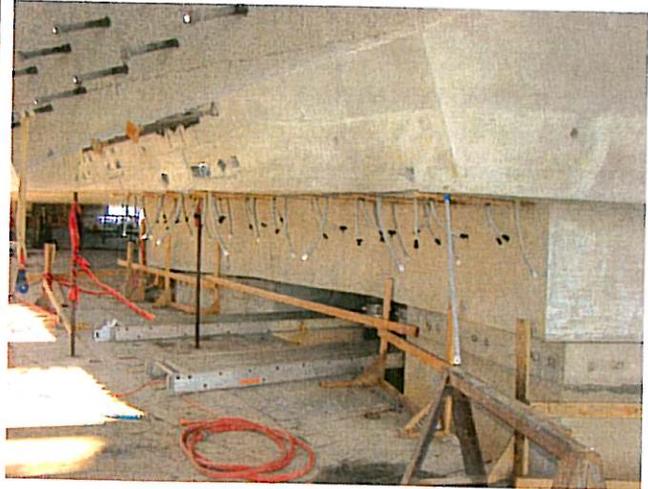
File Name: Sept-16-2009 W2 Cap 007

Description: Grout tubes for the vertical Pt tendon and the dead end pipe sleeve blockout.
