04-0120F4

SFOBB SAS

Date 09/17/2009

Description of Operations @ W2 Cap Beam:

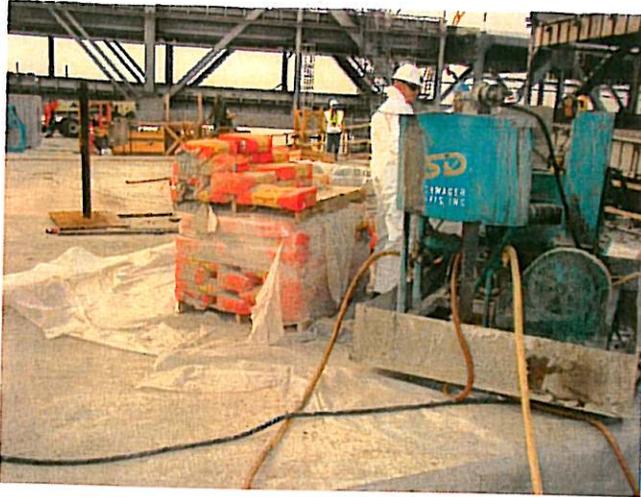
File Name:	Sept-17-2009 W2 Cap 001
------------	-------------------------

I informed SDI foreman Erin Jones that broken grout bags would be rejected. Some of the cementitious grout used had to be forcefully graded through the screen which indicated poor material quality. The paddles of the mixing machine were operating at full speed causing an increase in grout temperature. The temperature of the grout wasn't even tested due to the steam coming off the top of the grout in the mixing tank. The birds mouth was set to 280mm, the tank had a measured area of 300mm x 545mm. For eight bags of grout this equates to 12.1 gallons or 96.8 pints of water to be mixed in the mixer for 3 minutes. Based on the unit weight of the grout and the other observations noted above I rejected the grout to be placed. It should be noted that SDI or ABF didn't have an engineer onsite for quality control. SDI foreman Erin Jones informed me that a new grout pallet would be shipped onsite Monday September 21<sup>st</sup>, as well as a water meter independent of the grout machine. As a result no vertical PT tendon dead end sleeves were grouted today.

Description: SDI grouting equipment used which was the same piece of equipment used back in April for the transverse tendons. The machine made a large noise when started this morning. The equipment may not be suitable for producing quality grout. I informed SDI foreman that this machine should probably be taken out of service. Also note the broken grout bags adjacent to the grouting mixer.

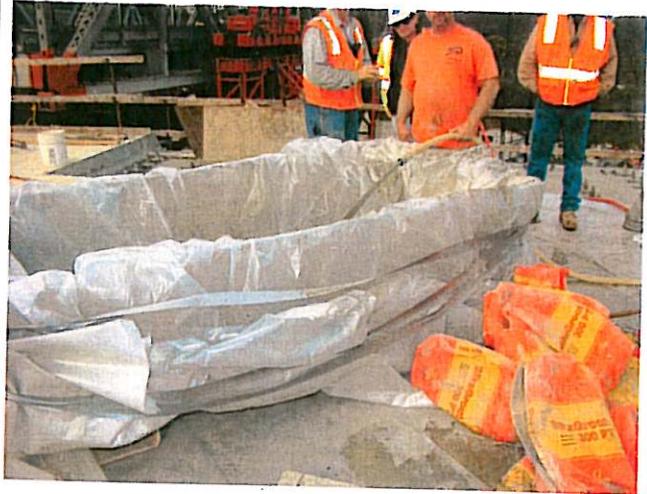
File Name:	Sept-17-2009 W2 Cap 003
------------	-------------------------

- Attempted to grout the dead end pipe sleeves to create a plug for grouting the vertical PT tendons at W2E and W2W. A couple of tests were performed on the grout with the following results
  - Efflux time,  $t_e = 14$  seconds
  - Ambient Air Temperature,  $T_A = 60^\circ\text{F}$
  - Grout Unit Weight  $\gamma_G = 132\text{pcf}$  (S.G. = 2.12) Caltrans &  $133\text{pcf}$  (S.G. = 2.13) SDI.  
The minimum required for compressive strength is  $135\text{pcf}$  using the mud balance.
  - Bleed test was done by Ken Beede which proved the grout wasn't segregating.
  - Grout cubes were not taken since the unit weight wasn't acceptable.

Description: Disposing rejected grout which was intended to be placed in the dead end pipe sleeves of the vertical PT tendons.

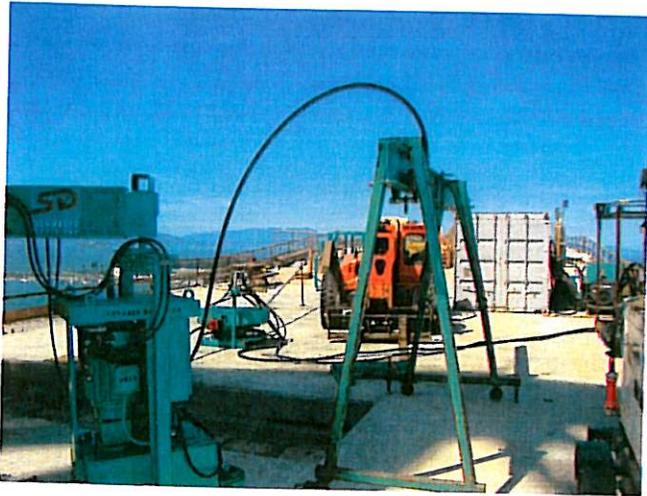
File Name:	Sept-17-2009 W2 Cap 005
------------	-------------------------

Description: SDI set up the strand pushing equipment to be used for placing the cable tie down strand at pier W2E.

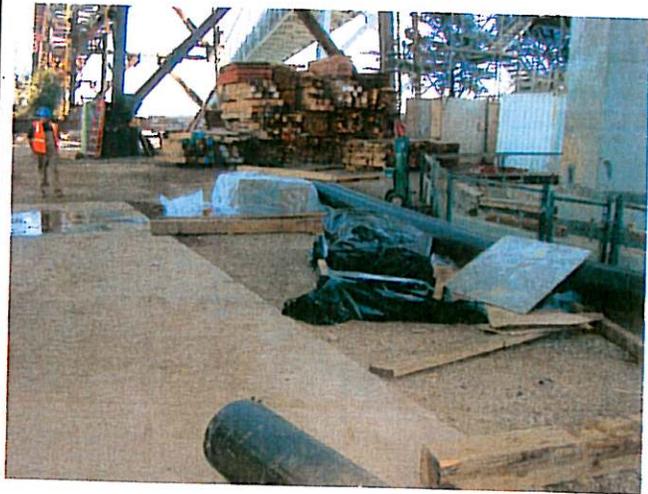
File Name:	Sept-17-2009 W2 Cap 006
------------	-------------------------

Description: Prior to leaving the jobsite SDI ironworkers covered the cable tie down and continuity tendon anchorheads with plastic.
