04-0120F4

SFOBB SAS

Date 09/24/2009

ASSISTANT RESIDENT ENGINEER'S

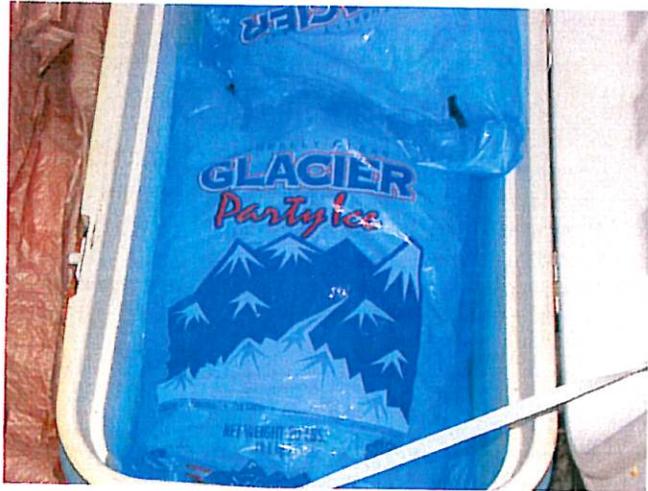
File Name:	Sept-24-2009 W2 Cap 001
Date:	09-24-09
By Int:	M Bruce

Description: 20lbs bags of ice were used to cool the grout temperature down. The grouting pump/mixer used may increase the temperature of the grout by mixing it too fast. Steam was seen rising off the grout in the mixing tank when the grout temperatures were over 90°F. Also there was a build up of hardened grout in the pump when the temperatures were too high. This indicates that the hydration process was premature.

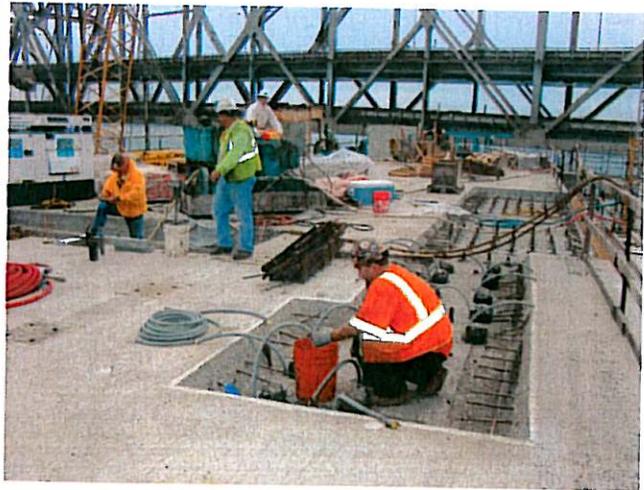
File Name:	Sept-24-2009 W2 Cap 002
Date:	09-24-09
By Int:	M Bruce

Description: SDI ironworkers grouting vertical tendon VT-16W and Smith Emery testing the grout mix.

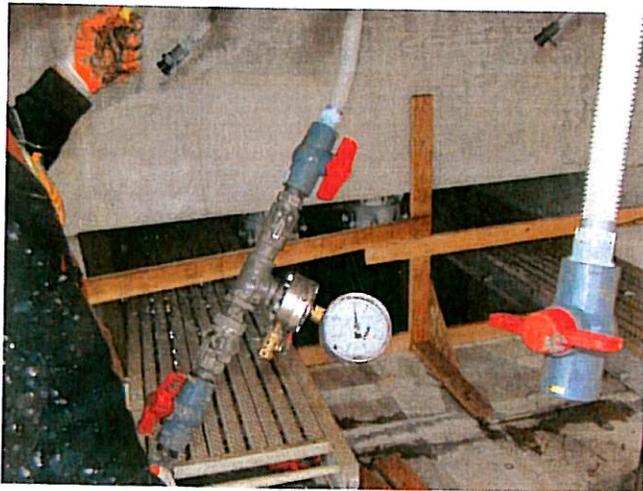
File Name:	Sept-24-2009 W2 Cap 004
Date:	09-24-09
By Int:	M Bruce

Description: Inlet at the dead end of the vertical PT tendons. The grout was pumped at a low pressure of 40psi. The tendons that I saw grouted from the bottom had grout coming out of the dead end drain tube, prior to grouting the entire tendon. Once good grout was seen at the top outlet tube and through the grout cap (fixed to the anchorhead) the pressure was increased to approximately 50psi to grout the tendon under pressure.

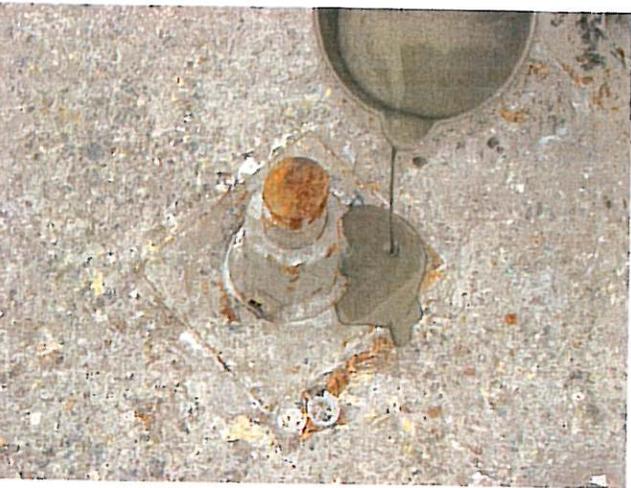
File Name:	Sept-24-2009 W2 Cap 009
Date:	09-24-09
By Int:	M Bruce

Description: Topping off the few vertical PT bars that weren't done back in May.

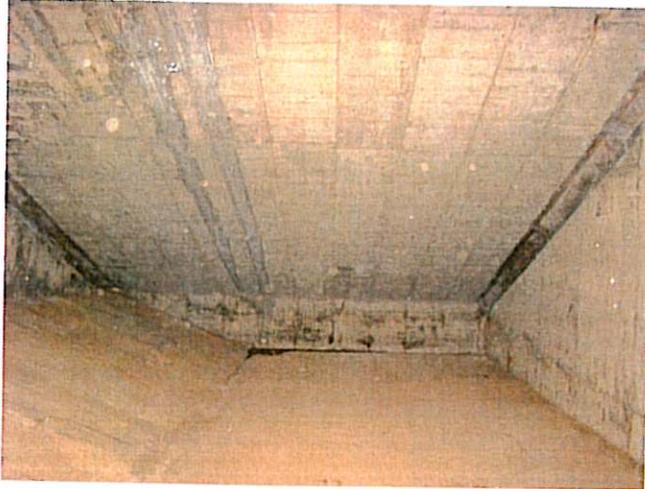
File Name:	Sept-24-2009 W2 Cap 015
Date:	09-24-09
By Int:	M Bruce

Description: Concrete surfaces in the southeast void area looking south.

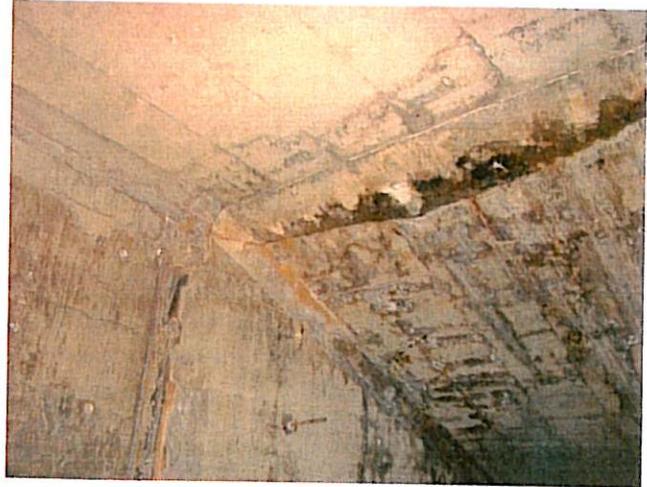
File Name:	Sept-24-2009 W2 Cap 016
Date:	09-24-09
By Int:	M Bruce

Description: Concrete surface at the pour 4/6 joint in the southeast void area.

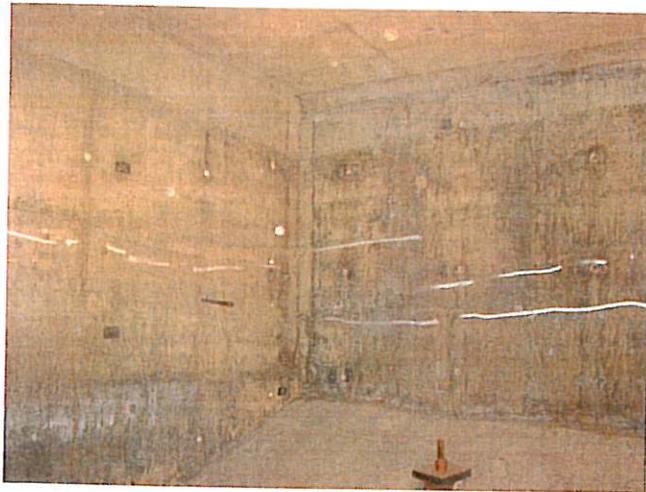
File Name:	Sept-24-2009 W2 Cap 018
Date:	09-24-09
By Int:	M Bruce

- Assisted SDI with moving material and equipment from the ground to the top of the W2 cap beam.
- ABF foreman Terry Cronk, and Nigel Lohse assisted Lalit, Gil, Ken Beede, Rick Magentti, and myself with the concrete crack inspection in all four void areas. Cracks patterns to be fixed were spray painted silver. Prior to entry into the confined space the air was tested.

Description: Cracks that needed to be repaired which were identified with silver spray paint.

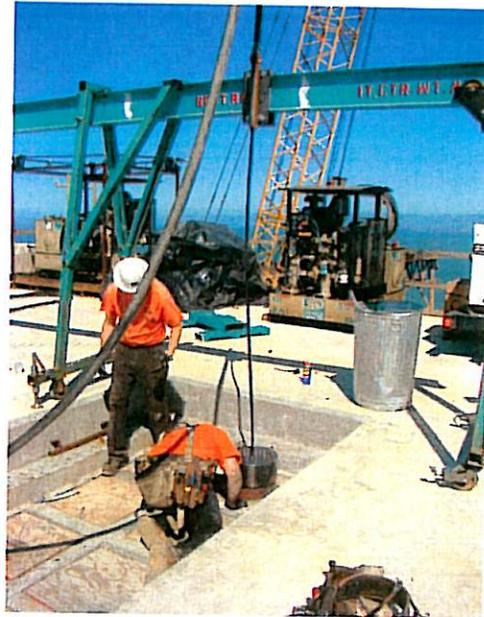
File Name:	Sept-24-2009 W2 Cap 025
Date:	09-24-09
By Int:	M Bruce

Description: Installing the first sheathed strand for the W2E southeast cable tie down tendon. The ironworkers spent most of the time assessing the operation and figuring out how they were going to efficiently install the strand.
