STATE OF CALIFORNIA	Job Stamp	7-day Const. Calendar	Day No. 993
DEPARTMENT OF TRANSPORTATION	SFOBB SAS	Project Work Day No.	Day No. 1203
Form HC-10A (Rev. 6/80)	04-0120F4	Date	9/1/2009

Description of Operation:
Erect Temporary Truss and Towers: Drilling Anchor Bolt Holes at E2 and bolt up Truss FS W13 to FS W16

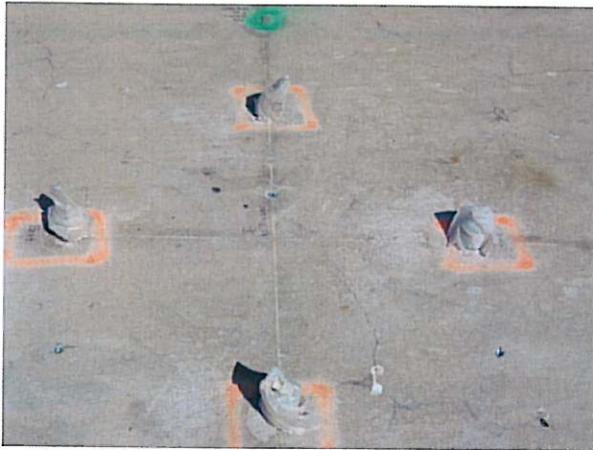
Small water bottles wrapped in plastic to cover holes

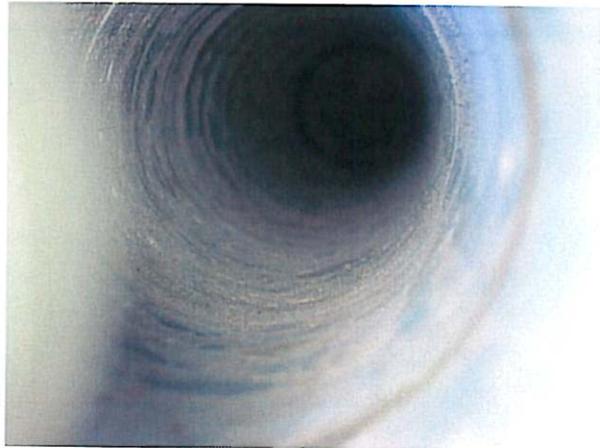
Cleared out hole

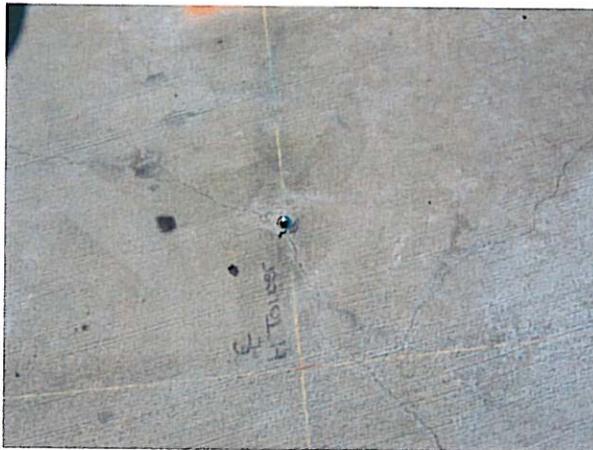
Cracks on E2 through attachment for drill rig

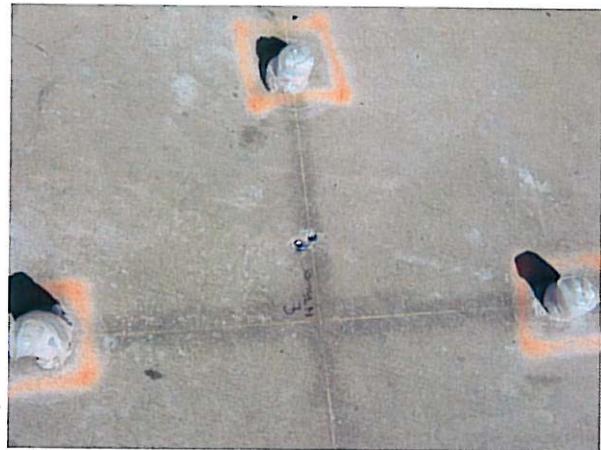
Two attachments for drill rig next to each other
