STATE OF CALIFORNIA	Job Stamp	7-day Const. Calendar	Day No. 1015
DEPARTMENT OF TRANSPORTATION	SFOBB SAS	Project Work Day No.	Day No. 1225
Form HC-10A (Rev. 6/80)	04-0120F4	Date	9/23/2009

Description of Operation:
Erect Temporary Truss and Towers: Assemble E12/13/14 at Pier 7 Test Anchor Rods at E2

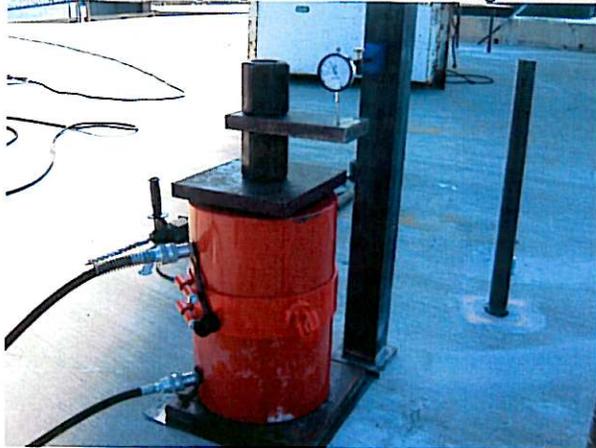
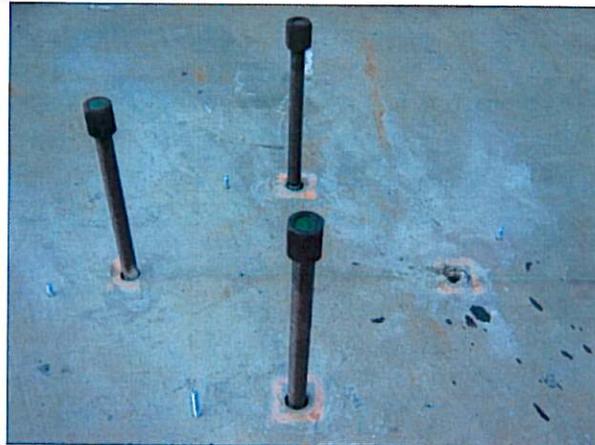
I observed the testing of the West bents on the North side of E2 throughout the morning today. They started on the South one around 0800 hrs and finished by 1030 hrs. One of the rods failed under the prescribed testing set forth by the designers, Klohn Crippen Berger. The workers placed a jack around the rods, placed a plate containing a hole through it for the rod on top, then had another plate stick out to push against the dial gauge used to track elongation. See photo.

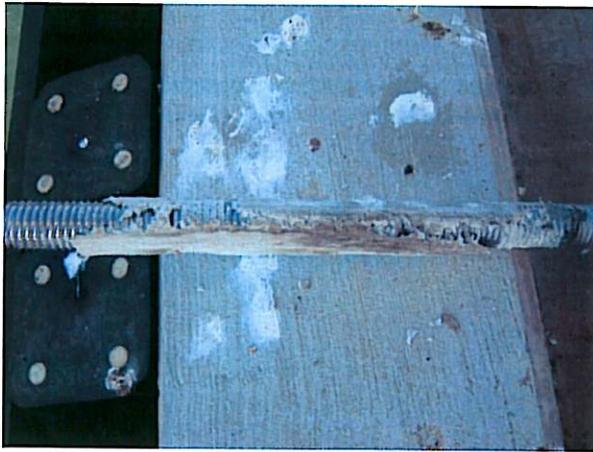
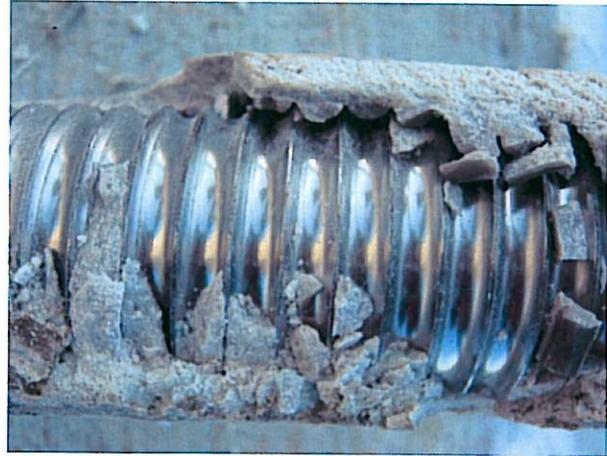
The failed rod, pictured above, happened on the North side of the column cluster of rods. The other three rods were brought up to 5,550 psi, which associates with the 1000kN required by the designer, then held at that pressure for ten minutes, while the elongation/relaxation is observed and tracked. The maximum change set forth is 0.04 inches, and all three were less than 0.04 inches. They were accepted by the Contractor, for now.

The same testing happened on the North rod cluster, W-Line, West bent. Here, there was one failure as well, but it was the Eastern most rod. This was brought up to 5,550 psi, and failed immediately. The rod was removed and samples were taken of the epoxy. There appeared to be portions of the epoxy that did not set, experiencing characteristics of gel and still unset after three or four days. Some of the other areas showed signs of disintegration. Upon first seeing this, it appeared as though either the epoxy is bad, the mixing was not adequate, or the setting time was inadequate. The Contractor is going to take the results and contact me later in the week.
