JOB STAMP
 04-0120F4
 04-SF-80-12.6/13.2
 San Francisco Oakland Bay Bridge
 Self Anchored Suspension Span

REPORT NO.	865	to	871	DATE	Apr 26 – May 2, 2009	S T W Th F S
SHIFT HOUR	START	Var.	STOP	Var.	TEMPERATURE	
WEATHER	Sunday	Monday –	Tuesday –	Wednesday –	Thursday –	Friday – Saturday –

SUB 915 COMMENTS Dated: 28-Apr-09

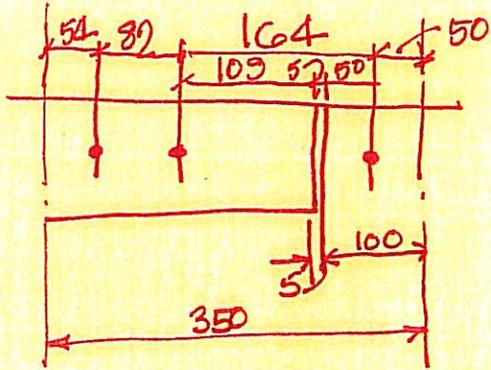
E2-SB1a

- **Deleted Bolt Holes:** In redlines, David indicated bolt holes at certain locations along the Steel Barrier had to be deleted in order to have adequate edge distance (*See Attachment of his comments*). He expressed that by deleting a bolt hole, the existing hole in the Deck Plate would have to be caulked. I reviewed his redlines contained in Submittal 915 and agree with his observation. Issue resolved with latest indicated redlines.

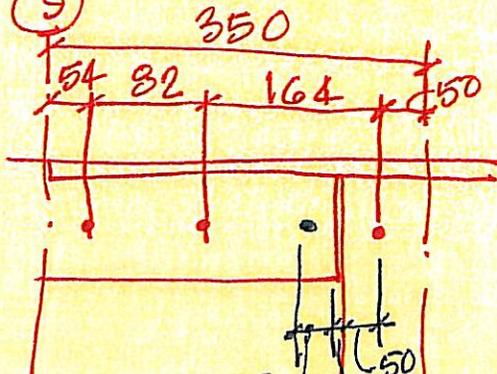
W5-SB2

inadequate
edge
distance
