Job Stamp  
04-0120F4  
SFOBB SAS

ASSISTANT RESIDENT ENGINEER'S

EA	04-0120F4		
Co-Rte-KP (PM)	SF-080-13.2/13.9 (8.2/8.7)		
Structure Rep.	Rick Morrow

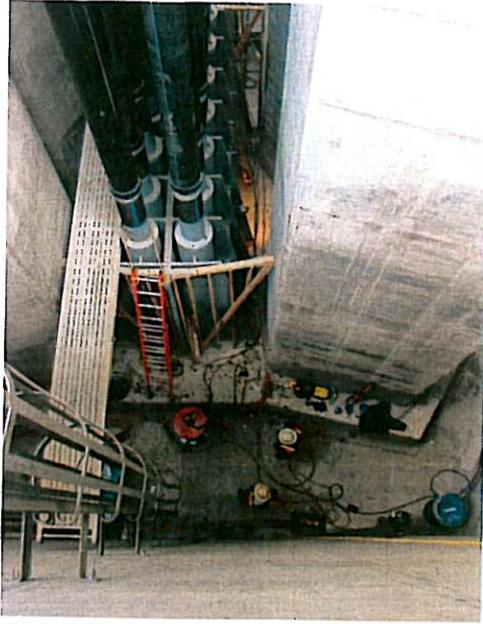
Date:	01-07-10	By Int:	M Bruce
Description: SDI Ironworkers seen in the W2W foundation injecting grease into the lower grease caps. Heating straps placed around the grease barrels and a mixing paddle were used to make the grease more viscous.			
Date:	01-07-10	By Int:	M Bruce
Description: Standing water seen in the W2W cable tie down blockout. The water should be drained at the low end where there is a pipe to collect/drain the water. ABF needs to address this issue prior to placing the cover slab. A similar condition exists at the W2E cable tie down blockout.
