SAS Superstructure

Daily Diary Report by Bid Item

Contract No.: 04-0120F4

Diary #: 002 Const Calendar Day: 142 Date: 28-Jan-2010 Thursday

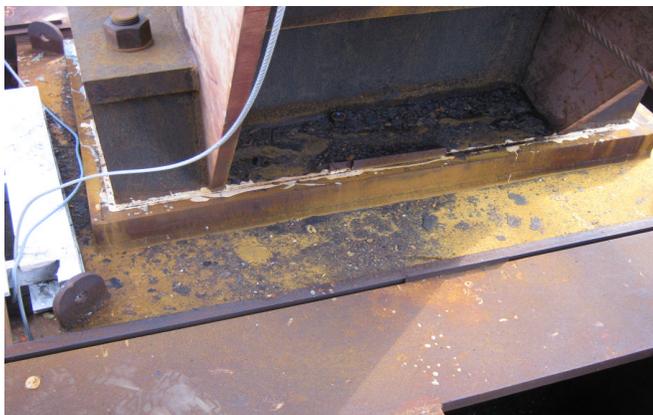
1300-1445: performed walk-through inspection of temp tower E-line foundations. Noted that temp tower F & G locations had "spacer plates" or shims installed to position the tower "pocket" assemblies. These shims were not shown in the KCB plan sheets, but may have been "field fixes". In all inspected loactions, these spaces were installed in three groups to a side, except for the north face of the west bent south leg at temp tower F, which only had two sets of spacers. It was unclear if this was intentional or if one set of spacers has slipped out of position.

TT F, e-line, north face, south tower leg. Two sets of spacers, instead of usual three.

02-01-2010 -- follow-up to spacer issue noted above. John Callaghan (ABF) stated that it was unclear if the third spacer at the north side of the TTF South tower leg, west bent had slipped out or was not installed to start with. He stated that Bill O'Sullivan was tasked with assigning personnel to remedy this condition by reinstalling the spacer and welding these in place wherever necessary to ensure they did not slip out in the future.
