SAS Superstructure
 Location: 04-SF-80-13.2 / 13.9
 Client Name: CalTrans

Daily Diary Report by Bid Item

Contract No.: 04-0120F4

04-0120F4
 04-SF-80-13.2/13.9
 Self-Anchored
 Suspension Bridge

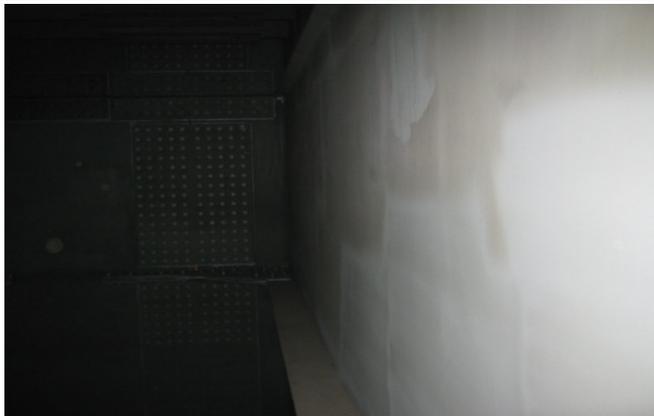
OBG 1E PP10 northeast face bowed out, Jason Wilcox, 1/29/10

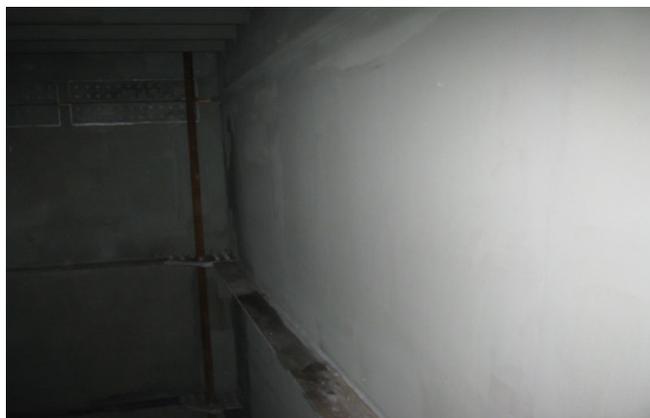
As we moved along the floorbeams looking for damage , it was noticed that there is a portion of the floorbeam, at PP11 on the North side of the box, East face of the floorbeam that sticks out more than the surrounding area. One of the lifting lugs is located about 4 feet down and 2 feet from the area. Pictures were taken and are attached. The same ocurance is at PP10, on the North side, East face as well. There are no lifting lugs in this location, but there was type F shoring at this panel point. Type F shoring had the highest load of the shorings used for this lift. See attached pictures.

OBG 1E PP11 northeast face bowed out, Jason Wilcox, 1/29/10
