**Daily Diary Report by Bid Item**

Contract No.: 04-0120F4

04-0120F4  
 04-SF-80-13.2/13.9  
 Self-Anchored  
 Suspension Bridge

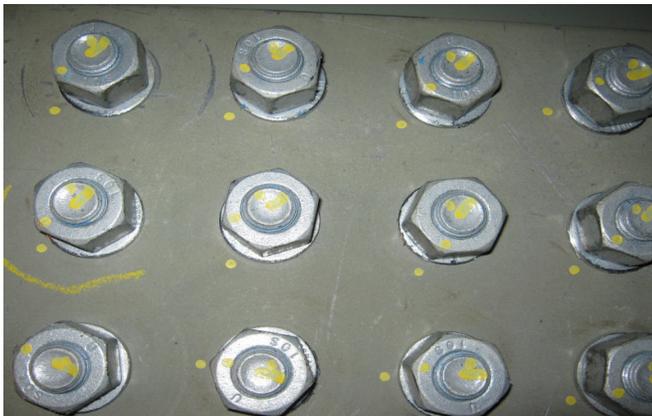
Throughout the day I worked with Bob Brignano and Chris Bausone on the overturned bolt situation at Splice 3. There are some U-ribs that have bolts that were turned further than the allowable 180 degrees + 30. The concern is that the ductility of the bolt may have been lost in overtightening. It was agreed to remove some of the bolts that were tightened too much to see if threads had been stripped or if "necking" had occurred. Once removed the nuts were run down as far as they could go. In most every one tried, the nut would not go past the spot it was at after tightening in the U-rib. This showed that overtightening the bolts yielded unwanted results. Chris agreed and the bolts were replaced.

Splice 3; Overtightened bolts remarked to appear acceptable

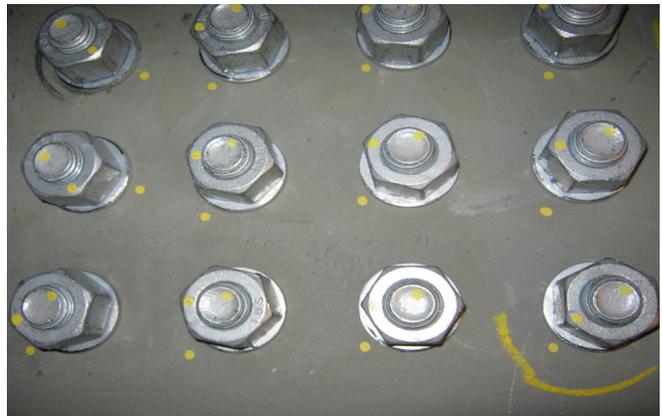
Splice 3; Overtightened bolts in U-rib

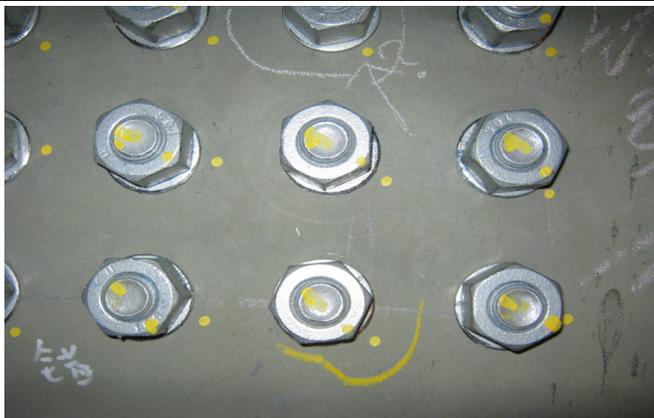
Splice 3; Overtightened bolts remarked to appear acceptable
