Daily Diary Report by Bid Item

Contract No.: 04-0120F4

04-0120F4
 04-SF-80-13.2/13.9
 Self-Anchored
 Suspension Bridge

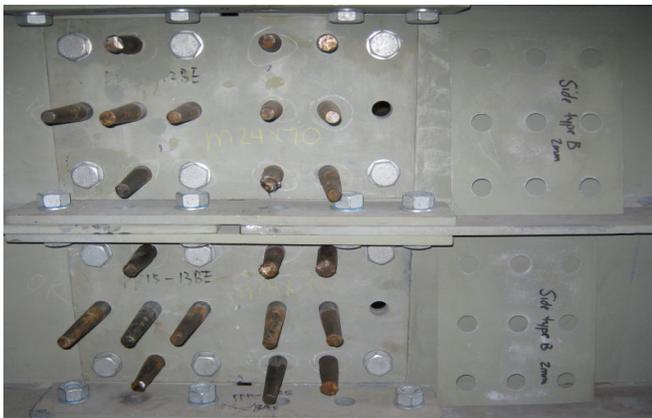
CB1 Interior web bottom splice

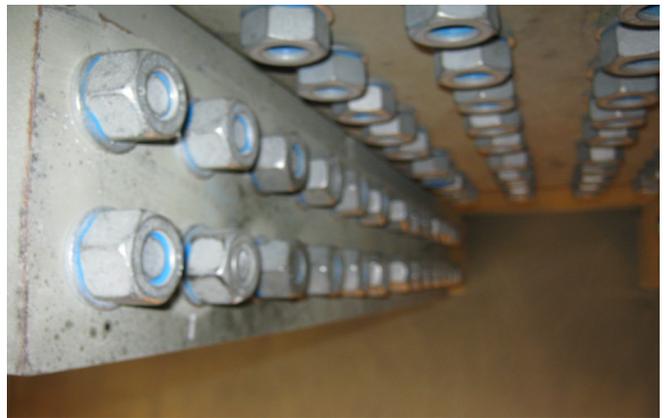
Bolting continues at Crossbeam 1, (CB1). Dan Hester had a concern about some bolts on the top splice plate stiffeners being flush. Bob and I took a look and concluded that the bolts have engaged all of the nuts threads and can be considered "flush." Dan said that the bolts in this connection are 100mm long, and that the next size up is 110mm, which would violate our 6mm stick-out limit on bolted connections. Bob said he would look into that statement. While looking at this connection I observed that the top splice plate stiffeners were not aligned well with each other and suggested that they tighten the top plate prior to pretensioning the stiffeners so there is no misaligned splice plates prior to their pretensioning. The ironworker agreed that they were going to do that.

CB1 Top Splice Non-flush snug nuts

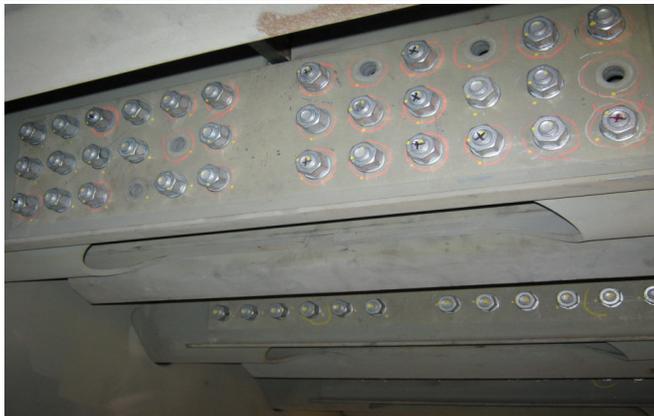
Arrived on site with Bob Brignano to meet Chris Bausone to remove some bolts in a couple of areas of the U-ribs in Splice 3. There was concern about some bolts that were "overturned" according to the procedure. The turn-of-the-nut procedure calls for these bolts to be turned one-half turn with a tolerance of +30 degrees. Some of the bolts were turned one half +90 or more. These bolts were removed and checked to see if the nut spun down the shank of the bolt easily or whether necking occurred, distorting the bolt. During RoCap testing, necking occurred far beyond the one half +30 degree turn point. The RoCap turned the nut a full turn to make sure that the fastener assemblies are made of acceptable material. Some of the removed bolts had difficulty in spinning the nut down the shank of the bolt. It was concluded among the three of us that these bolts were tightened too much, decreasing the serviceability of the bolts. They were replaced with new bolts and then pretensioned. At U-rib #21, on the North splice plate, 34 bolts were replaced and on the South splice plate 9 were replaced. At U-rib #25 one bolt was removed that was tightened one half turn + 90 degrees, at least, and did not exhibit the aforementioned difficulty in spinning the nut down the shank. It was apparent that the concern was localized to U-rib #21, and the questionable bolts were removed and replaced. Now, there remains 8 U-ribs to test. These were not tested because there was concern about the over tightened condition of the bolts as well as the marking on the bolts. Since then, it was agreed to check some bolts as we did today. The remaining U-ribs have not been tested because of the Crossbeam being erected and there are no ironworkers to perform the testing.

3E/4E Urib 21 Overturned nuts

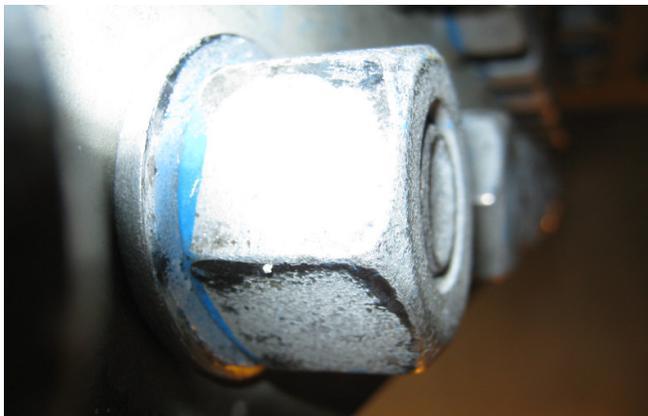
CB1 Top Stiffener Non-flush nut
