Daily Diary Report by Bid Item

Contract No.: 04-0120F4

Diary #: 037 Const Calendar Day: 191 Date: 18-Mar-2010 Thursday

04-0120F4
 04-SF-80-13.2/13.9
 Self-Anchored
 Suspension Bridge

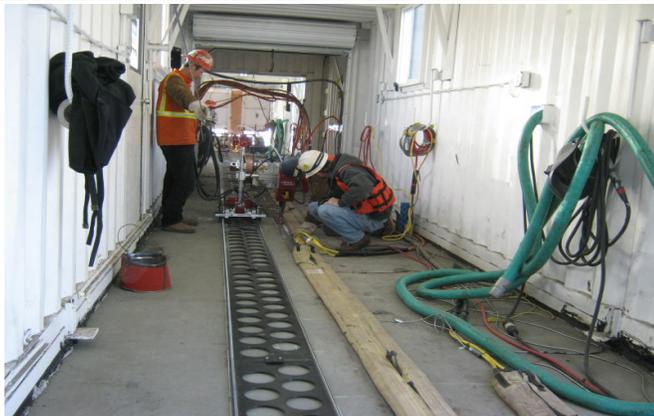
2E/3E Top Deck Welding with SAW machine 1

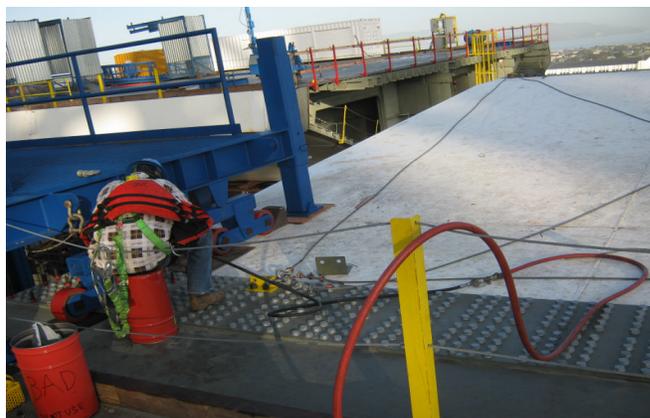
-Pretensioning bolts on the Top Splice between CB1 and 2E. There are two workers on top with the air guns turning the bolt heads while two other workers are below inside the Crossbeam using a wrench to prevent the nuts from turning. They are in radio contact throughout the whole time talking about which bolt to tighten next. By the end of the day they were able to pretension all but 6 of the Top Splice plates, namely A, B, and C on both the East end and West end.

CB1/2E Top Splice Pretensioning

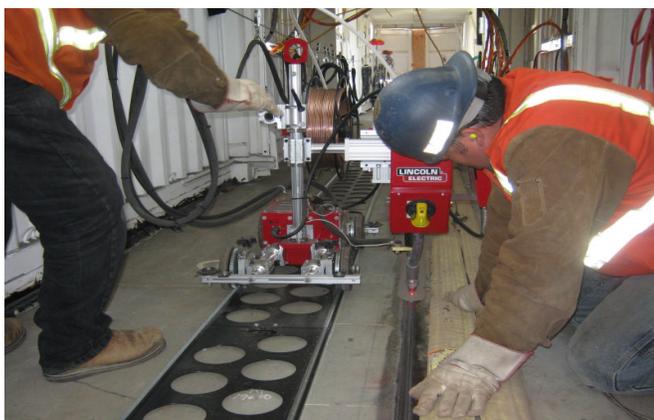
2E/3E Top Deck Welding with SAW machine 2
