Daily Diary Report by Bid Item

Contract No.: 04-0120F4

04-0120F4
 04-SF-80-13.2/13.9
 Self-Anchored
 Suspension Bridge

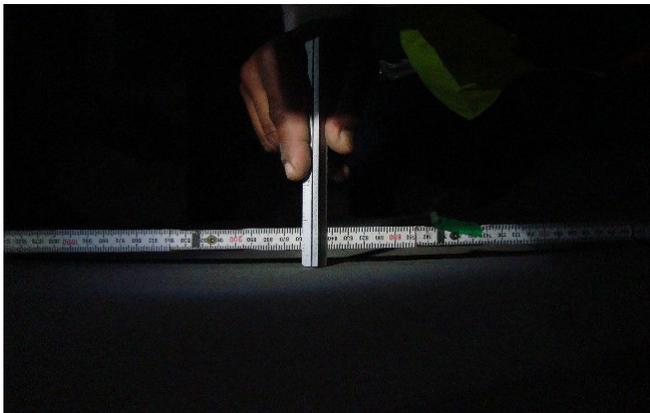
10mm depression over approximately 1.5m length measured at Panel Point 33 on the north side of the OBG (crossbeam end) and east side of plate.

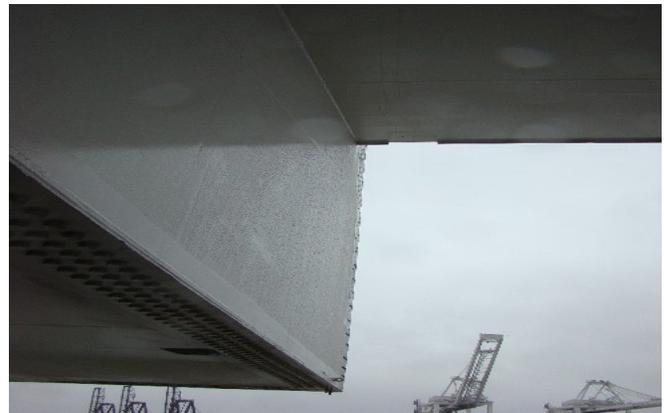
Deformation seen at the top corner of the east end of the crossbeam splice which was bent during sea transportation or offloading

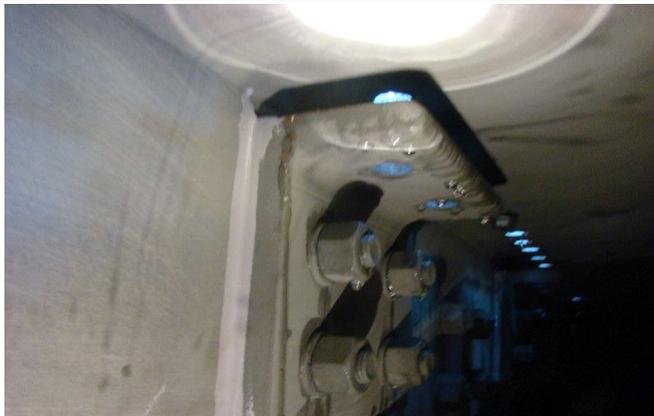
Barrier angle (typical) without caulking along the top edge where water was found
