**SAS Superstructure**

**Daily Diary Report by Bid Item**

Contract No.: 04-0120F4

04-0120F4  
04-SF-80-13.2/13.9  
Self-Anchored  
Suspension Bridge

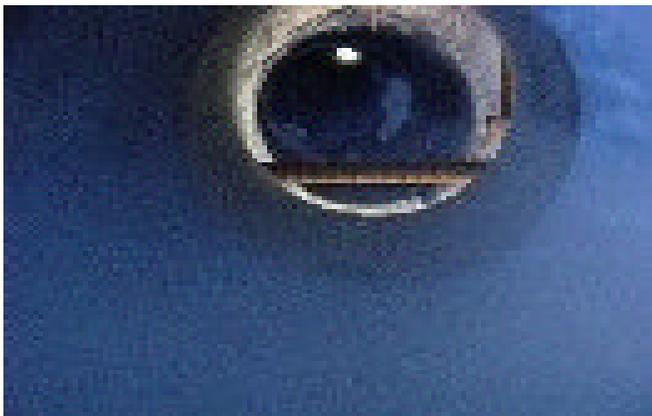
- Inspected the continuity tendon alignment between the steel pipes in OBG lifts 1E and 1W related to the openings in the W2 cap beam concrete. The majority of the "B" tendons were inspected for both E-Line and W-Lines and a few "A" tendons in the top corners were inspected. In general the bottom row was aligned properly and there wasn't any rebar conflicting with the area of the blockout mandrel. However approximately 20% of the tendons along the inclines for both E and W-Lines had conflicts with rebar, see photos below.

Continuity tendon along the E-Line conflict with rebar looking west.

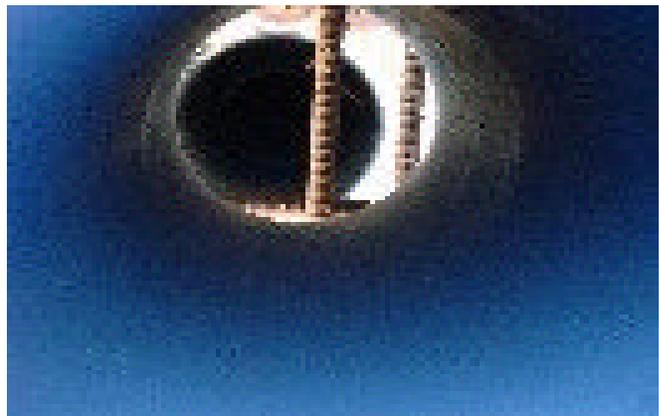
Continuity tendon along the W-Line conflict with rebar looking west.
