Daily Diary Report by Bid Item

Contract No.: 04-0120F4

Diary #: 006 Const Calendar Day: 323 Date: 28-Jul-2010 Wednesday

04-0120F4
 04-SF-80-13.2/13.9
 Self-Anchored
 Suspension Bridge

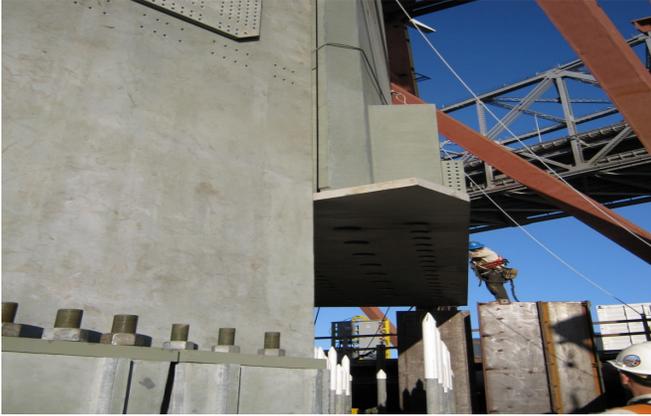
- At 16:30, the shaft was rotated with winch lines attached to padeyes on the shaft skins
- By 17:30, the shaft was over the rods. However, there was not enough clearance between shear plate c(W) and the alignment bumper attached to the T1 foundation at the C-D corner. They needed to raise the shaft back above the alignment bumper to fit past the shear plate, then lowering continued again.

South shaft between shear plate cW & alignment bumper

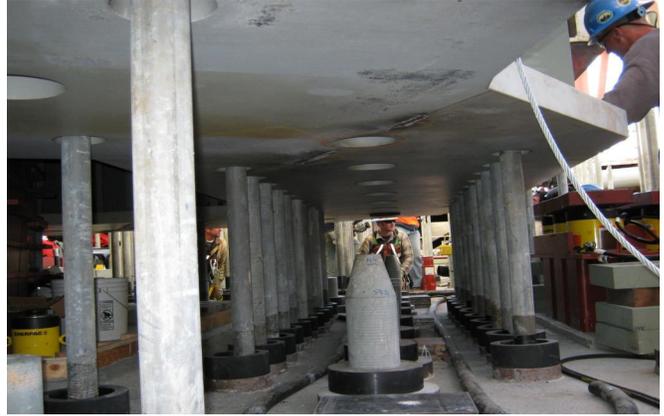
Note: Prior to setting the shaft, all of the plastic alignment bolts for the anchor rods had already been broken. All of the neoprene rings around the rods and dowels were in place. During the lowering, there was no damage noticed to the shaft or to any anchor rods or dowels.

South shaft over dowels

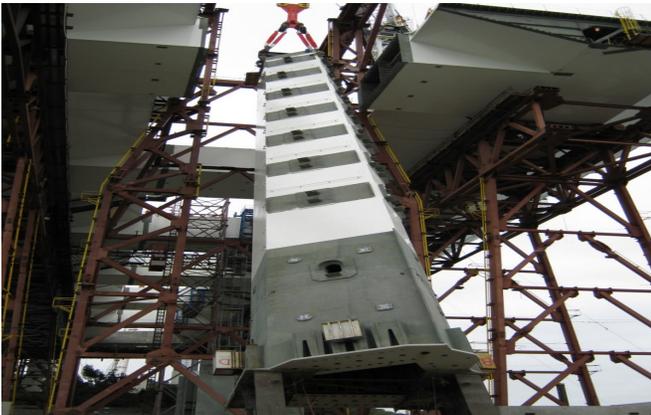
- When I arrived at 09:00, the shaft was being tipped up, and was at about 50 degrees from horizontal
- At 10:30, the shaft was vertical, and work began removing the rods between the shaft & tipping cart

South shaft tip-up 50 degrees from horizontal

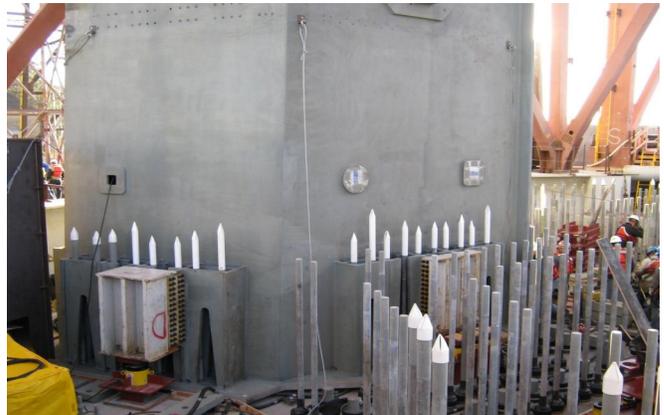
- At 19:20, the anchor rods were aligned to pass through the base plate holes, & shaft was lowered past the rods
- At 19:30, the shaft touched down on the shims

South shaft in place
