**Daily Diary Report by Bid Item**

Contract No.: 04-0120F4

04-0120F4  
 04-SF-80-13.2/13.9  
 Self-Anchored  
 Suspension Bridge

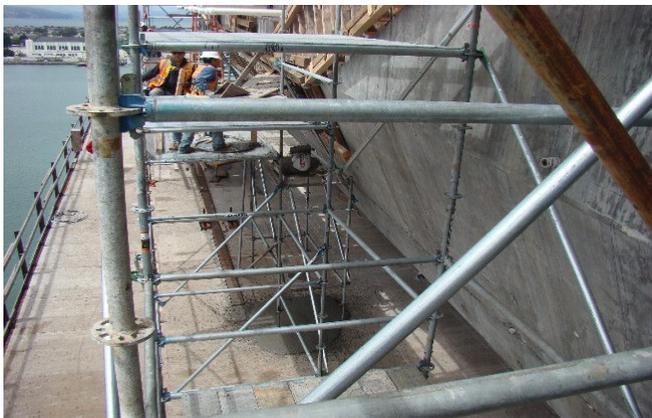
At 2:07pm the opening near CT-W15B was not closed and concrete spilled out of the forms when concrete placement was being done at CT-W43.

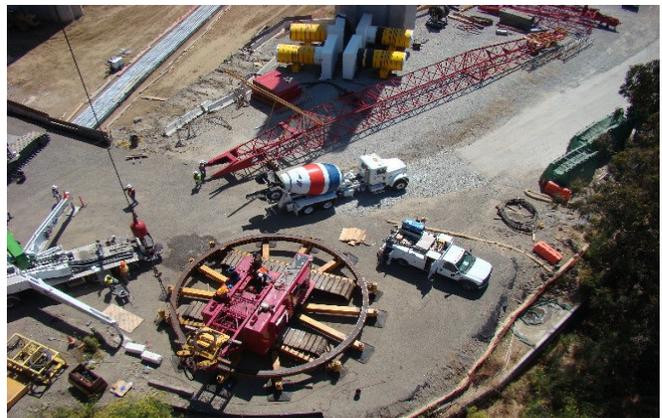
Progress of assembling the Manitowoc Ringer crane, and the concrete pump placing SCC into the CT-WB forms.

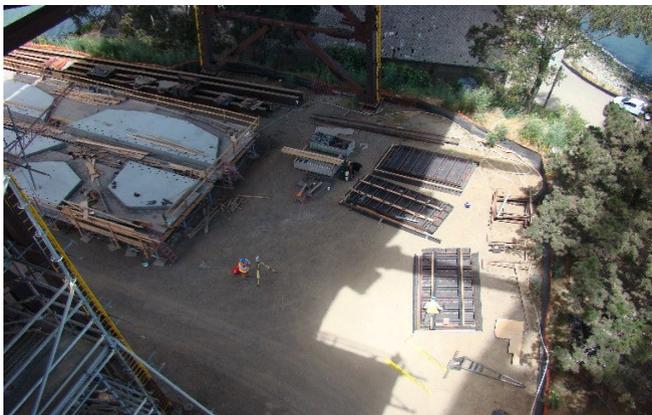
E-Line west deviation saddle mockup forms being checked by ABF surveyors.

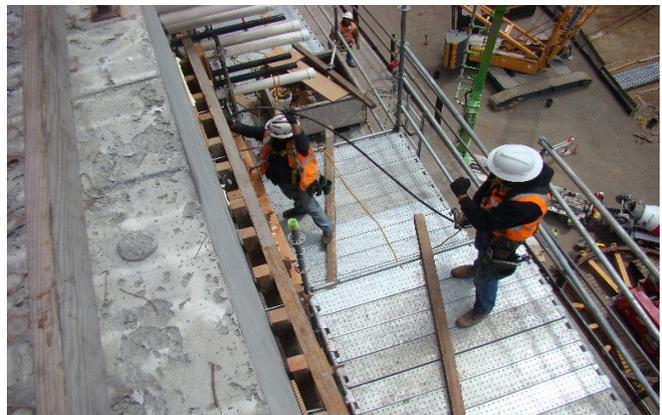
External vibration was done to WB continuity tendon blockout forms to push/consolidate the SCC due to the blockout geometry.

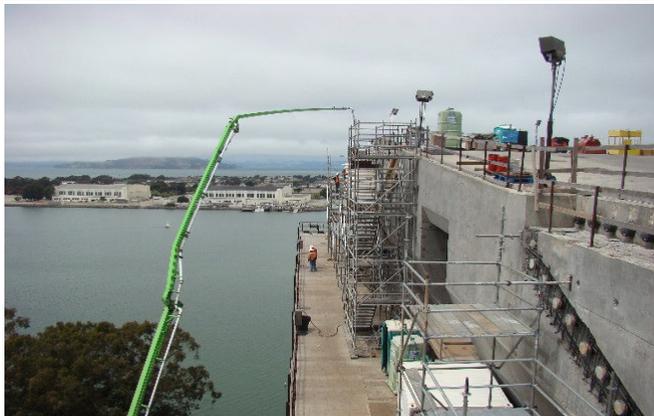
Concrete placement for the WB continuity tendon blockouts.

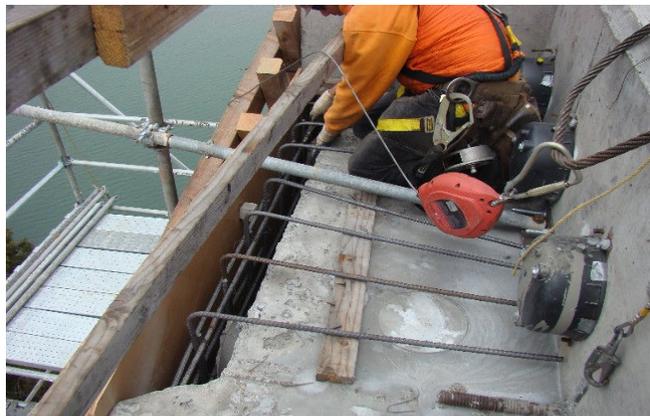
- Placed 7 "L" bars at the W42B and W44 blockout and 2 "L" bars at the W43 blockout. The dowel bars were missing and a decision was made in the field due to impending concrete placement today. See detail A section A-A on sheet 500R2 for additional details and the attached photo below.

CMC ironworker adding 7 "L" bars at the W42B and W44 blockout per my direction since drill and bond wasn't done.
