Daily Diary Report by Bid Item

Contract No.: 04-0120F4

04-0120F4
 04-SF-80-13.2/13.9
 Self-Anchored
 Suspension Bridge

Tower Activities

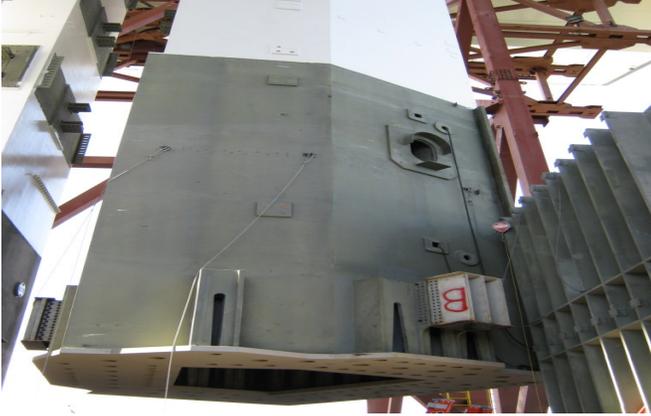
North shaft being lowered between West shaft & shear plate c(E)

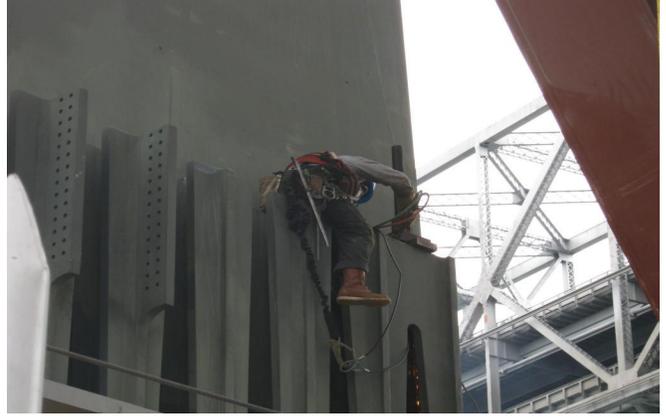
North shaft - torching rods to detach shaft from tip-up cart

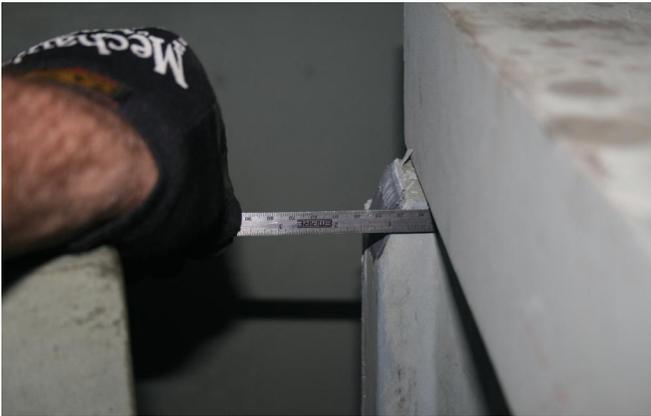
Note: During the lowering, there was no damage noticed to any anchor rods or dowels. However, minor damage occurred on the northerly-most interior type 1 bearing stiffener on shear plate c(E). During the lowering, the base plate of the North shaft scraped against the top edge of the type 1 bearing stiffener. A small piece (10mm X 20mm) of the shear plate bearing stiffener was sheared off (see attached photo).

Sheared corner of type 1 bearing stiffener on shear plate c(E)
