**Daily Diary Report by Bid Item**

Contract No.: 04-0120F4

Diary #: 124 Const Calendar Day: 351 Date: 25-Aug-2010 Wednesday

04-0120F4  
 04-SF-80-13.2/13.9  
 Self-Anchored  
 Suspension Bridge

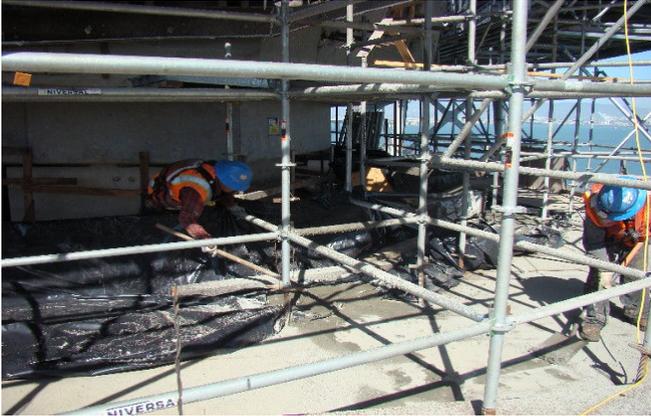
- 7.) Leaks were noticed in the forms between the top of Panels 1 and 2 at 3:25pm.

ABF laborers cleaning up the grout that leaked out of the forms.

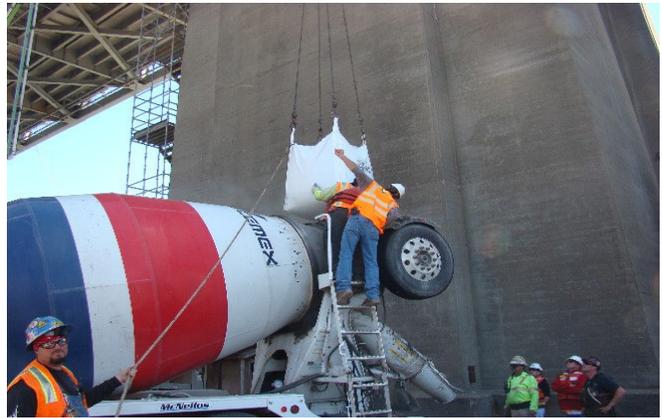
Placing a Masterflow 928 superbag into the drum of a Cemex concrete truck after a predetermined amount of water was placed in the drum.

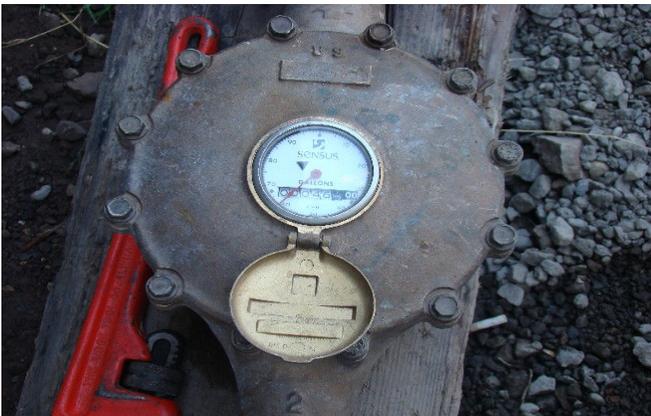
Water meter used to discharge water into the concrete truck drums.

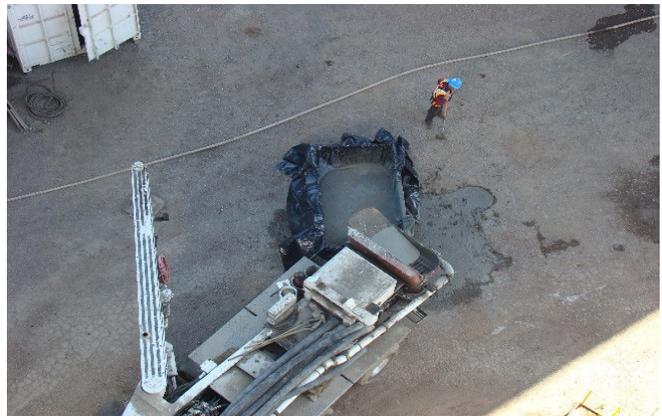
Grout which flowed out of the concrete pump hopper as soon as the grouting operation was stopped to fix leaks in the forms.

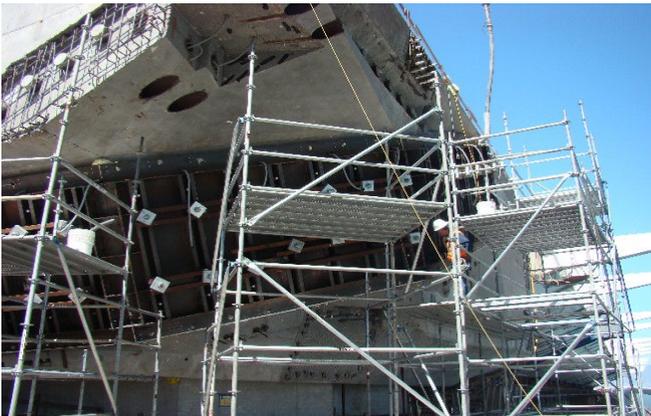
- 8.) The grouting operation ended at 4:25pm as the mockup forms were not completely filled with grout approximately 2 to 3 grout tubes from the top of Panel 3.

West Deviation Saddle grout pad mock up forms shown as there were multiple leaks observed during the grouting operation.

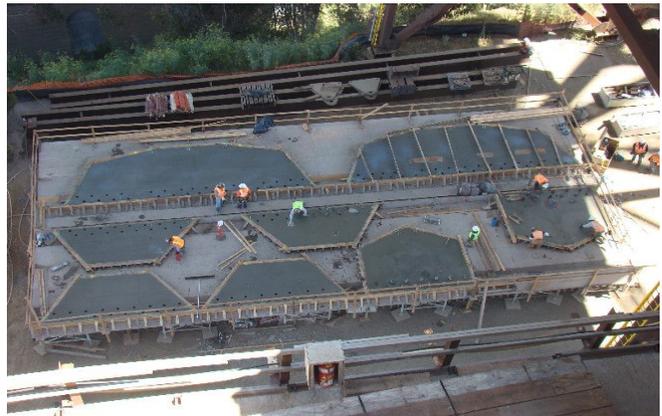
Conco carpenters and laborers working on the W2W precast retaining wall cover slabs.
