Daily Diary Report by Bid Item

Diary #: 016 Const Calendar Day: 513 Date: 03-Feb-2011 Thursday
 Inspector Name: Wright, Doug Title: Transportation Engineer
 Inspection Type: Intermittent
 Shift Hours: 07:00 AM 06:00 PM Break: 00:30 Over Time: 02:00

04-0120F4
 04-SF-80-13.2/13.9
 Self-Anchored
 Suspension Bridge

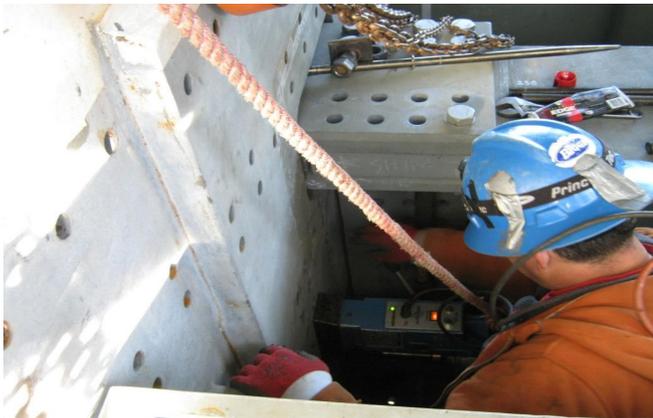
Stuck pin in the West shaft, end bolt hole for strut E-North:
 A drift pin, which appeared to be from ZPMC since it was primed coated on the shaft interior, was stuck in a bolt hole in the West shaft end bolt hole for strut E-North. The crews tried to drive it out with hammers and jacks without success. Eventually, they had to drill through the hole to remove it (see attached photo). The angle connection plate was removed prior to drilling. After the pin was removed, I inspected the bolt hole for damage. Only minor scuffing to the bolt hole was noticed.

Drilling out a stuck drift pin from West shaft end bolt hole
